Preowned Vehicle Inspection Report

Premium Inspection Analysis

Customer Name	: MERCEDES-BENZ MOBILITY (THAILAND) CO., LTD.	Inspection Date	: 2024-04-12
Tel.	: 0873663242	Lemon Inspection ID	: LEMON24040088
Inspector	: Aekkawit Tee Bunleng	Approved By	:

Brand	MERCEDES BENZ	Model year	2021
Model	GLA200	Engine Code - No.	28291430636010
Sub-model	URBAN	Registration year	2021-12-01
Registration No.	1UQ1924	Chassis No.	W1N2477876L003158
Current Mileage(km.)	84957	Engine Capacity(cc.)	1300

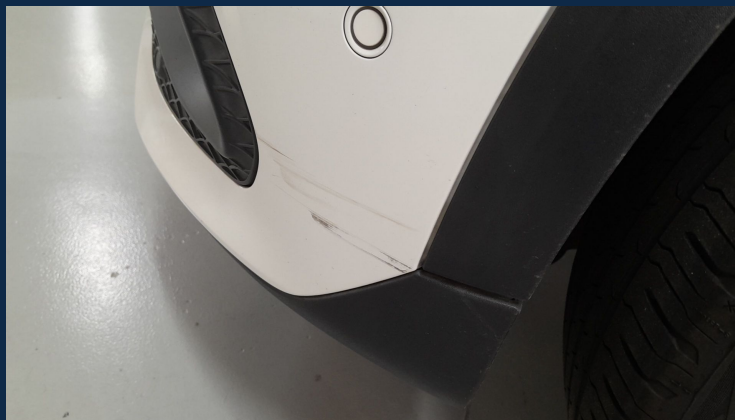
Vehicle Defect Notices

1. Front Skirt	O	14. Left Skirt	O
2. Front Bumper	O (D2)	15. Left Wing Mirror	O
3. Front Right Fender	O	16. Front Windshield	O
4. Front Right Wheel	O	17. Roof	O
5. Front Left Fender	O	18. Rear Right Fender	O
6. Front Left Wheel	O	19. Rear Bonnet	O
7. Front Bonnet	O	20. Back Right Wheel	O
8. Right Wing Mirror	O	21. Rear Bumper	O
9. Front Right Door	O	22. Rear Skirt	O
10. Rear Right Door	O	23. Rear Left Fender	O
11. Right Skirt	O	24. Back Left Wheel	O
12. Rear Left Door	O	25. Back Windshield	O
13. Front Left Door	O

Inspector : รุ่นรถ : ***MERCEDES BENZ GLA 200 Progressive*** ภายนอก : ไม่พบหลักฐานการทำสีเก็บสี
กันชนหน้าถลอก สภาพยางปกติทั้ง 4 เส้น ภายใน : โดยรวมสะอาดเรียบร้อย อุปกรณ์ไฟฟ้าทำงานได้ปกติ เครื่องยนต์
: เครื่องยนต์สามารถทำงานได้ปกติ ตรวจสอบด้วย OBD ไม่มีปัญหา โครงสร้าง : โครงสร้างหลักปกติ ไม่พบหลักฐาน
การซ่อมแซม

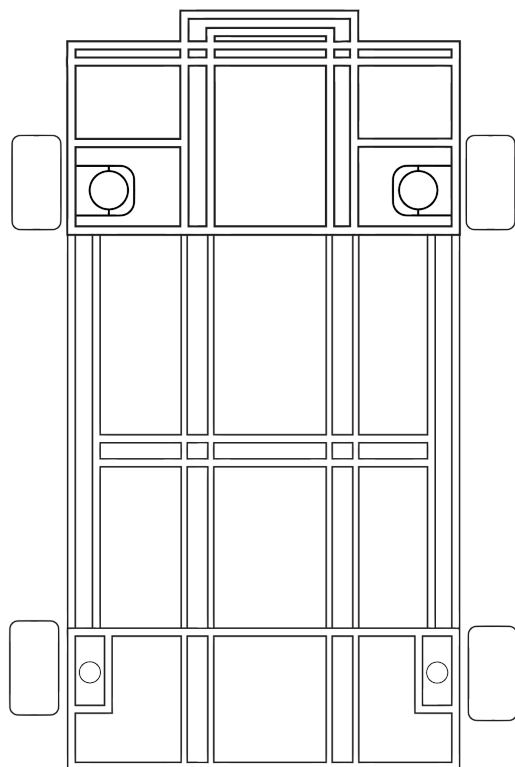
Chassis Report

No dent in the under carriage (th)	PASS
No deform chassis or chassis frame (th)	PASS
No visible corrosion on the chassis or chassis frame (th)	PASS
No missing part on the chassis frame (th)	PASS
Half cut Analysis (th)	PASS
Chassis Damage Level	no-damage
