Preowned Vehicle Inspection Report

Premium Inspection Analysis

Customer Name	:	Inspection Date	:	2024-04-30
Tel.	:	Lemon Inspection ID	:	LEMON24040199
Inspector	:	Approved By	:	tanruk tipin

Brand	MERCEDES BENZ	Model year	2018
Model	E350E	Engine Code - No.	27492031584042
Sub-model	AVANTGARDE	Registration year	2020-01-14
Registration No.		Chassis No.	WDD2130506L019731
Current Mileage(km.)	83684	Engine Capacity(cc.)	2000

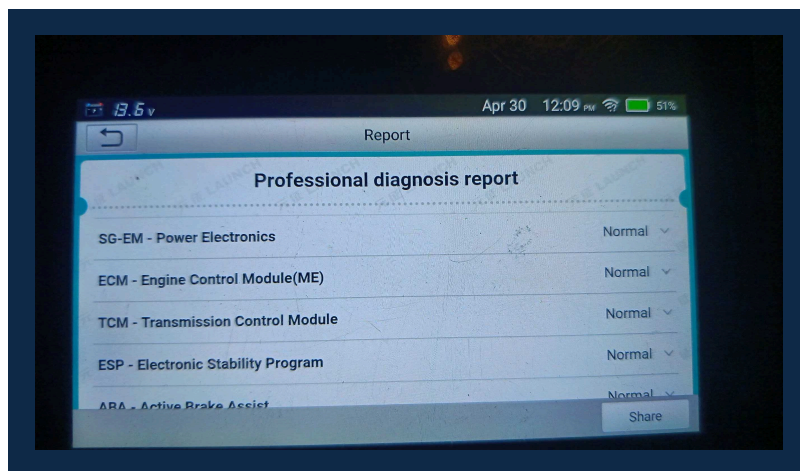
OBD Vehicle Health Analysis

Inspector : ภายนอก : พบมีริ้วรอยขีดข่วนตลอด รอบคัน , กระจกหน้ามีรอยสะเก็ดหิน ยางล้อหน้าซ้ายขวา ปกติ , ยางล้อหลังซ้ายขวาพบความผิดปกติ ยางรถคู่หลังกินด้านในของยาง แนะนำให้เปลี่ยนยางตั้งศูนย์ล้อใหม่ ภายใน : อุปกรณ์อำนวยความสะดวกภายในใช้งานได้ปกติ , เบาะนั่งหน้าขวามีคราบขาว , ผ้าหลังคามีรอยเจิม , พวงมาลัยมีรอยถลอกเล็กน้อย เครื่องยนต์และเกียร์ : สภาพเครื่องยนต์ใช้งานได้ปกติ , ตรวจสอบด้วยเครื่อง OBD ไม่พบโค้ดผิดปกติ โครงสร้าง : ไม่พบอุบัติเหตุเข้าถึงโครงสร้าง , ไม่พบความเสียหายหนักถึงโครงสร้าง

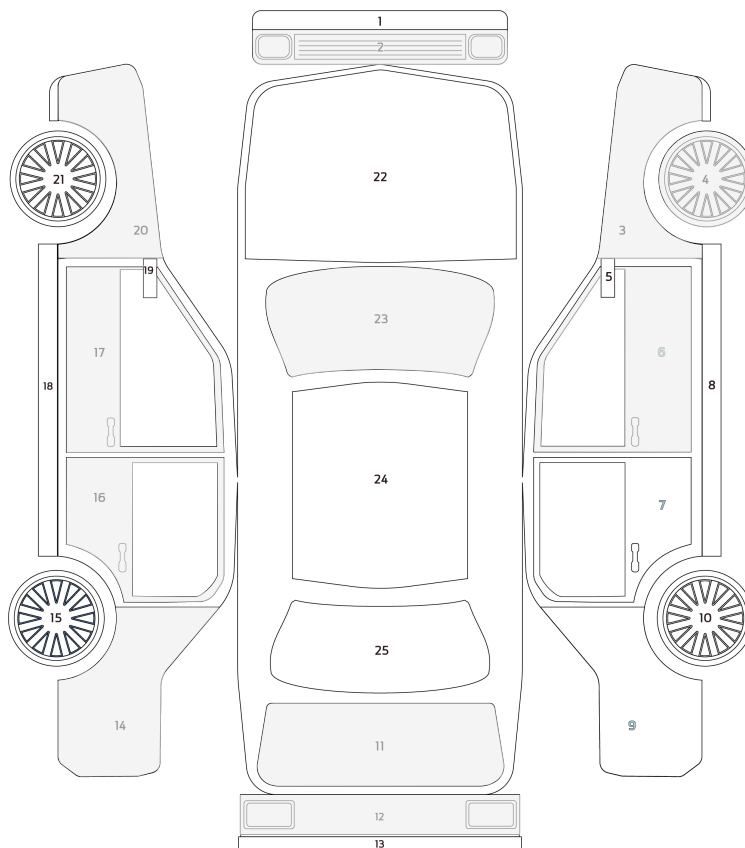
Exterior Inspection Points

1. Front Skirt	O	14. Left Skirt	O
2. Front Bumper	O (S2)	15. Left Wing Mirror	O
3. Front Right Fender	O (S1)	16. Front windshield	O (S1)
4. Front Right Wheel	O (S1)	17. Roof	O
5. Front Left Fender	O (S1)	18. Rear Right Fender	O
6. Front Left Wheel	O	19. Rear Bonnet	O (S1)
7. Front Bonnet	O	20. Back Right Wheel	O
8. Right Wing Mirror	O	21. Rear Bumper	O (S2)
9. Front right door	O (S1)	22. Rear Skirt	O
10. Rear Right Door	O	23. Rear left fender	O (S1)
11. Right Skirt	O	24. Back Left Wheel	O
12. Rear Left door	O (S2)	25. Back Windshield	O
13. Front left door	O (S1)

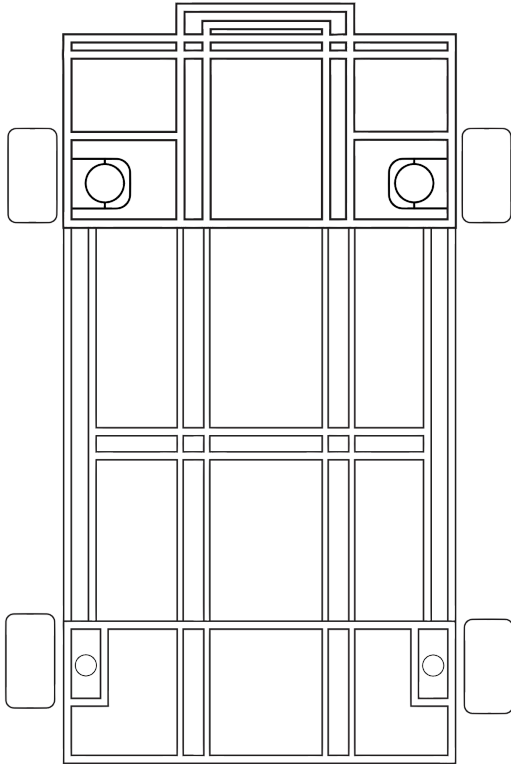
Chassis Report

No dent in the under carriage (th)	PASS
No deform chassis or chassis frame (th)	PASS
No visible corrosion on the chassis or chassis frame (th)	PASS
No missing part on the chassis frame (th)	PASS
Half cut Analysis (th)	PASS
Chassis Damage Level	No Damage
