Preowned Vehicle Inspection Report

Customer Name	: MERCEDES-BENZ MOBILITY (THAILAND) CO., LTD.	Inspection Date	: 2024-05-29
Tel.	: _____	Lemon Inspection ID	: LEMON24050296
Inspector	: tanruk tipin	Approved By	: Sakulpong Singnarong

Brand	MERCEDES BENZ	Model year	2023
Model	E300e	Engine Code - No.	27492032031863
Sub-model	AMG Dynamic	Registration year	2023-10-06
Registration No.		Chassis No.	W1K2130536L055713
Current Mileage(km.)	22715	Engine Capacity(cc.)	1991

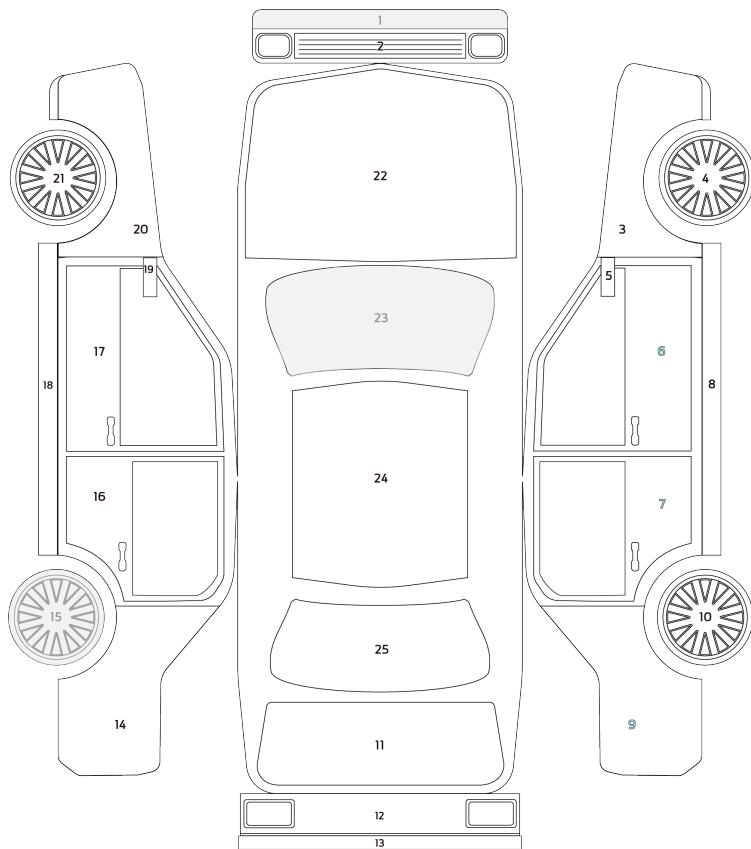
Exterior Inspection Points

1. Front Skirt	O (S1)	14. Left Skirt	O
2. Front Bumper	O	15. Left Wing Mirror	O
3. Front Right Fender	O	16. Front windshield	O (G1)
4. Front Right Wheel	O	17. Roof	O
5. Front Left Fender	O	18. Rear Right Fender	O
6. Front Left Wheel	O	19. Rear Bonnet	O
7. Front Bonnet	O	20. Back Right Wheel	O
8. Right Wing Mirror	O	21. Rear Bumper	O
9. Front Right Door	O	22. Rear Skirt	O
10. Rear Right Door	O	23. Rear Left Fender	O
11. Right Skirt	O	24. Back left wheel	O (S1)
12. Rear Left Door	O	25. Back Windshield	O
13. Front Left Door	O

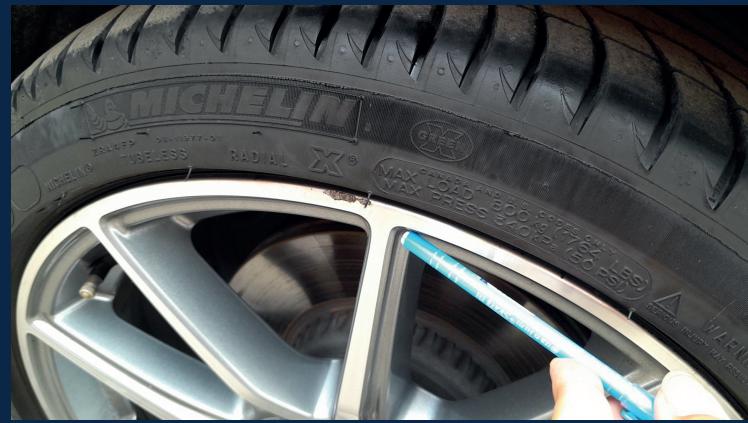
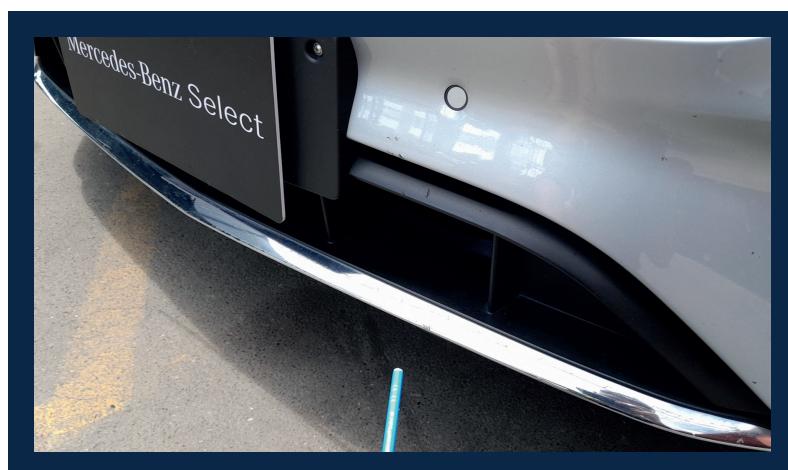
Vehicle Defect Notices

Inspector : MERCEDES BENZ E300e AMG Dynamic ภายนอก(Exterior) : ภายนอกโดยรวมไม่พบหลักฐานการซ่อมแซมทำสี / รถมีรอยคลอกเล็กน้อย / สภาพยางปักติดกัน 4 เส้น / ล้อแม็กหลังชำรุดลอก ภายใน(Interior) : ภายในปักติด สะอาดเรียบร้อย, อุปกรณ์ไฟฟ้า แอร์ วิทยุ ใช้งานได้ปกติ เครื่องยนต์(Engine) : เครื่องยนต์ทำงานปกติ, วิเคราะห์ปัญหาด้วยเครื่อง OBDII ไม่พบสิ่งผิดปกติ (ไม่ได้ทดสอบขับขี่) โครงสร้าง(Frame) : ตรวจสอบไม่พบอุบัติเหตุ, โครงสร้างหลักปักติด ไม่มีการซ่อมแซมโครงสร้างหรือมีการชนถึงโครงสร้าง รถสวาย พร้อมใช้งาน โครงสร้างตัวรถเดิม

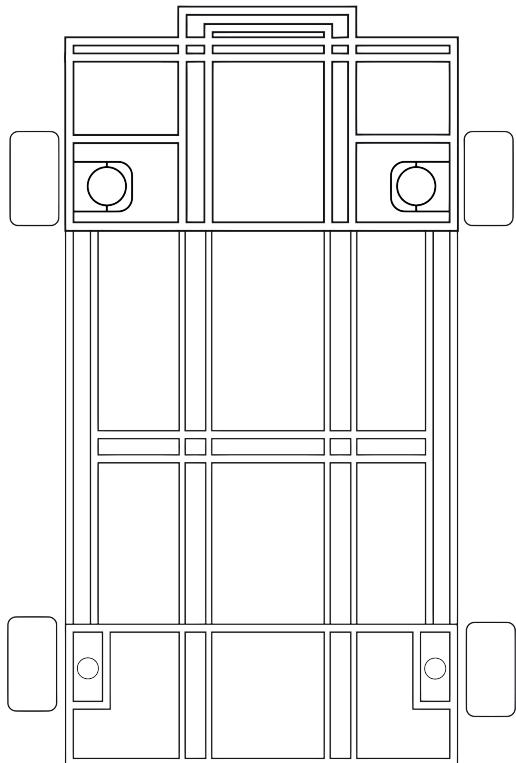
Chassis Report

No dent in the under carriage (th)	PASS
No deform chassis or chassis frame (th)	PASS
No visible corrosion on the chassis or chassis frame (th)	PASS
No missing part on the chassis frame (th)	PASS
Half cut Analysis (th)	PASS

Chassis Damage Level	No Damage
----------------------	-----------
