# Preowned Vehicle Inspection Report

| Customer Name | : MERCEDES-BENZ MOBILITY (THAILAND) CO., LTD. | Inspection Date | : 2024-05-30 |

| Brand | MERCEDES BENZ | Model year | 2019 |
| Model | GLA250 | Engine Code - No. | 27092031823632 |

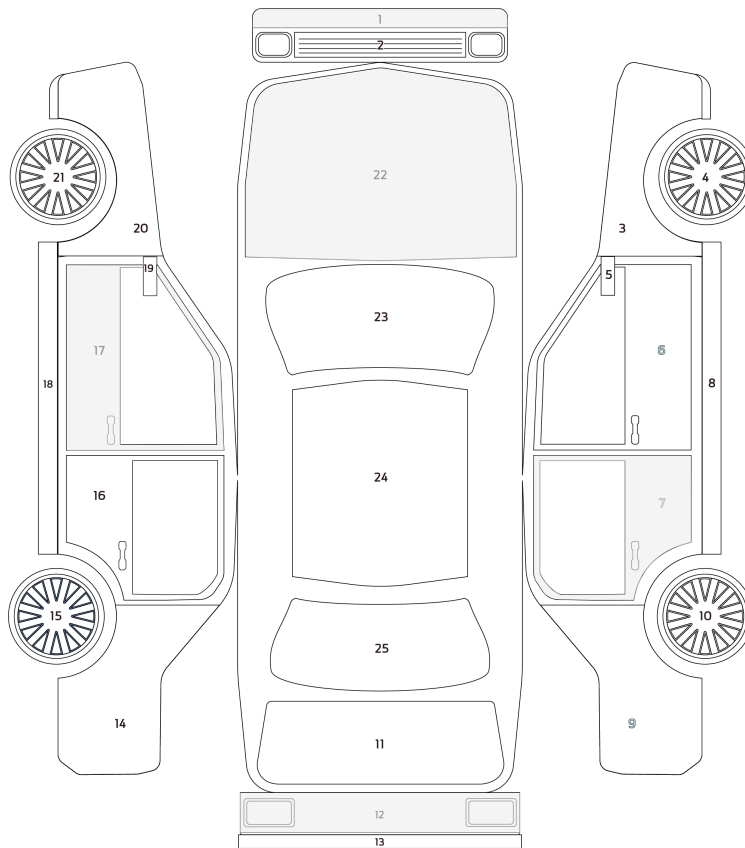
## Exterior Inspection Points

| 1. Front Skirt | O (S1) | 14. Left Skirt | O |
| 7. Front bonnet | O (G1) | 20. Back Right Wheel | O |
| 8. Right Wing Mirror | O | 21. Rear Bumper | O (S1) |
| 10. Rear right door | O (S1) | 23. Rear Left Fender | O |
| 13. Front left door | O (G1) | | |
