Preowned Vehicle Inspection Report

Premium Inspection Analysis

Customer Name	: MERCEDES-BENZ MOBILITY (THAILAND) CO., LTD.	Inspection Date	: 2024-05-31
Tel.	: 0873663242	Lemon Inspection ID	: LEMON24050329
Inspector	: tanruk tipin	Approved By	:

Brand	MERCEDES BENZ	Model year	2019
Model	GLC250D	Engine Code - No.	65192134947724
Sub-model	4MATIC AMG PLUS	Registration year	2019-09-03
Registration No.	9นข2356	Chassis No.	WDC2539096L021434
Current Mileage(km.)	105939	Engine Capacity(cc.)	2143

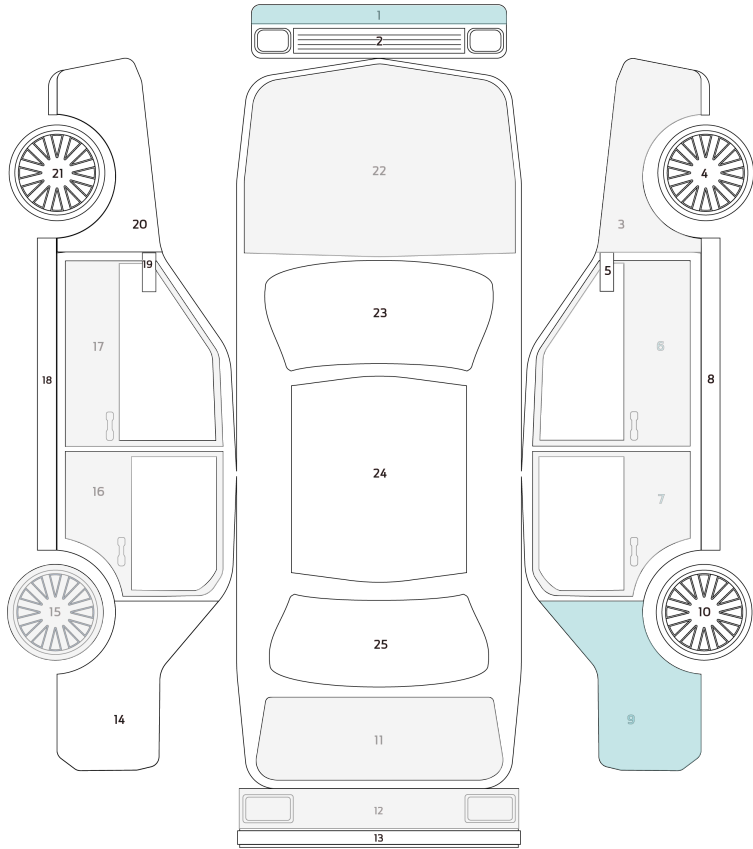
Exterior Inspection Points

1. Front Skirt	BP (S1)	14. Left Skirt	O
2. Front Bumper	O	15. Left Wing Mirror	O
3. Front Right Fender	O (S1)	16. Front Windshield	O
4. Front Right Wheel	O	17. Roof	O
5. Front Left Fender	O	18. Rear right fender	BP (D1)
6. Front Left Wheel	O	19. Rear Bonnet	O (S1)
7. Front bonnet	O (G1)	20. Back Right Wheel	O
8. Right Wing Mirror	O	21. Rear Bumper	O (S1)
9. Front right door	O (S1)	22. Rear Skirt	O
10. Rear right door	O (S1)	23. Rear Left Fender	O
11. Right Skirt	O	24. Back left wheel	O (S1)
12. Rear Left door	O (S1)	25. Back Windshield	O
13. Front left door	O (S1)

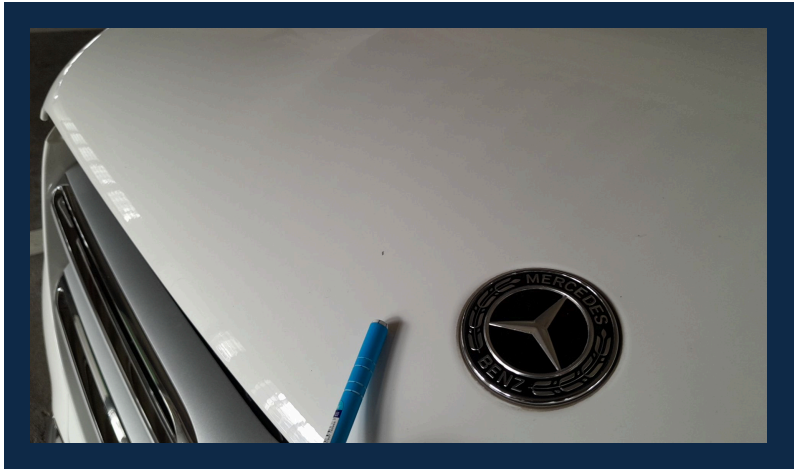
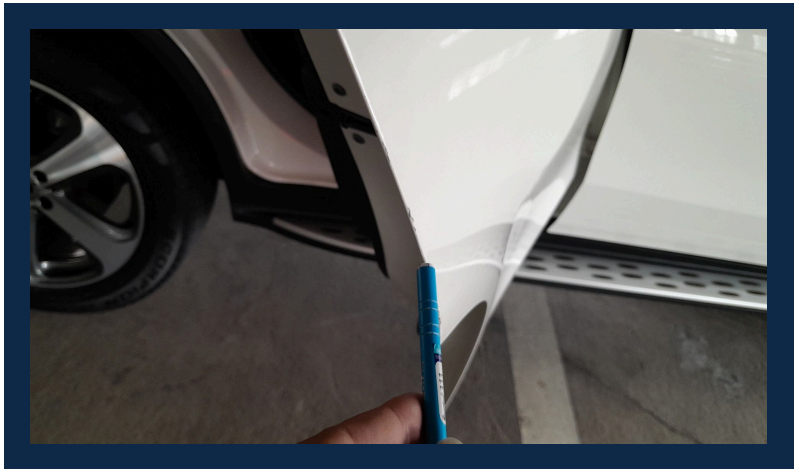
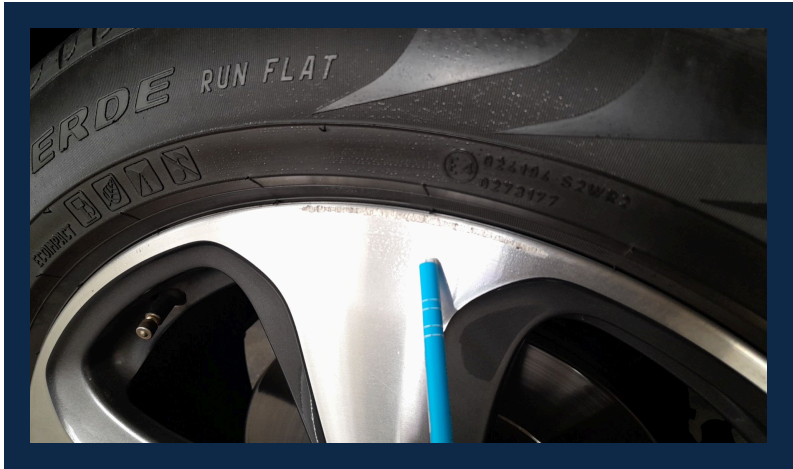
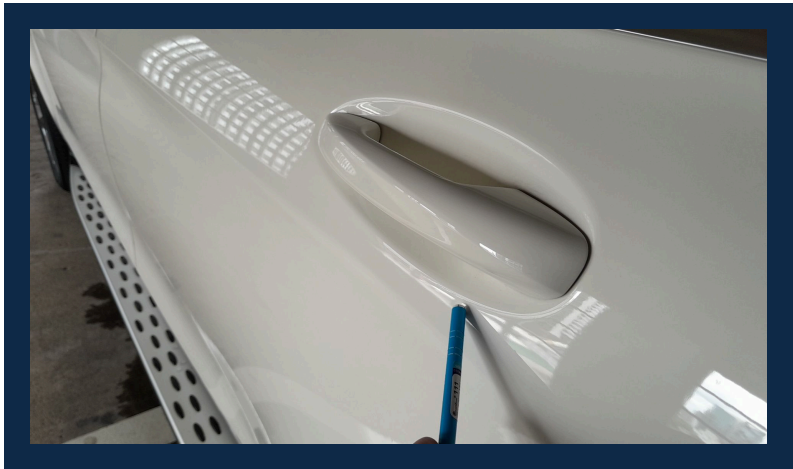
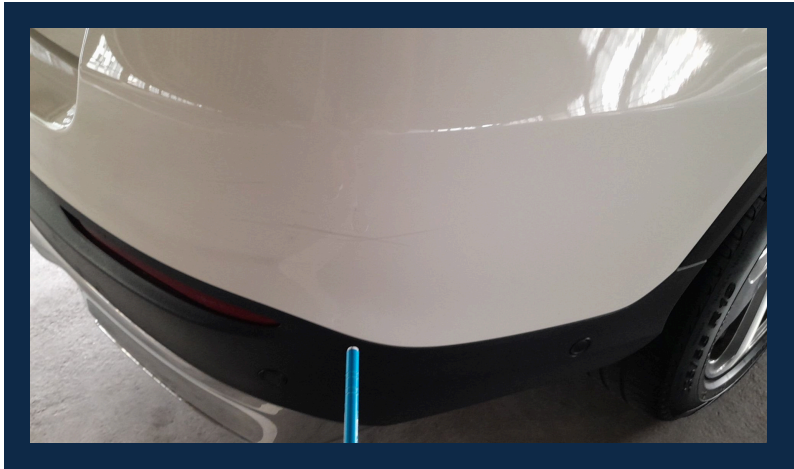
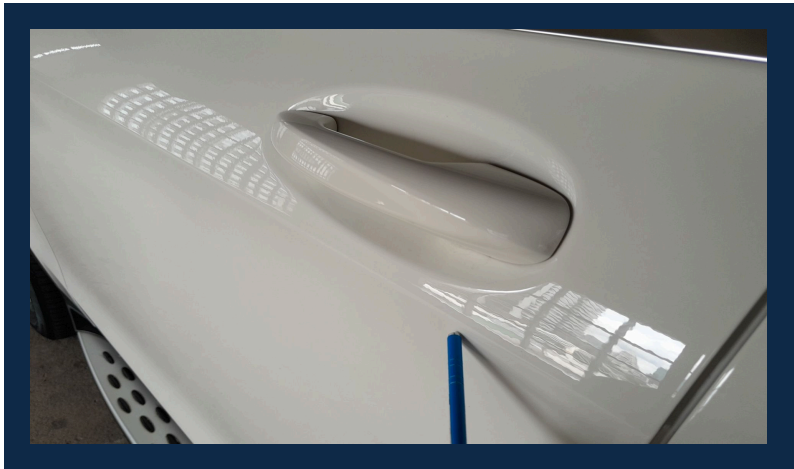
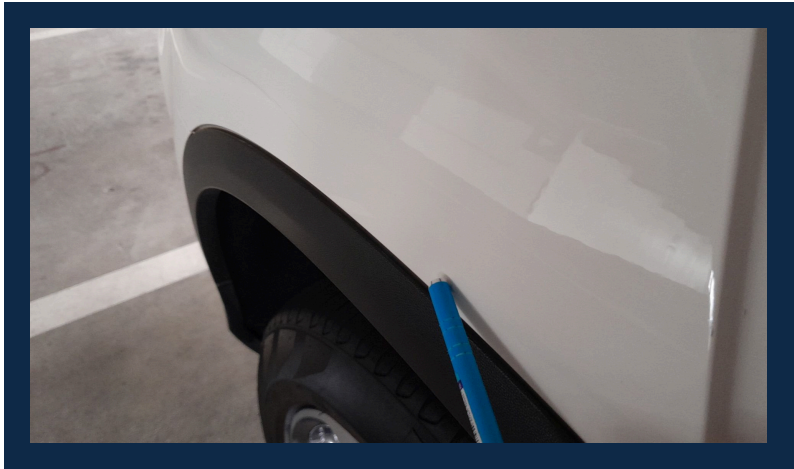
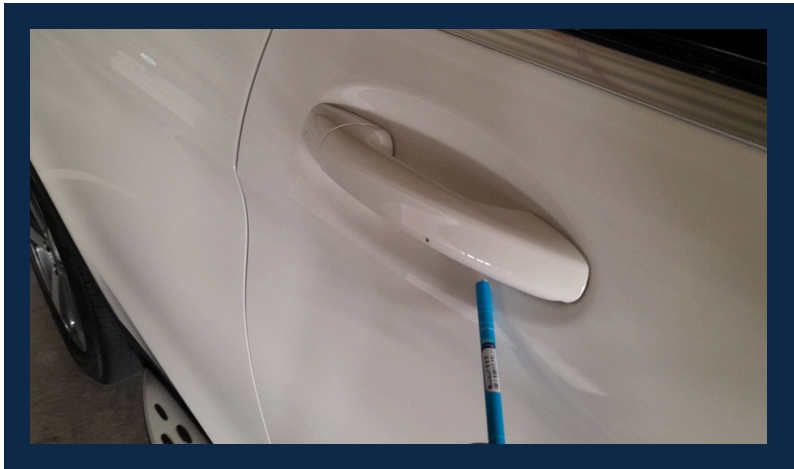
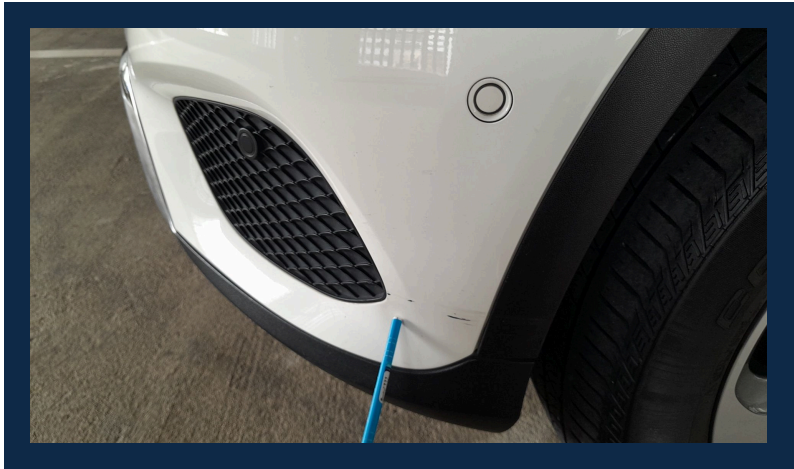
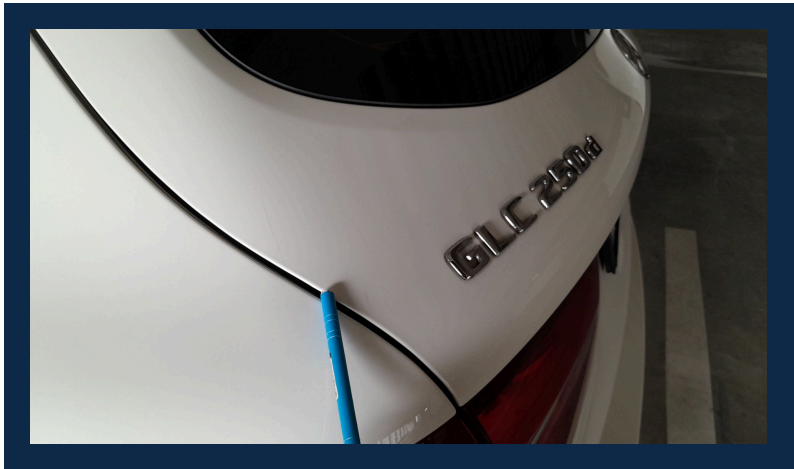
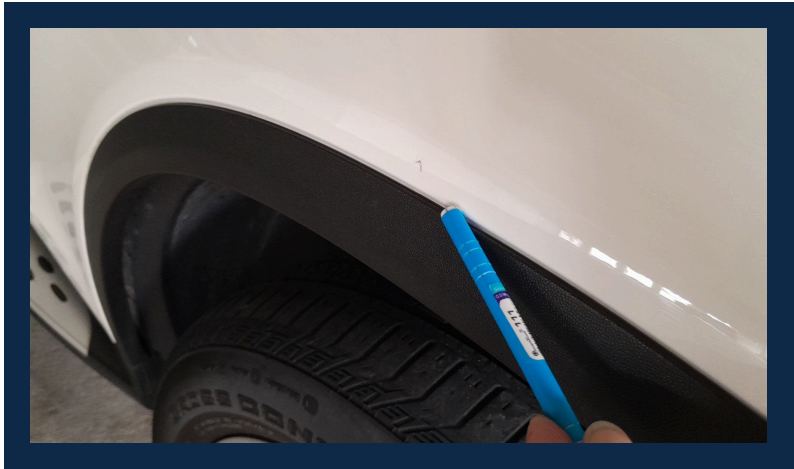
Vehicle Defect Notices

Inspector : MERCEDES BENZ GLC250d 4MATIC Off Road ภายนอก(Exterior) : ภายนอกพพหลักฐานการซ่อมแซมทำสีบางชิ้น / รั้วรอยรอบคันเล็กน้อย / ยางคู่หลังเสื่อมสภาพ ยางคู่หน้าปกติ / ล้อแม็กเป็นรอยถลอกเล็กน้อย ภายใน(Interior) : ภายในสะอาดเรียบร้อย ,อุปกรณ์ไฟฟ้า แอร์ วิทยุ ใช้งานได้ปกติ เครื่องยนต์(Engine) : เครื่องยนต์ทำงานปกติ ,ไม่สามารถตรวจเช็ค OBDII ได้ รุ่นนี้ OBDII ไม่รองรับ (ไม่ได้ทดสอบขั้วชี้) โครงสร้าง(Frame) : ตรวจสอบไม่พบอุบัติเหตุ ,โครงสร้างหลักปกติ ไม่มีการซ่อมแซมโครงสร้างหรือมีการชนถึงโครงสร้าง โดยรวม รถมสวย พร้อมใช้งาน โครงสร้างรถเดิม
