# Preowned Vehicle Inspection Report

Premium Inspection Analysis

| Brand | MERCEDES BENZ | Model year | 2019 |
| Model | GLC250D | Engine Code - No. | 65192134946078 |

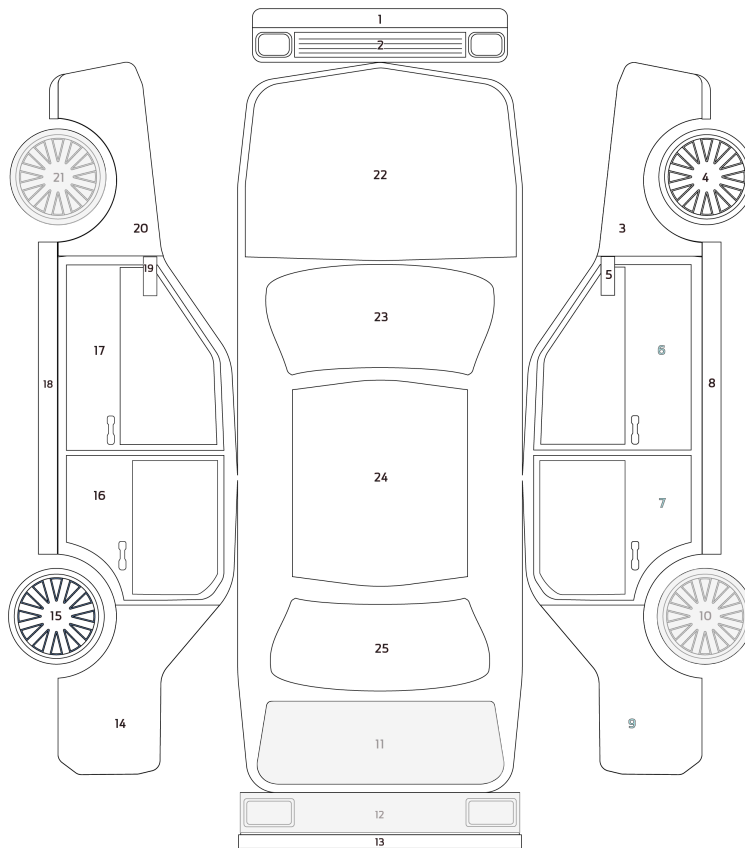
**Exterior Inspection Points**

| 6. Front Left Wheel | O (S1) | 19. Rear Bonnet | O (S1) |
| 7. Front Bonnet | O | 20. Back right wheel | O (S1) |
| 8. Right Wing Mirror | O | 21. Rear Bumper | O (S1) |

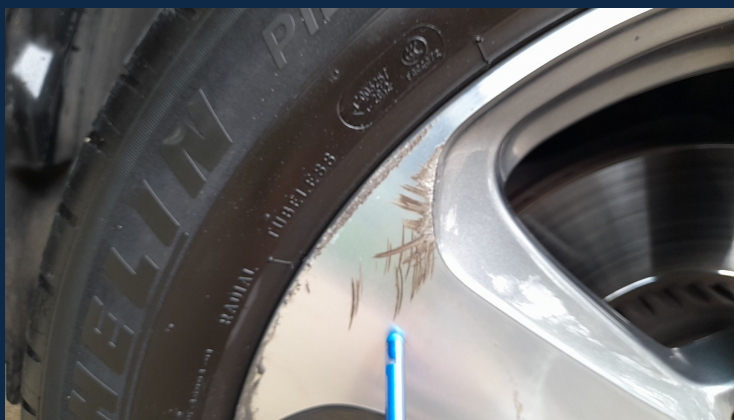
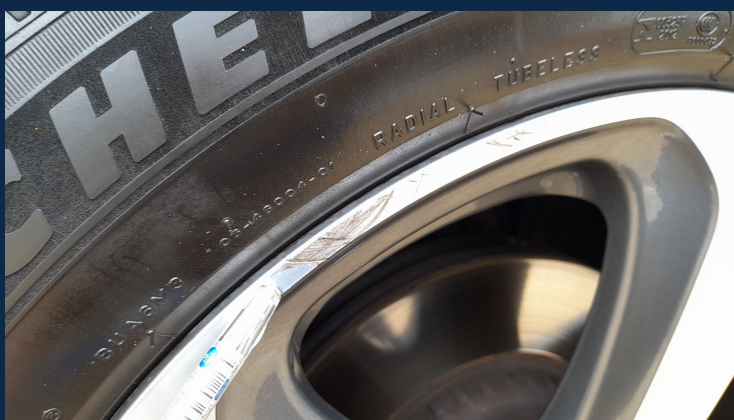
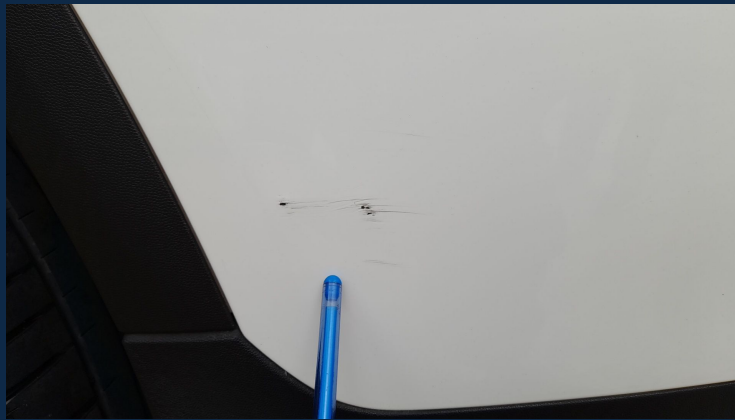
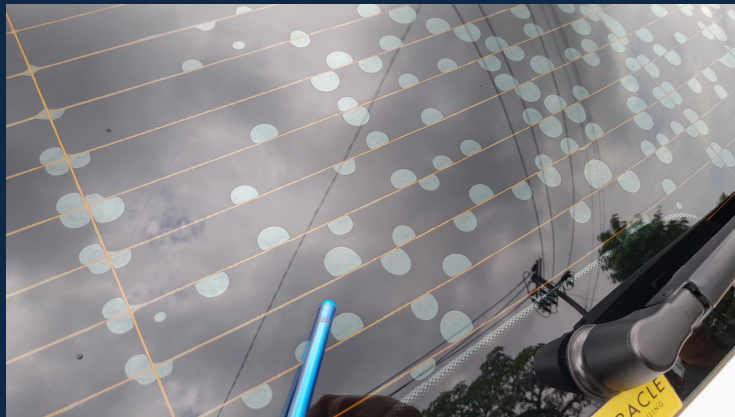
**Vehicle Defect Notices**

**Inspector :** \*\*GLC 250d 4MATIC Off-Road หมายถึง\* ภายนอก(Exterior) : การตรวจสอบสภาพภายนอกโดยรวมไม่พบหลักฐานการซ่อมแซมทำสี ล้อแม็กหน้าซ้ายมีรอยครูด รื้อรอยกลอกรอบคัน ล้อหลังขวาครูดเล็กน้อย / สภาพยางปกติทั้ง4เส้น ปี22 ภายใน(Interior) : ภายในเบาะหน้าขวาเป็นรอยถลอก ภายในสะอาดเรียบร้อย , อุปกรณ์ไฟฟ้า แอร์ วิทยุFM ใช้งานได้สมบูรณ์ครบปกติ เครื่องยนต์(Engine) : เครื่องยนต์ทำงานได้ปกติ ฝาครอบวาวล์สรวซึมเล็กน้อย , วิเคราะห์ปัญหาด้วยเครื่อง OBDII พบโค้ดผิดปกติแนะนำเข้าสู่ศูนย์ตรวจเช็ค(ไม่ได้ทดสอบขับ) โครงสร้าง(Frame) : อุบัติเหตุไม่มี , โครงสร้างหลักปกติ ไม่มีการซ่อมแซมโครงสร้างหรือมีการชนถึงโครงสร้าง
