# Preowned Vehicle Inspection Report

Premium Inspection Analysis

Customer Name	: MERCEDES-BENZ MOBILITY (THAILAND) CO., LTD.	Inspection Date	: 2024-06-19
Tel.	: 0873663242	Lemon Inspection ID	: LEMON24060184
Inspector	: tanruk tipin	Approved By	: Chaimongkol C

Brand	MERCEDES BENZ	Model year	2022
Model	A200	Engine Code - No.	28291430656636
Sub-model	AMG Dynamic	Registration year	2022-02-07
Registration No.		Chassis No.	W1K1771876L003283
Current Mileage(km.)	27984	Engine Capacity(cc.)	1300

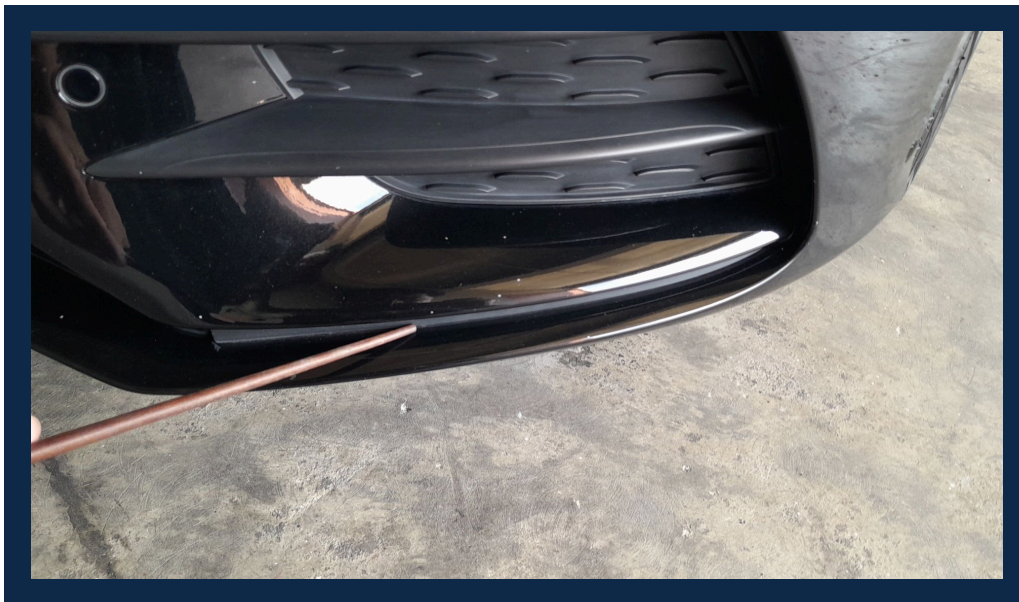
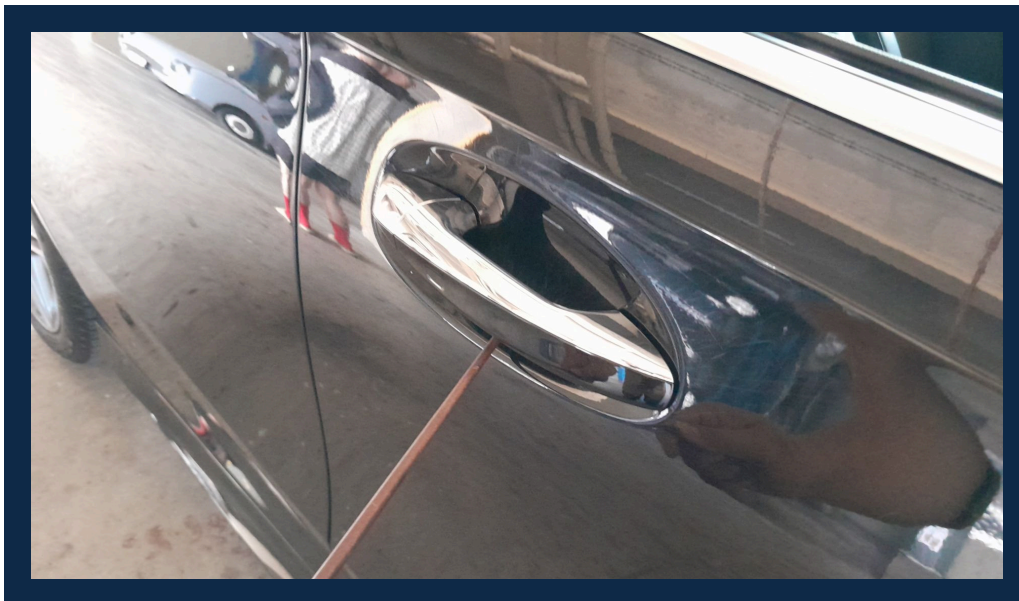
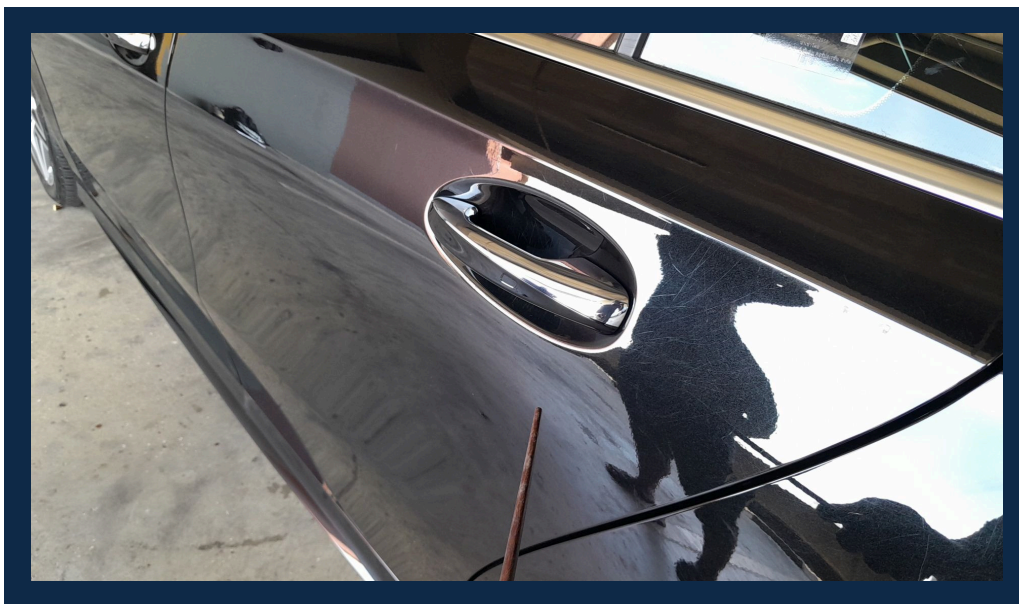
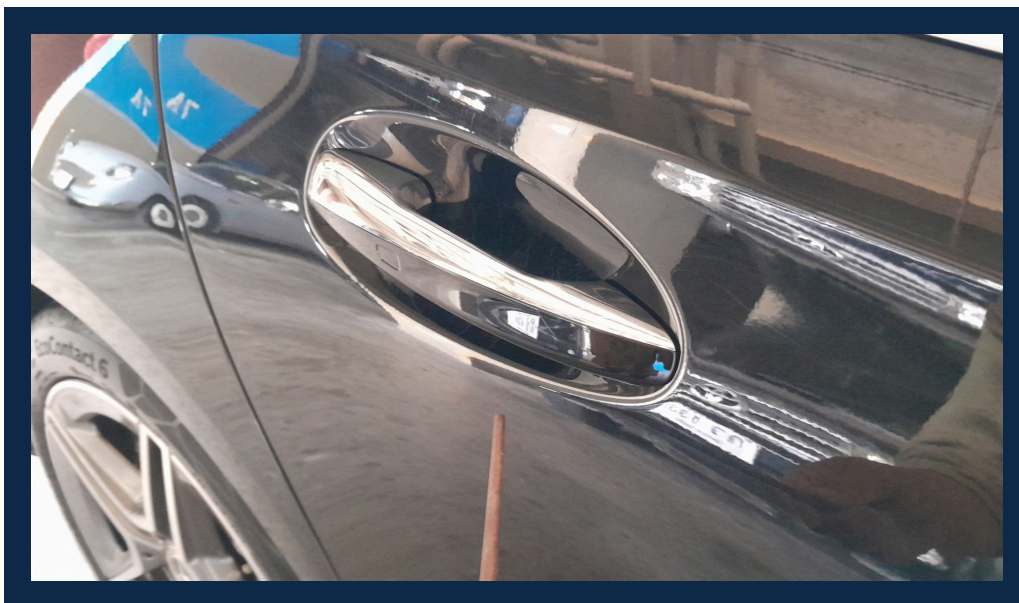
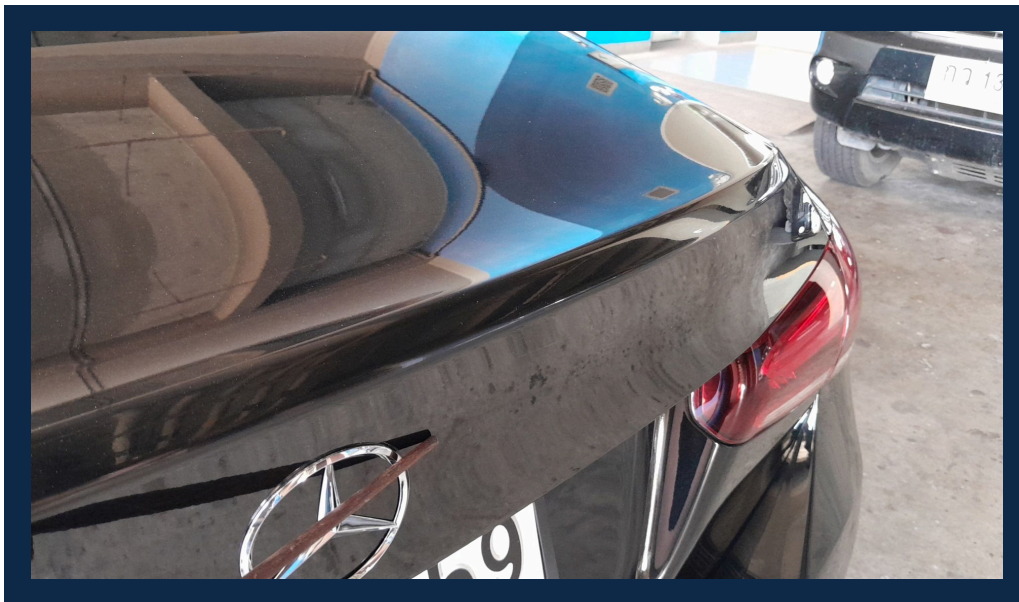
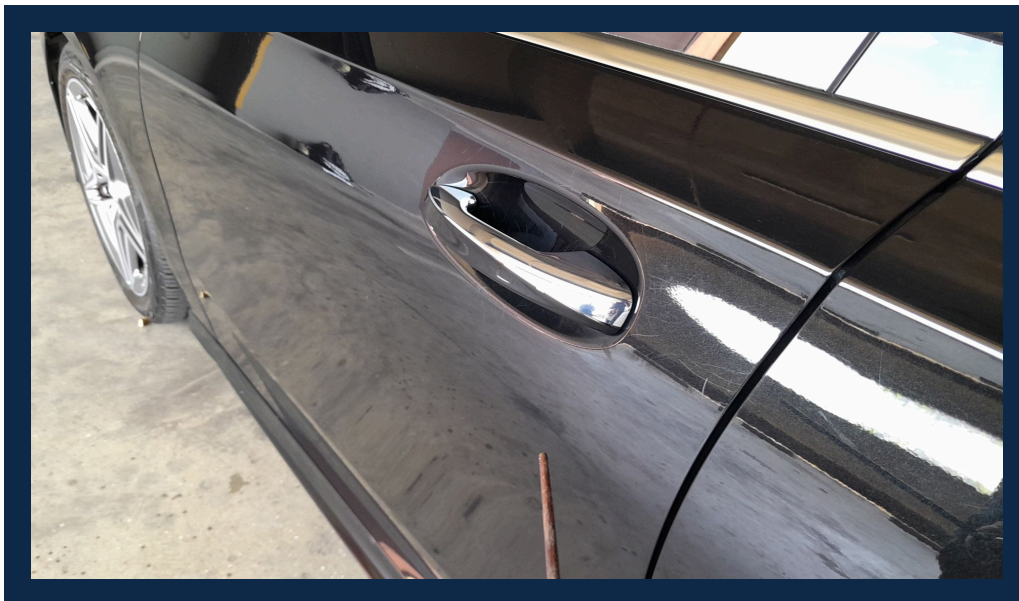
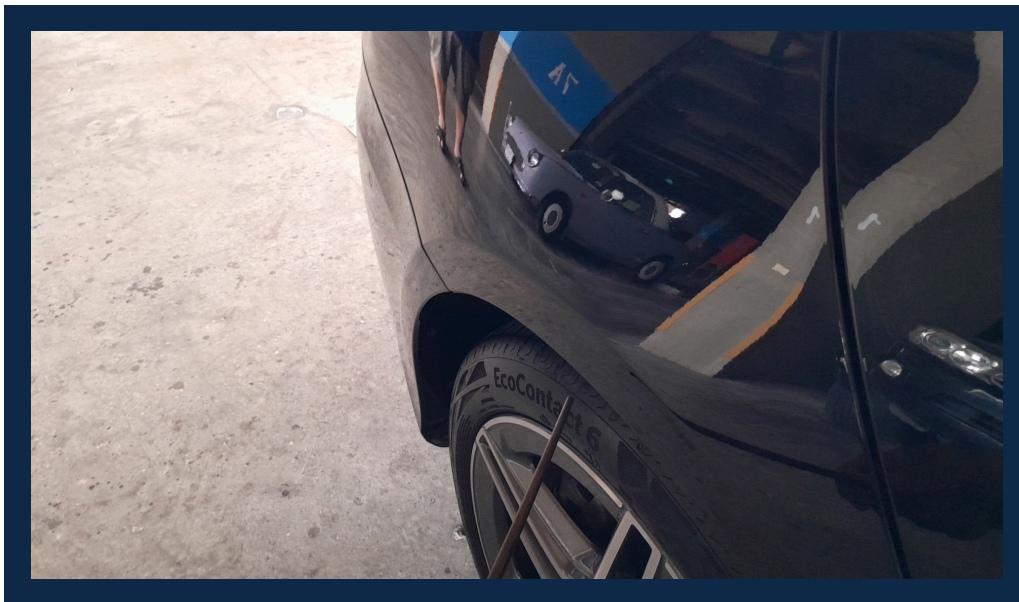
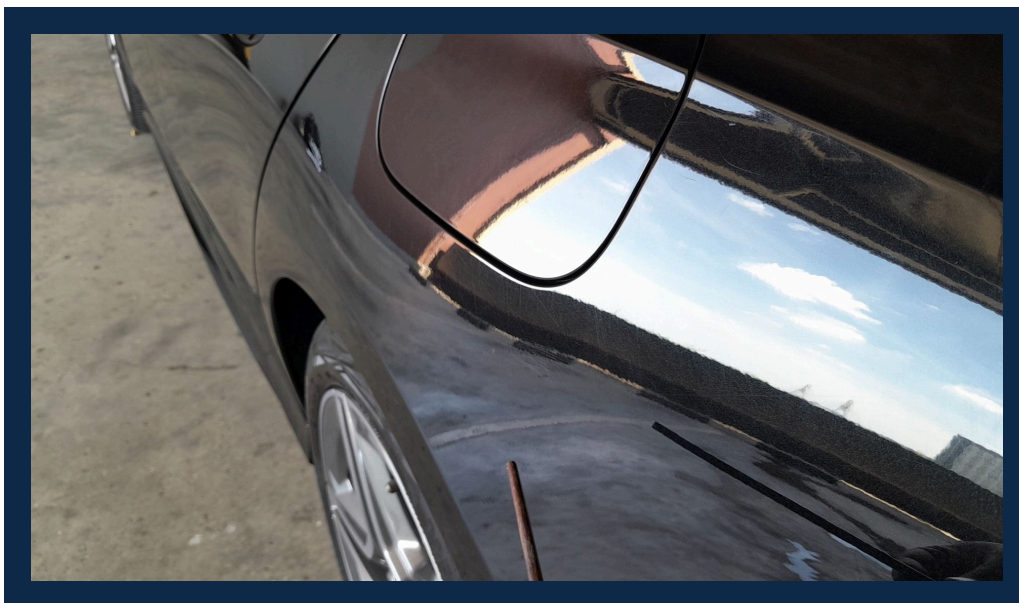
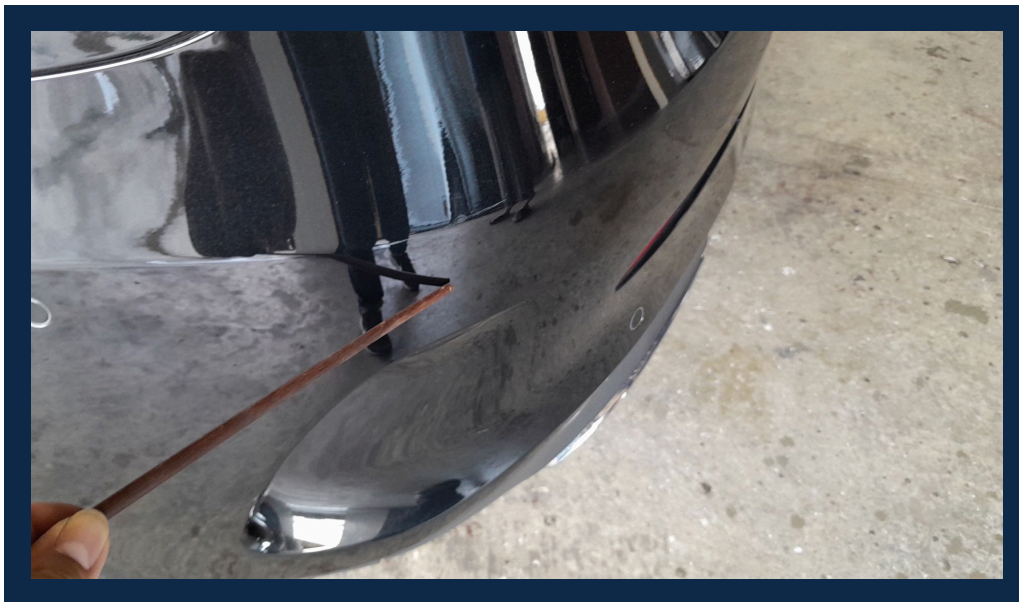
1. Front Skirt	O	14. Left Skirt	O
2. Front Bumper	O (G1)	15. Left Wing Mirror	O
3. Front Right Fender	O	16. Front Windshield	O
4. Front Right Wheel	O	17. Roof	O
5. Front Left Fender	O	18. Rear right fender	O (S1)
6. Front Left Wheel	O	19. Rear Bonnet	O (S1)
7. Front Bonnet	O	20. Back Right Wheel	O
8. Right Wing Mirror	O	21. Rear Bumper	O (S1)
9. Front right door	O (S1)	22. Rear Skirt	O
10. Rear right door	O (S1)	23. Rear left fender	O (S1)
11. Right Skirt	O	24. Back Left Wheel	O
12. Rear Left door	O (S1)	25. Back Windshield	O
13. Front left door	O (S1)
