# Preowned Vehicle Inspection Report

Premium Inspection Analysis

| Brand | MERCEDES BENZ | Model year | 2019 |
| Model | GLC250 | Engine Code - No. | 65192134912652 |

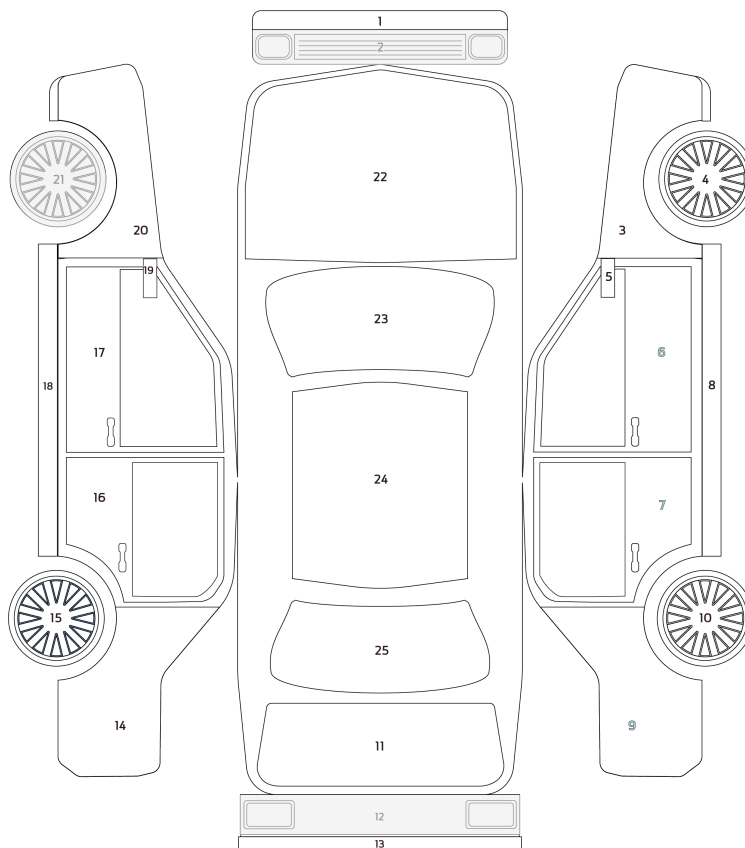
## Exterior Inspection Points

| 2. Front Bumper | O (S1) | 15. Left Wing Mirror | O |
| 6. Front Left Wheel | O (S2) | 19. Rear Bonnet | O |
| 8. Right Wing Mirror | O | 21. Rear Bumper | O (S1) |

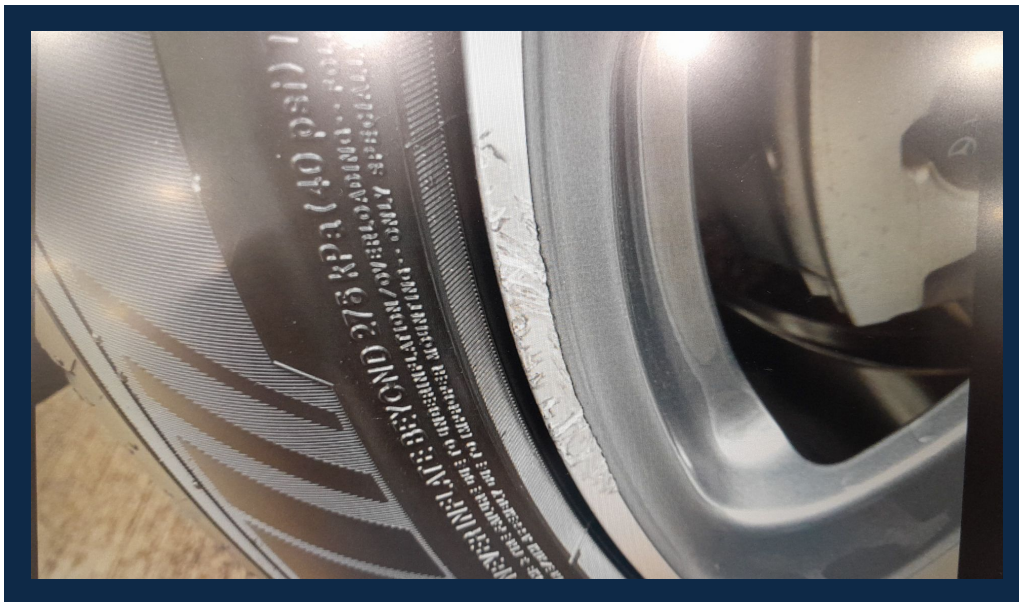
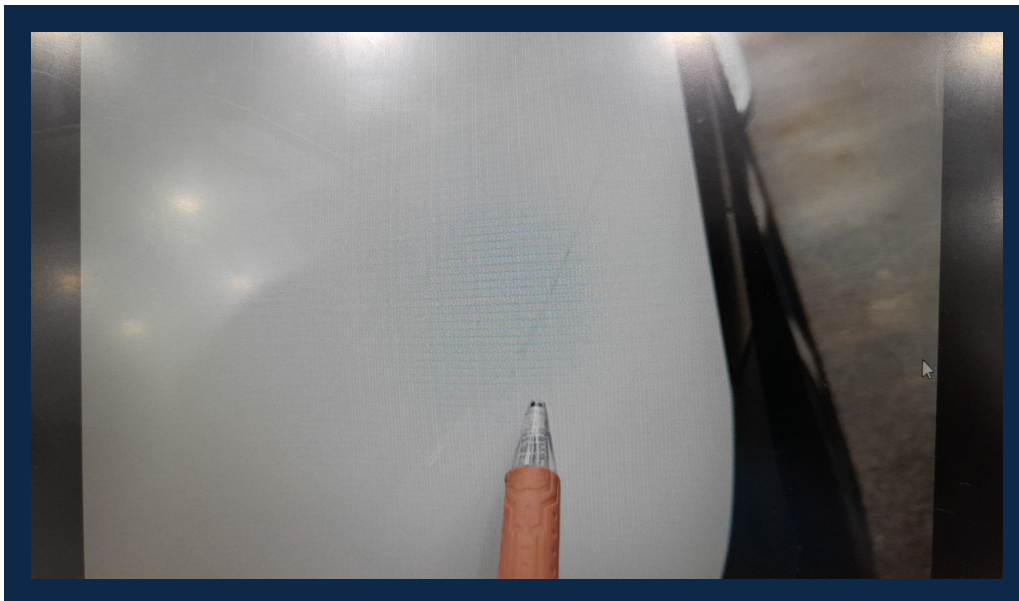
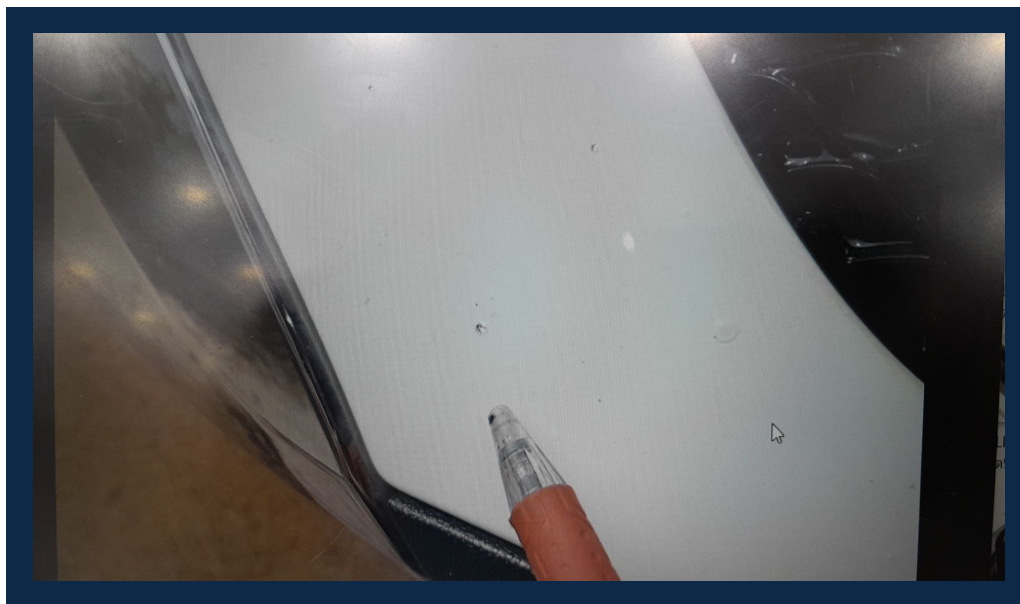
**Vehicle Defect Notices**

**Inspector :** ภายนอก(Exterior) : การตรวจสอบสภาพภายนอกโดยรวมไม่พบหลักฐานการซ่อมแซมทำสี มีริ้วรอยถลอก รอยคัน/ สภาพยางปกติทั้ง4เส้น ปี 23 ล้อแม็กเป็นรอยถลอก ภายใน(Interior) : ภายใน เบาะหน้าขวาเป็นรอยขาด สะอาดเรียบร้อย , อุปกรณ์ไฟฟ้า แอร์ วิทยุFM ใช้งานได้สมบูรณ์ครบปกติ เครื่องยนต์(Engine) : เครื่องยนต์ทำงานได้ปกติ , วิเคราะห์ปัญหาด้วยเครื่อง OBDII ไม่พบสิ่งผิดปกติ ไม่สามารถตรวจสอบเลขเครื่องได้ (ไม่ได้ทดสอบขับขึ้น) โครงสร้าง(Frame) : อุบัติเหตุไม่มี , โครงสร้างหลักปกติ ไม่มีการซ่อมแซมโครงสร้างหรือมีการชนถึงโครงสร้าง

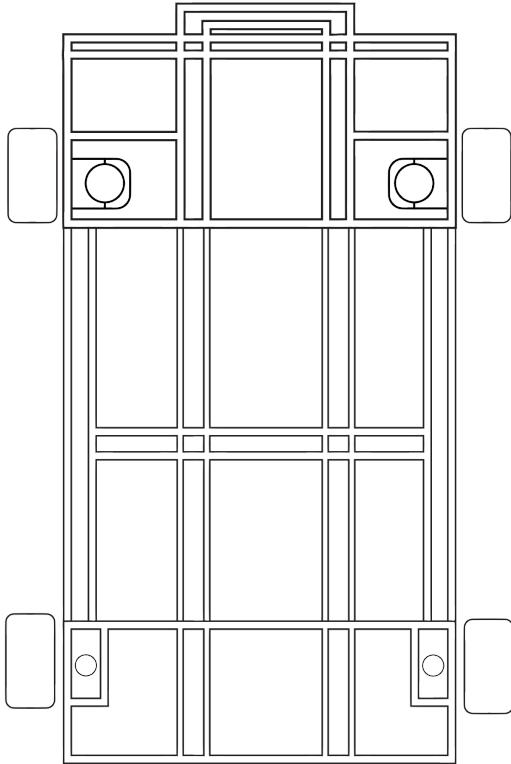
**Chassis Report**

| Chassis Damage Level | No Damage |
