# Preowned Vehicle Inspection Report

Customer Name	: MERCEDES-BENZ MOBILITY (THAILAND) CO., LTD.	Inspection Date	: 2024-06-21
Tel.	: _____	Lemon Inspection ID	: LEMON24060221
Inspector	: ແກ່າວສັກ ຖອຍ ທີພຍອິນທີ	Approved By	: Chaimongkol C

Brand	MERCEDES BENZ	Model year	2019
Model	GLC250	Engine Code - No.	27492031674104
Sub-model	d 4MATIC (AMG Dynamic)	Registration year	2019-08-07
Registration No.		Chassis No.	WDC2533466L019809
Current Mileage(km.)	44702	Engine Capacity(cc.)	2000

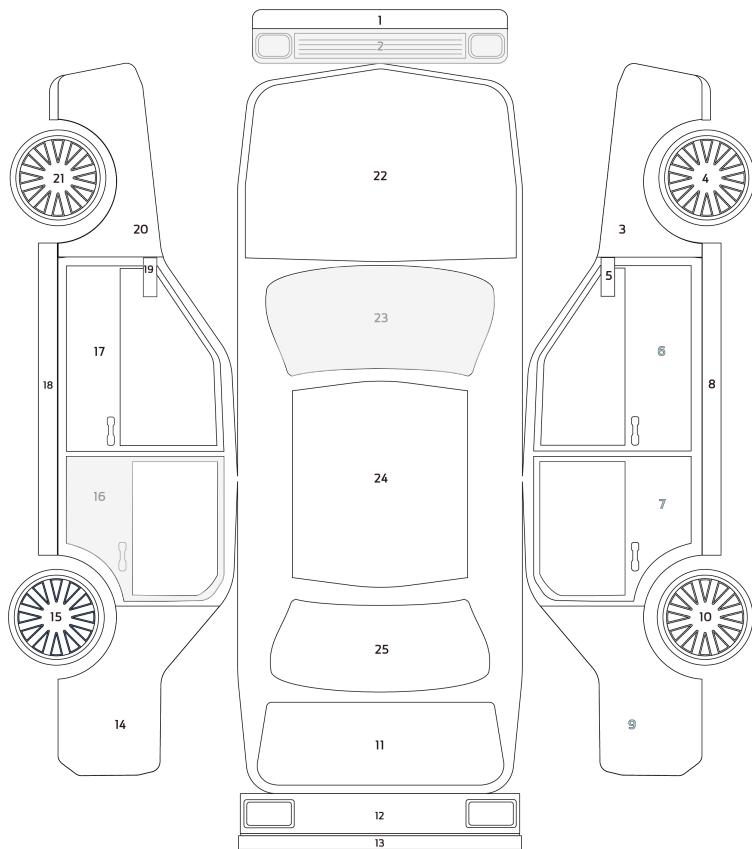
## Exterior Inspection Points

1. Front Skirt	O	14. Left Skirt	O
2. Front Bumper	O (S2)	15. Left Wing Mirror	O
3. Front Right Fender	O	16. Front windshield	O (G1)
4. Front Right Wheel	O	17. Roof	O
5. Front Left Fender	O	18. Rear Right Fender	O
6. Front Left Wheel	O	19. Rear Bonnet	O
7. Front Bonnet	O	20. Back Right Wheel	O
8. Right Wing Mirror	O	21. Rear Bumper	O
9. Front Right Door	O	22. Rear Skirt	O
10. Rear Right Door	O	23. Rear Left Fender	O
11. Right Skirt	O	24. Back Left Wheel	O
12. Rear Left door	O (S1)	25. Back Windshield	O
13. Front Left Door	O

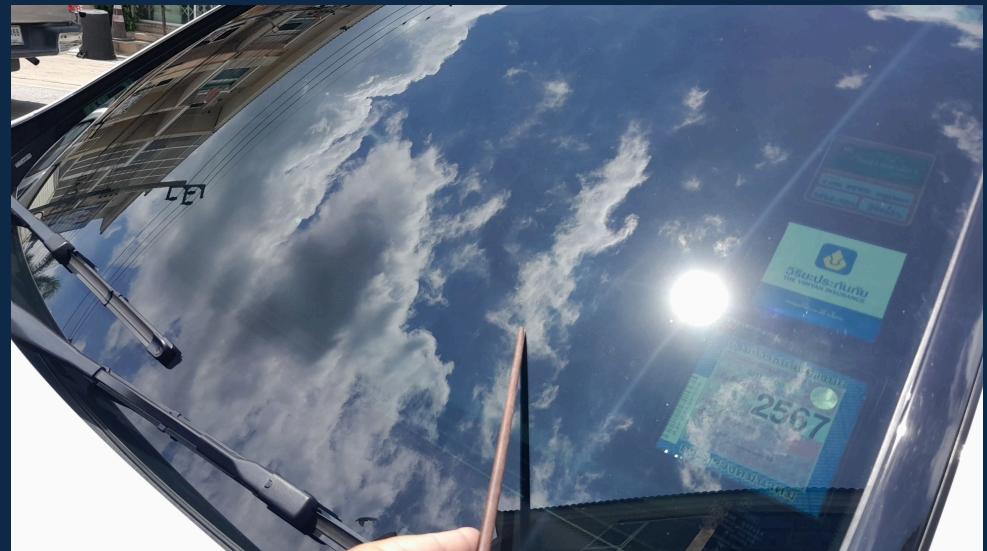
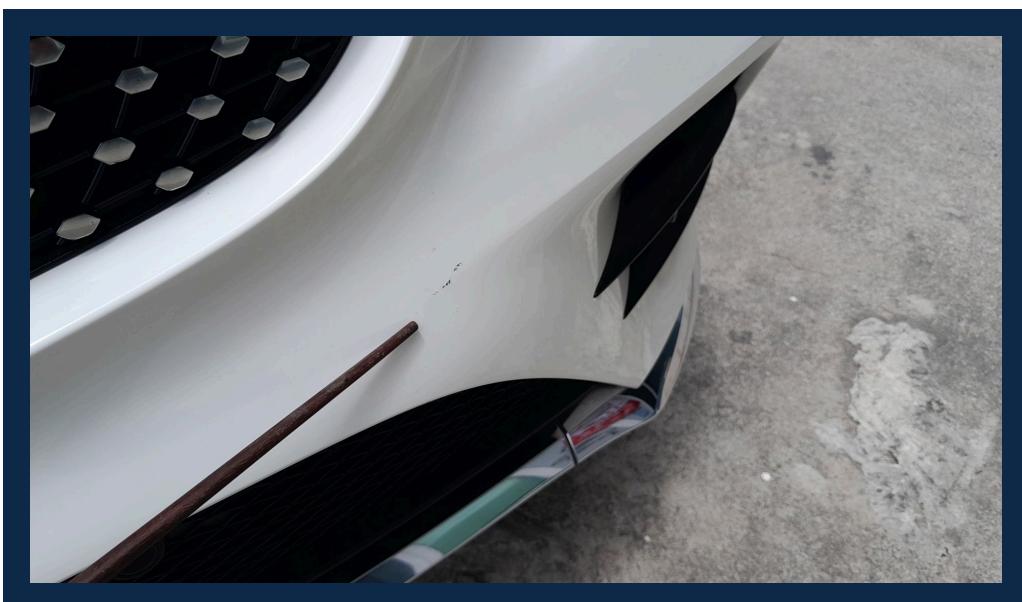
Vehicle Defect Notices

**Inspector :** ภายนอก(Exterior) : การตรวจสภาพภายนอกโดยรวมไม่พบหลักฐานการซ่อมแซมทำสี รั้วรอยเล็กน้อย/สภาพยางกั้ง4เส้น ปี 22 เสื่อมสภาพหน้าซ้ายขวา กันชนหน้าบุดคลอก กระจกบังลมหน้ามีรอยสะเก็ดหิน ภายใน(Interior) : ภายในตรวจพบตัวสวิตซ์พับเบาะหลังชำรุด สาขาวิศรีบปรับอุปกรณ์ไฟฟ้า แอร์ วิทยุFM ใช้งานได้ สมบูรณ์ครบถ้วน เครื่องยนต์(Engine) : เครื่องยนต์ทำงานได้ปกติ วิเคราะห์ปัญหาด้วยเครื่อง OBDII ไม่สามารถตรวจส่องได้ รุนไม่รับรอง (ไม่ได้ทดสอบขับขี่) โครงสร้าง(Frame) : อุบัติเหตุไม่มี โครงสร้างหลักปกติ ไม่มีการซ่อมแซม โครงสร้างหรือมีการชนถึงโครงสร้าง

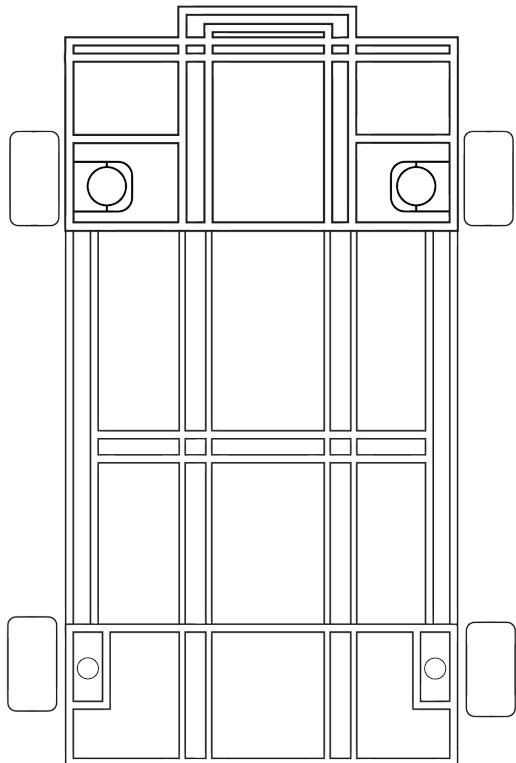
## Chassis Report

No dent in the under carriage (th)	PASS
No deform chassis or chassis frame (th)	PASS
No visible corrosion on the chassis or chassis frame (th)	PASS
No missing part on the chassis frame (th)	PASS
Half cut Analysis (th)	PASS

Chassis Damage Level	No Damage
----------------------	-----------
