# Preowned Vehicle Inspection Report

Premium Inspection Analysis

Customer Name	: MERCEDES-BENZ MOBILITY (THAILAND) CO., LTD.	Inspection Date	: 2024-07-02
Tel.		Lemon Inspection ID	: LEMON24070036
Inspector	: สุวัฒน์ วัฒน ทองพิมพ์	Approved By	: Chaimongkol C

Brand	MERCEDES BENZ	Model year	2019
Model	GLA200	Engine Code - No.	27091031855061
Sub-model	Urban	Registration year	2022-08-02
Registration No.		Chassis No.	WDC1569436L012546
Current Mileage(km.)	95000	Engine Capacity(cc.)	1600

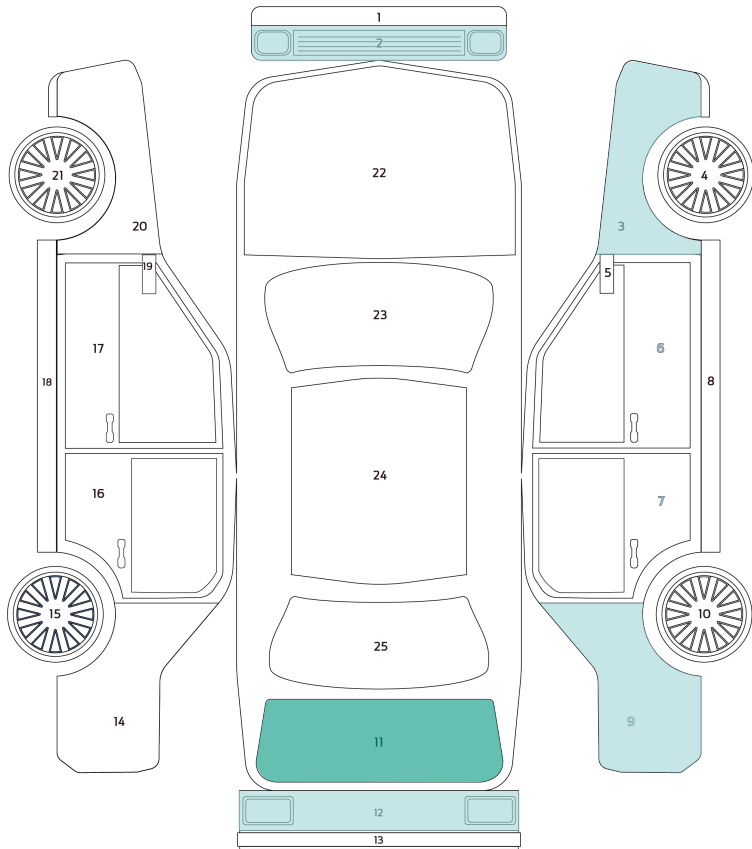
### Exterior Inspection Points

1. Front Skirt	O	14. Left Skirt	O
2. Front Bumper	BP	15. Left Wing Mirror	O
3. Front Right Fender	BP	16. Front Windshield	O
4. Front Right Wheel	O	17. Roof	O
5. Front Left Fender	O	18. Rear right fender	BP
6. Front Left Wheel	O	19. Rear Bonnet	N
7. Front Bonnet	O	20. Back Right Wheel	O
8. Right Wing Mirror	O	21. Rear Bumper	BP
9. Front Right Door	O	22. Rear Skirt	O
10. Rear Right Door	O	23. Rear Left Fender	O
11. Right Skirt	O	24. Back Left Wheel	O
12. Rear Left Door	O	25. Back Windshield	O
13. Front Left Door	O

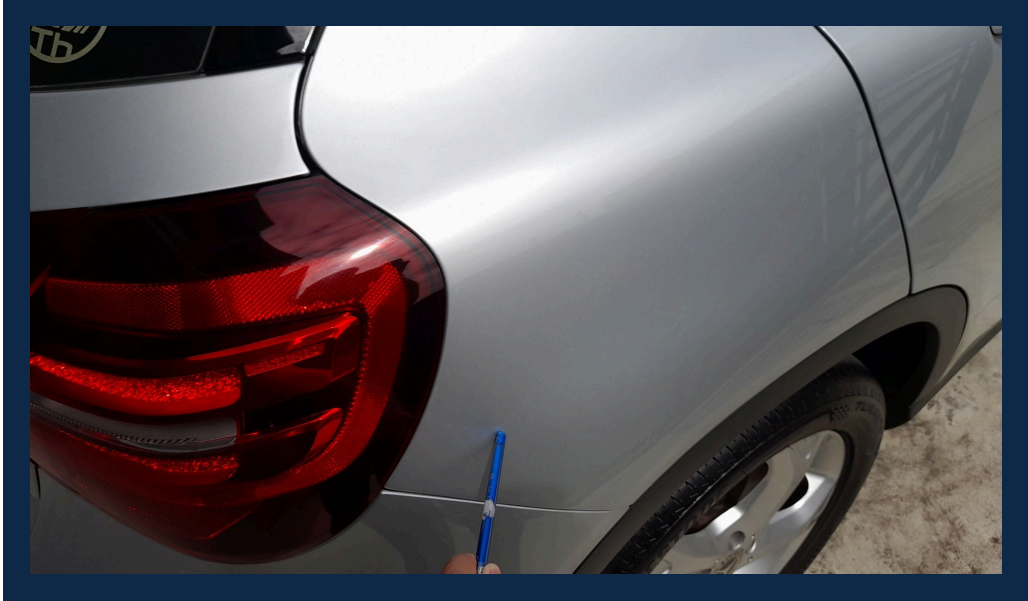
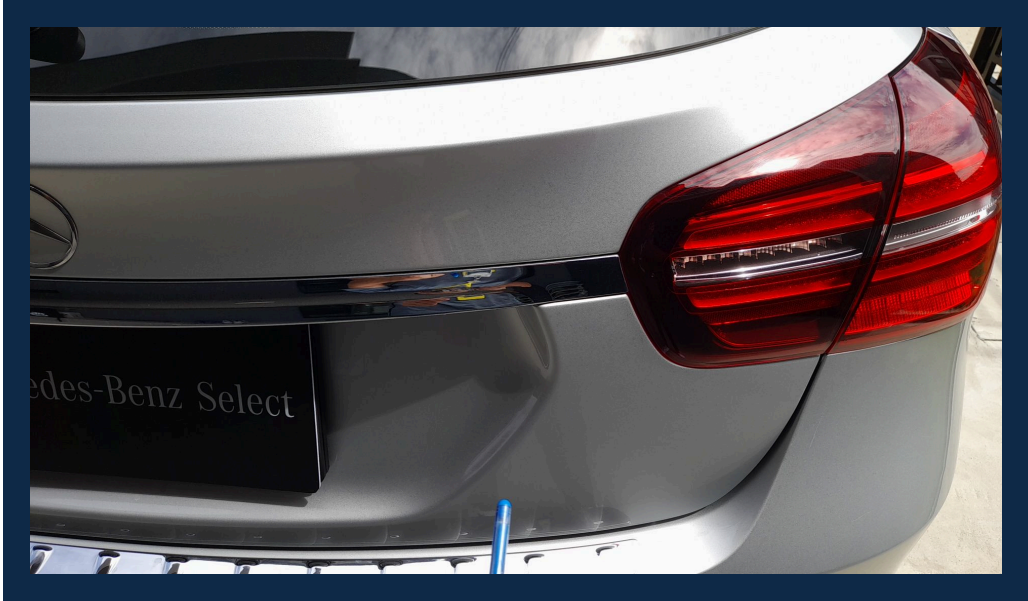
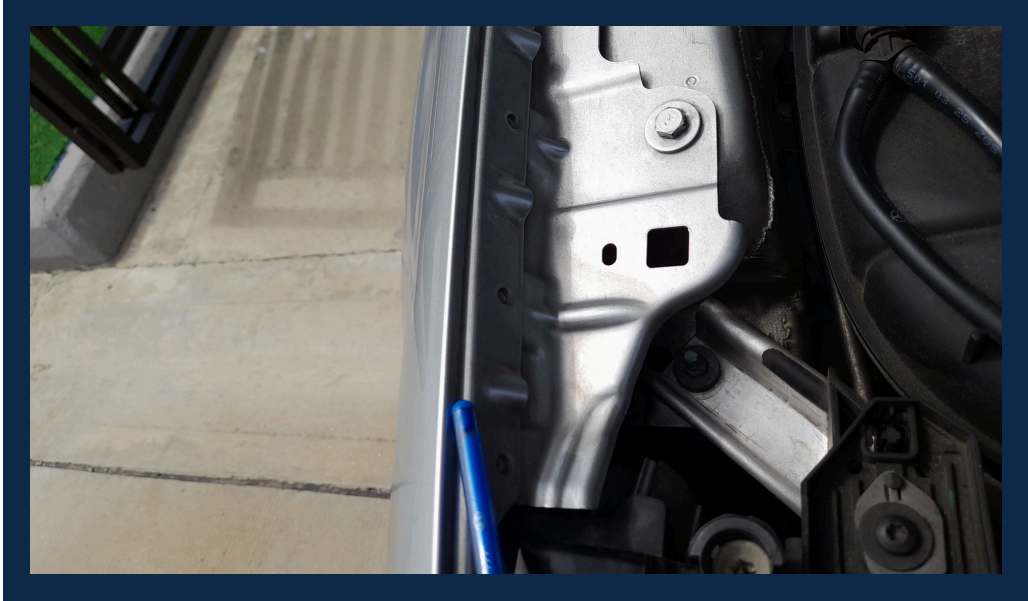
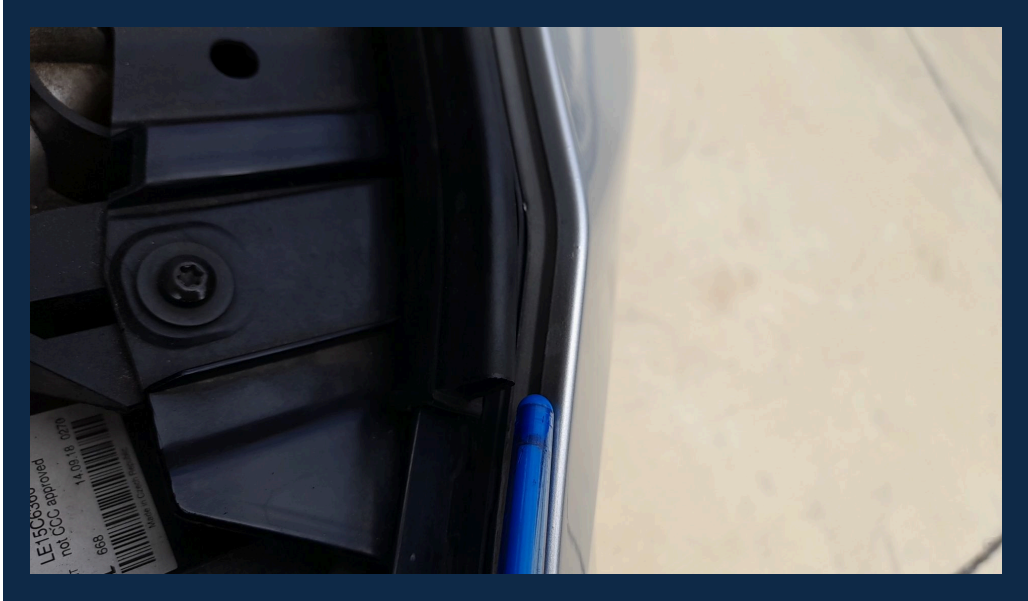
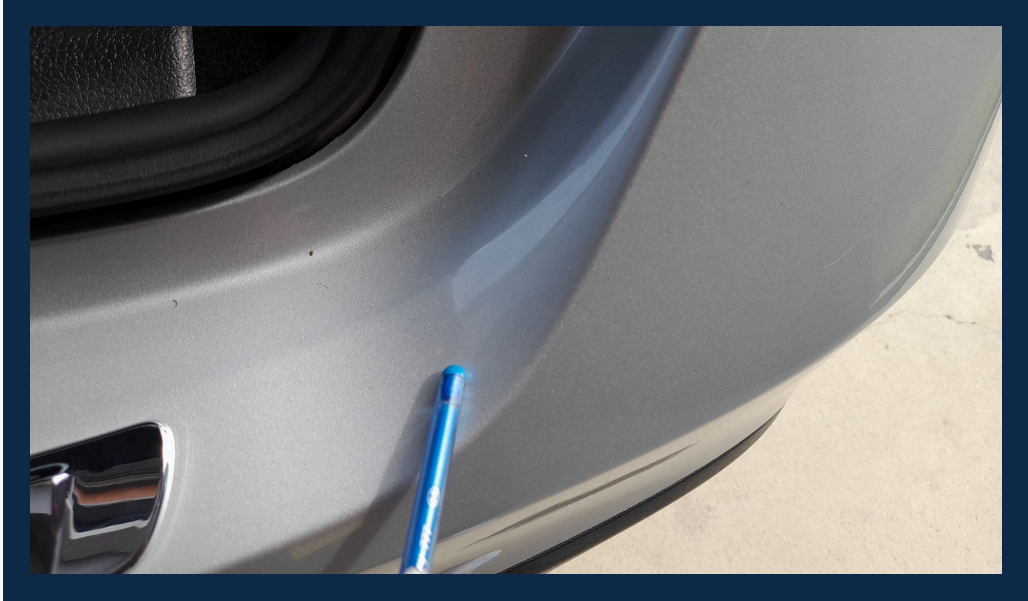
**Vehicle Defect Notices**

**Inspector :** หมายเอก\* ภายนอก(Exterior) : การตรวจสภาพภายนอกโดยรวมพบหลักฐานการซ่อมแซมทำสี ฟากระโปรงหน้า บังโคลนหน้าขวา ประตูหลังขวา บังโคลนหลังขวาเคาะซ่อมสี เปลี่ยนฟ้ายายมา สภาพยางปกติทั้ง4เส้น ปี21 ภายใน(Interior) : ภายในปกติไม่มีความเสียหาย สะอาดเรียบร้อย ,อุปกรณ์ไฟฟ้า แอร์ วิทยุFM ใช้งานได้สมบูรณ์ครบปกติ เครื่องยนต์(Electric) : เครื่องยนต์ทำงานได้ปกติ วิศวาระห้ปัญหาด้วยเครื่อง OBDII พบโค้ดผิดปกติ,P13c523,,แนะนำเข้าเช็คศูนย์(ไม่ได้ทดสอบขั้วขี้) โครงสร้าง(Frame) : อุบัติเหตุไม่มี ,โครงสร้างหลักปกติ ไม่มีการซ่อมแซมโครงสร้างหรือมีการชนถึงโครงสร้าง
