# Preowned Vehicle Inspection Report

Customer Name	: MERCEDES-BENZ MOBILITY (THAILAND) CO., LTD.	Inspection Date	: 2024-07-04
Tel.		Lemon Inspection ID	: LEMON24070077
Inspector	เนนรัก ทิพย์อินทร์	Approved By	: Chaimongkol C

Brand	MERCEDES BENZ	Model year	2019
Model	GLC250	Engine Code - No.	27492031674131
Sub-model	d 4MATIC AMG Dynamic (Coupe)	Registration year	2020-03-17
Registration No.		Chassis No.	WDC2533466L019836
Current Mileage(km.)	45261	Engine Capacity(cc.)	2000

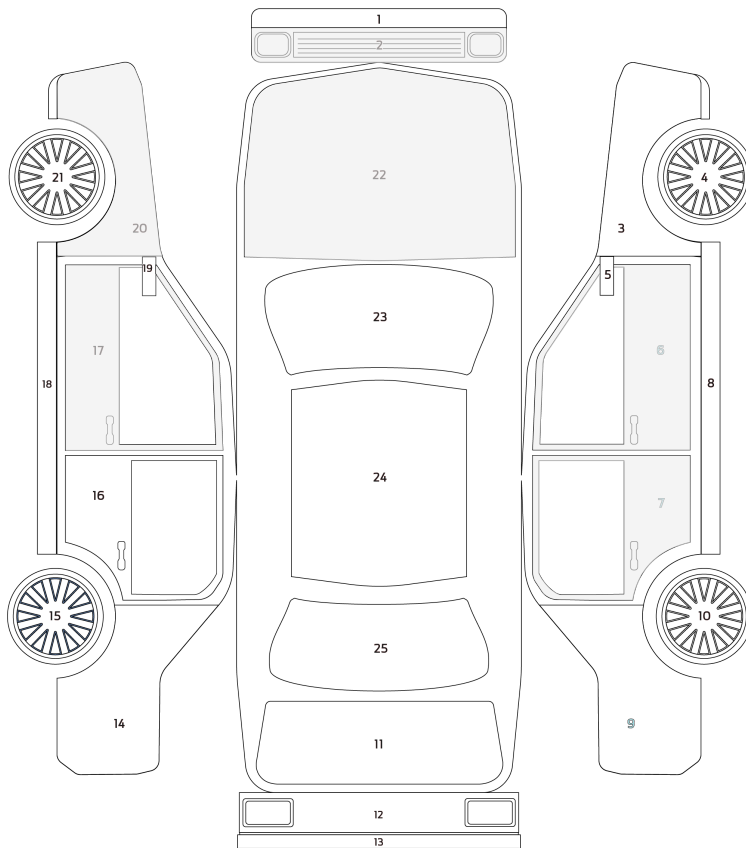
1. Front Skirt	O	14. Left Skirt	O
2. Front Bumper	O (S1)	15. Left Wing Mirror	O
3. Front Right Fender	O	16. Front Windshield	O
4. Front Right Wheel	O	17. Roof	O
5. Front Left Fender	O (G1)	18. Rear Right Fender	O
6. Front Left Wheel	O	19. Rear Bonnet	O
7. Front bonnet	O (G1)	20. Back Right Wheel	O
8. Right Wing Mirror	O	21. Rear Bumper	O
9. Front right door	O (S1)	22. Rear Skirt	O
10. Rear right door	O (S1)	23. Rear Left Fender	O
11. Right Skirt	O	24. Back Left Wheel	O
12. Rear Left Door	O	25. Back Windshield	O
13. Front left door	O (S1)
