# Preowned Vehicle Inspection Report

Premium Inspection Analysis

| Brand | MERCEDES BENZ | Model year | 2019 |
| Model | GLA250 | Engine Code - No. | 27092031823669 |

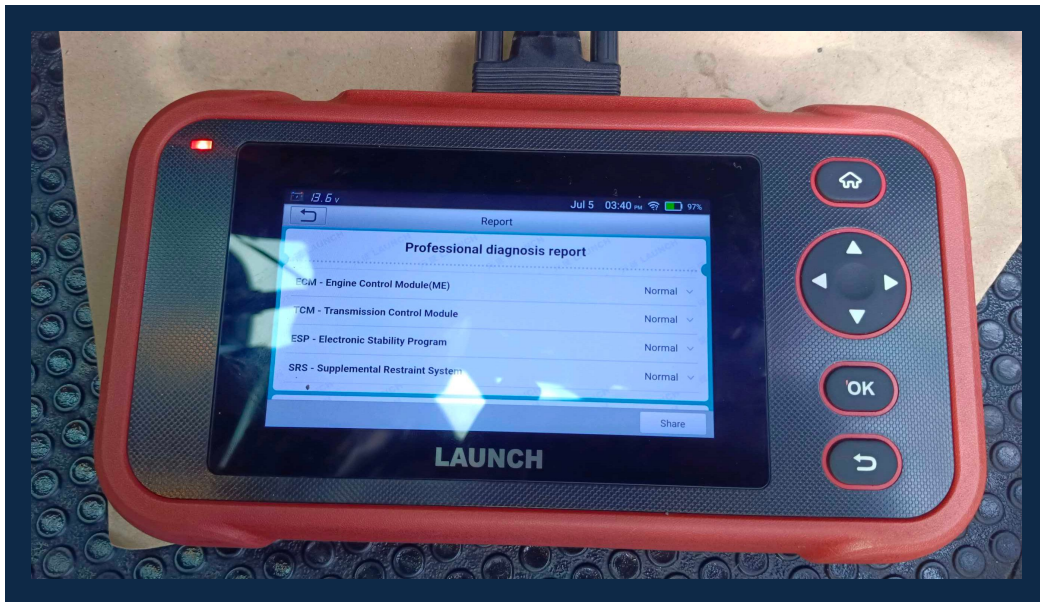
**OBD Vehicle Health Analysis**

**เครื่องยนต์(Engine) :** เครื่องยนต์ทำงานได้ปกติ วิเคราะห์ปัญหาด้วยเครื่อง OBDII ไม่พบสิ่งผิดปกติ (ไม่ได้ทดสอบขับขี) **โครงสร้าง(Frame) :** อุบัติเหตุไม่มี โครงสร้างหลักปกติ ไม่มีการซ่อมแซมโครงสร้างหรือมีการชนถึงโครงสร้าง

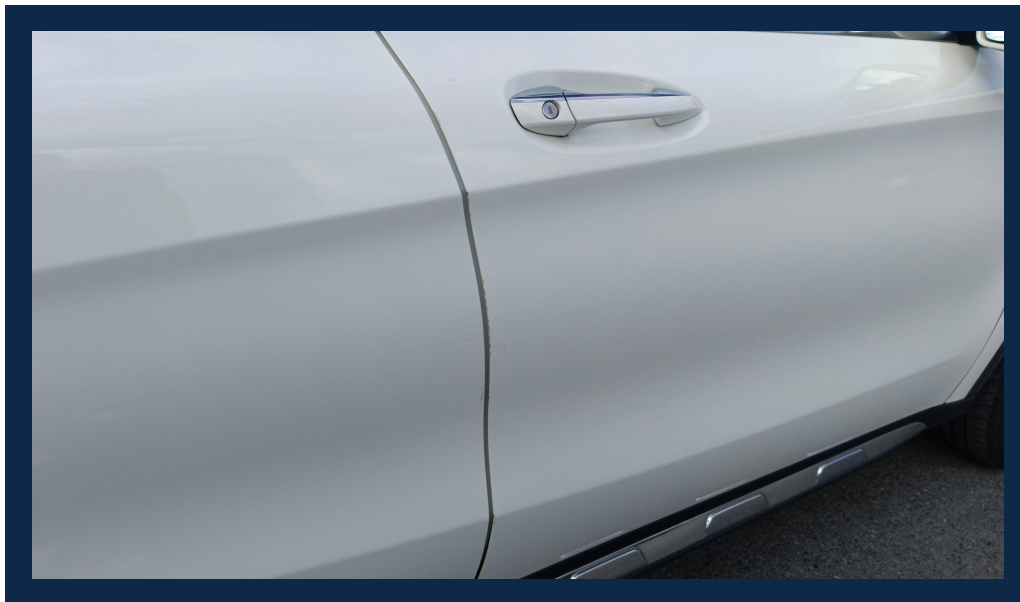
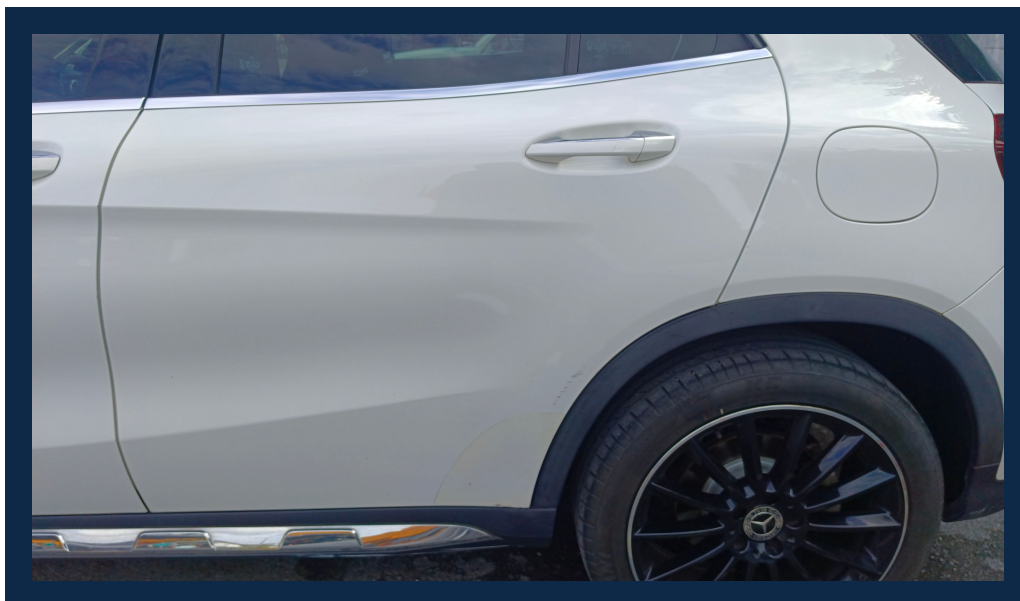
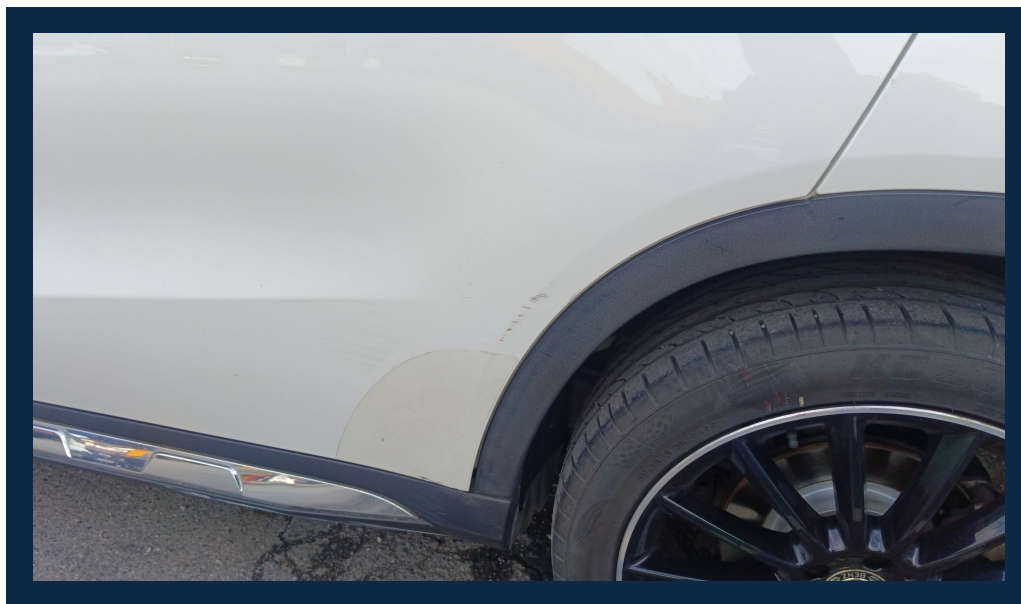
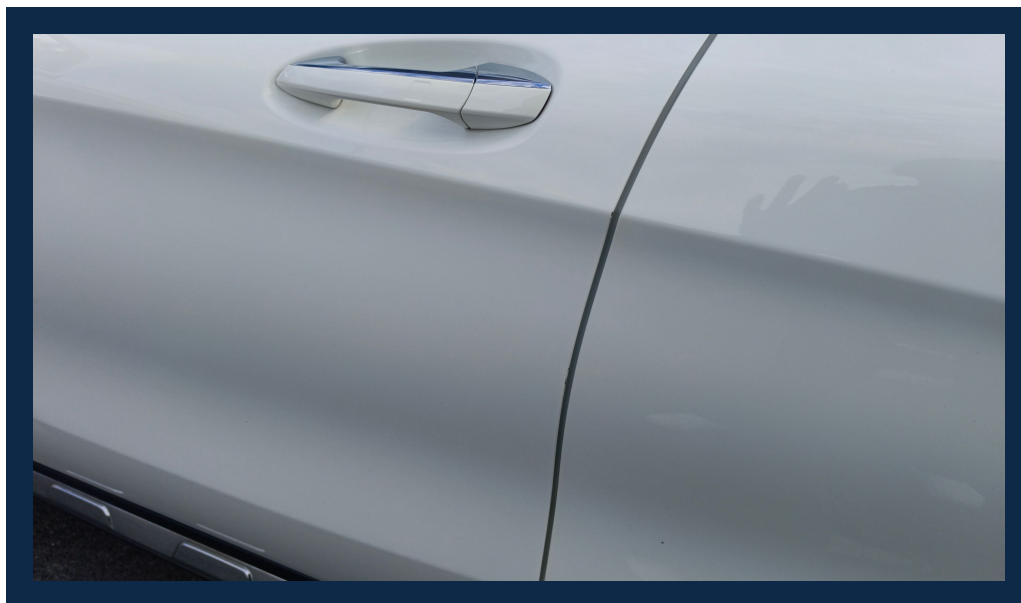
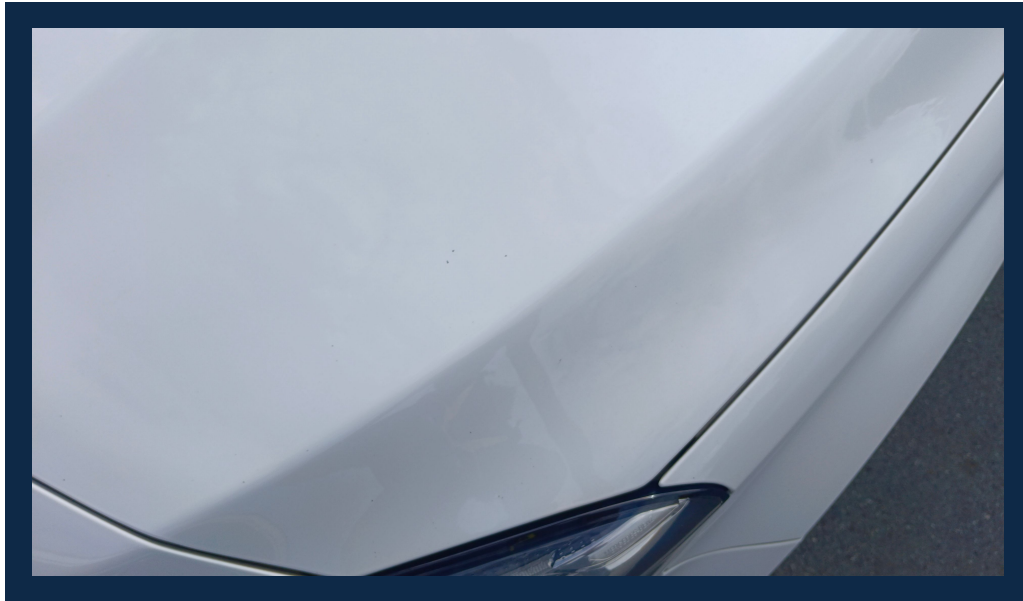
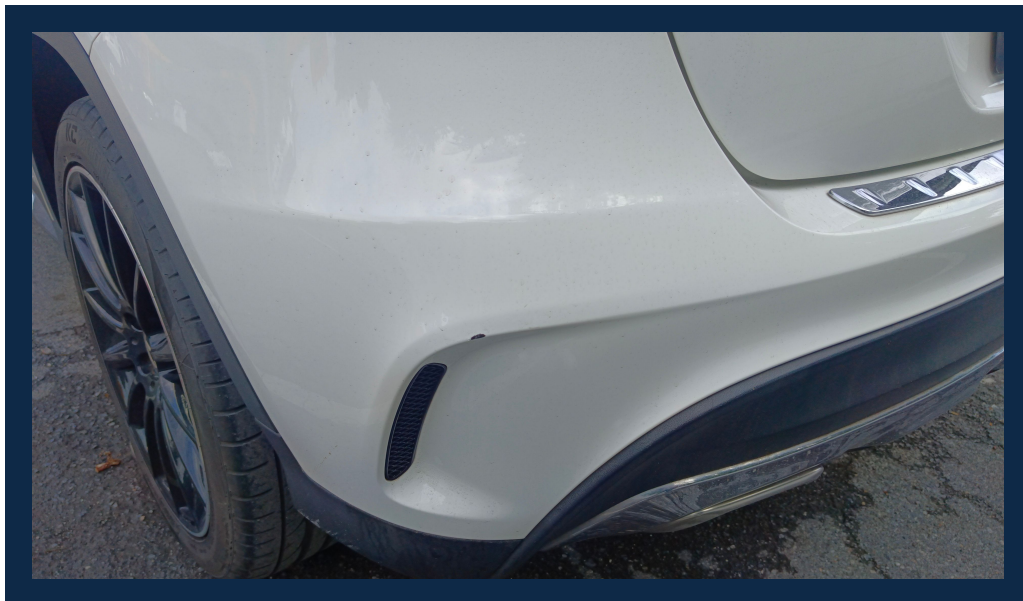
**Vehicle Defect Notices**

| 9. Front right door | O (S1) | 22. Rear skirt | O (S1) |
| 12. Rear Left door | O (S2) | 25. Back Windshield | O |

**Inspector :** ภายนอก(Exterior) : การตรวจสอบสภาพภายนอกโดยรวมไม่พบหลักฐานการซ่อมแซมทำสี พบสะเก็ดที่พื้นฝากระโปรงหน้ากันชนหลังครูด ประตูหลังซ้ายครูด /ประตูหน้าซ้ายขวาสีขอบประตูกระเทาะ สภาพยางปกติทั้ง4เส้น ปี22 ภายใน(Interior) : ภายในปกติ สะอาดเรียบร้อย อุปกรณ์ไฟฟ้า แอร์ วิทยุFM ใช้งานได้สมบูรณ์ครบปกติ

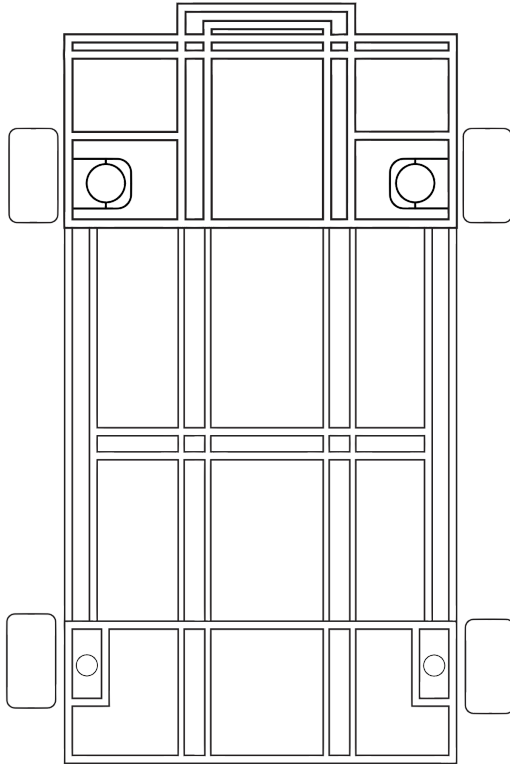
**Chassis Report**

| No dent in the under carriage (th) | PASS |
| No deform chassis or chassis frame (th) | PASS |
| No visible corrosion on the chassis or chassis frame (th) | PASS |
| No missing part on the chassis frame (th) | PASS |
| Half cut Analysis (th) | PASS |

| Chassis Damage Level | No Damage |
