Customer Name	: MERCEDES-BENZ MOBILITY (THAILAND) CO., LTD.	Inspection Date	: 2024-07-08
Tel.		Lemon Inspection ID	: LEMON24070119
Inspector	: แทนรัก ทิพย์อินทร์	Approved By	: ไซยมงคล ไพรเลี้ยง

Brand	MERCEDES BENZ	Model year	2019
Model	GLC220	Engine Code - No.	65192165023268
Sub-model	d AMG Dynamic	Registration year	2024-07-08
Registration No.		Chassis No.	WDC2539056L022987
Current Mileage(km.)	99858	Engine Capacity(cc.)	2200

### Inspection Lists

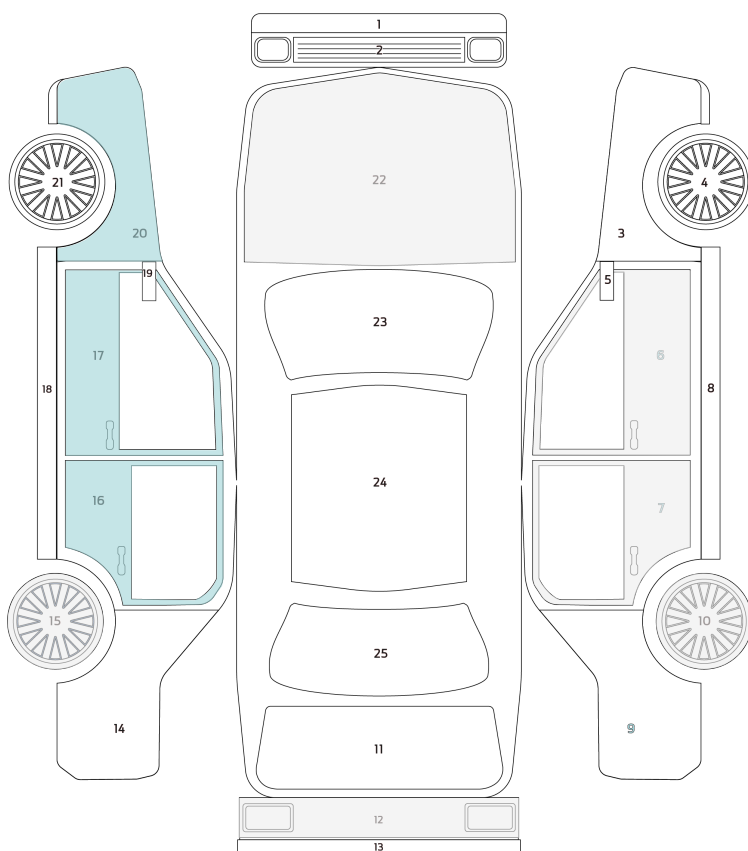
## Exterior Inspection Points

1. Front Skirt	O	14. Left Skirt	O
2. Front Bumper	O	15. Left Wing Mirror	O
3. Front Right Fender	O	16. Front Windshield	O
4. Front Right Wheel	O	17. Roof	O
5. Front Left Fender	BP	18. Rear Right Fender	O
6. Front Left Wheel	O	19. Rear Bonnet	O
7. Front bonnet	O (G1)	20. Back right wheel	O (S1)
8. Right Wing Mirror	O	21. Rear Bumper	O (S1)
9. Front right door	O (S1)	22. Rear Skirt	O
10. Rear right door	O (D1)	23. Rear Left Fender	O
11. Right Skirt	O	24. Back left wheel	O (S2)
12. Rear Left door	BP (S1)	25. Back Windshield	O
13. Front left door	BP

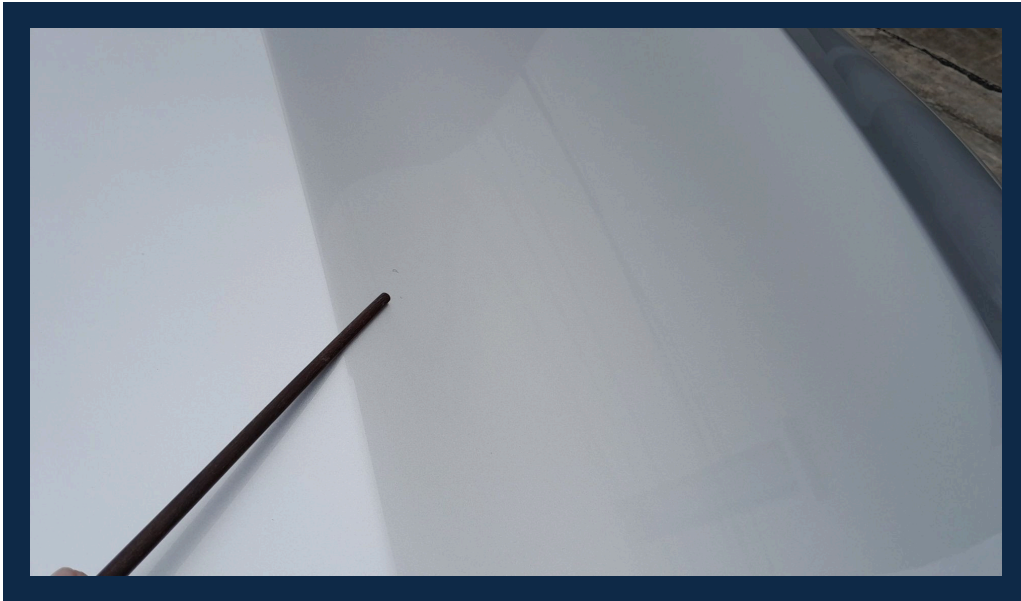
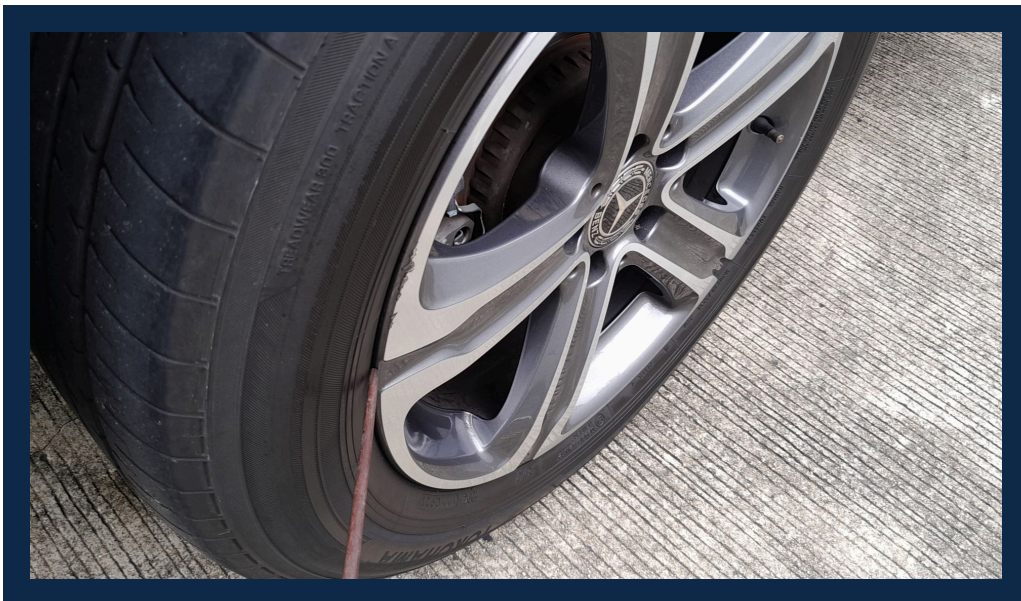
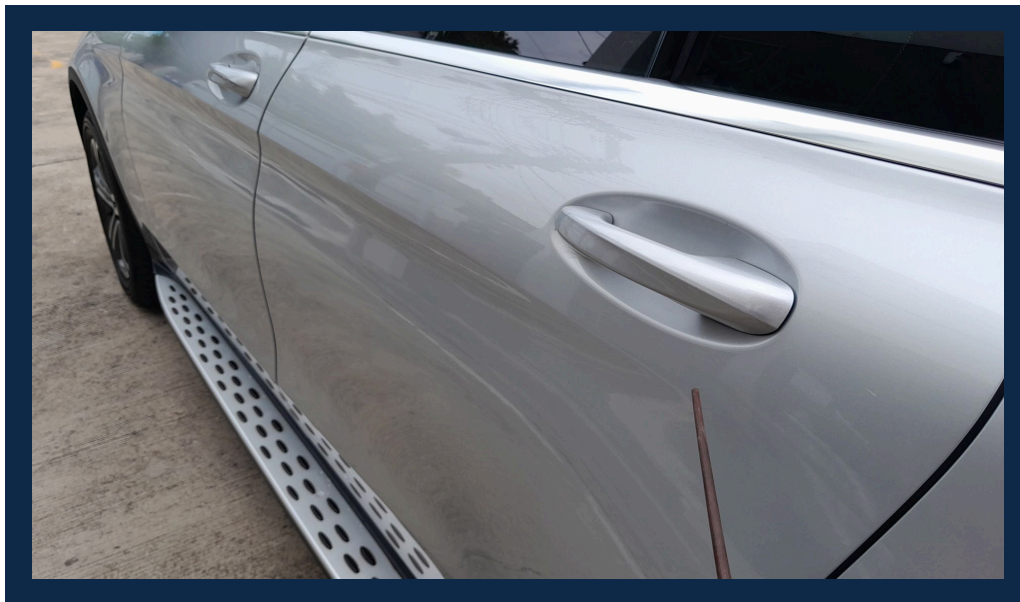
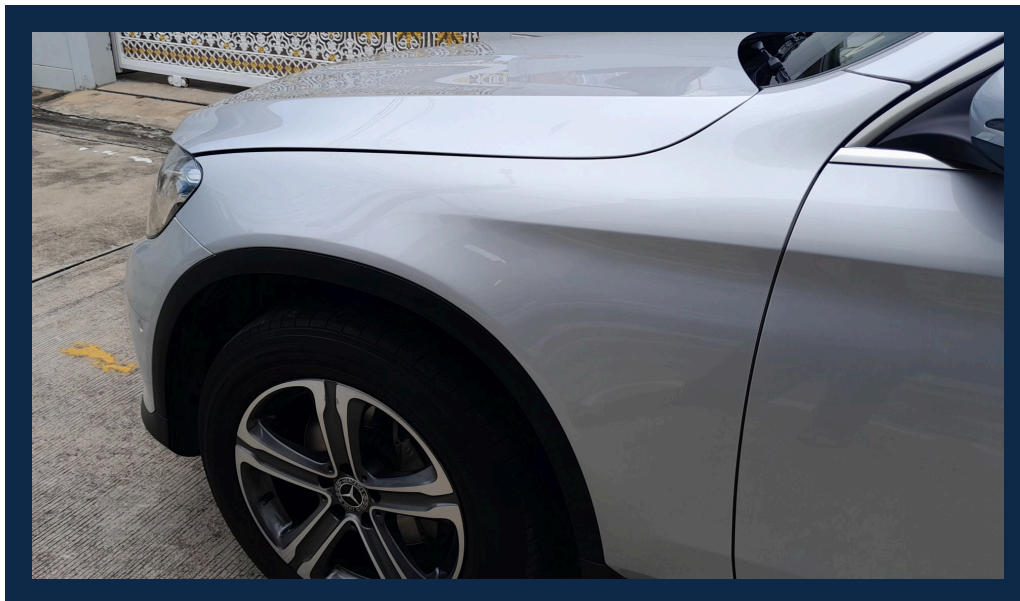
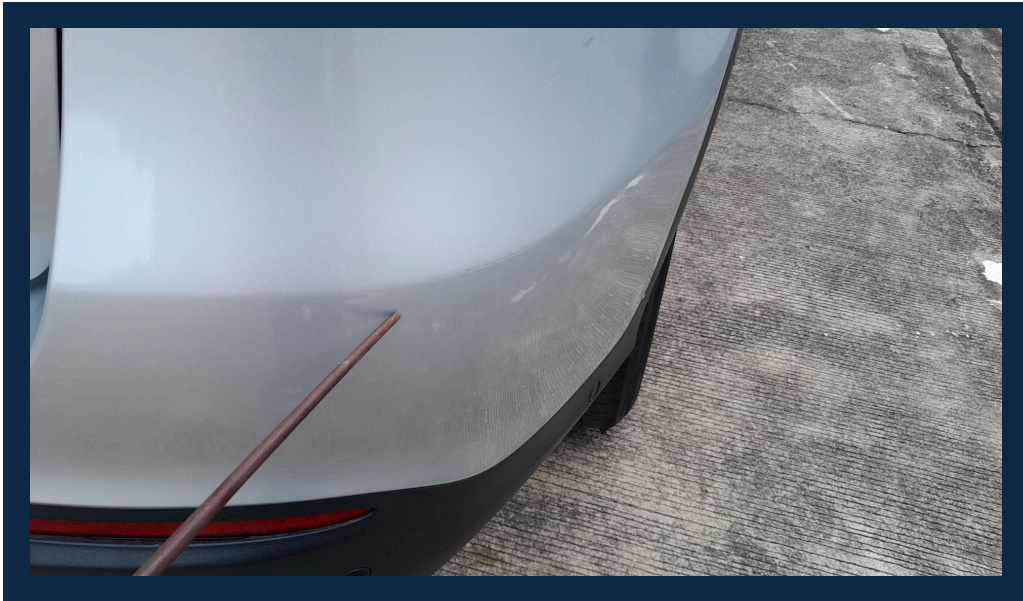
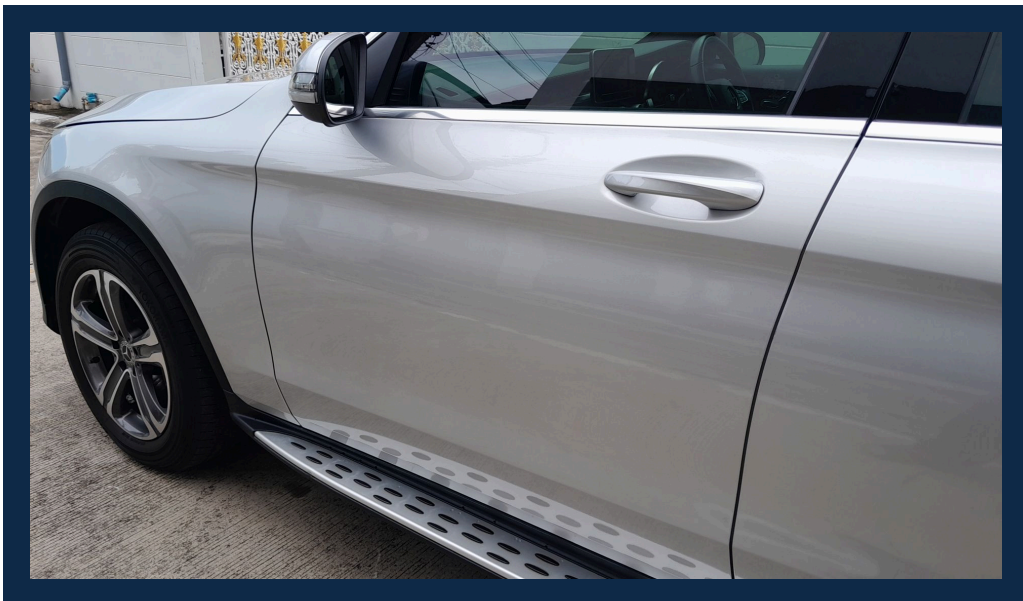
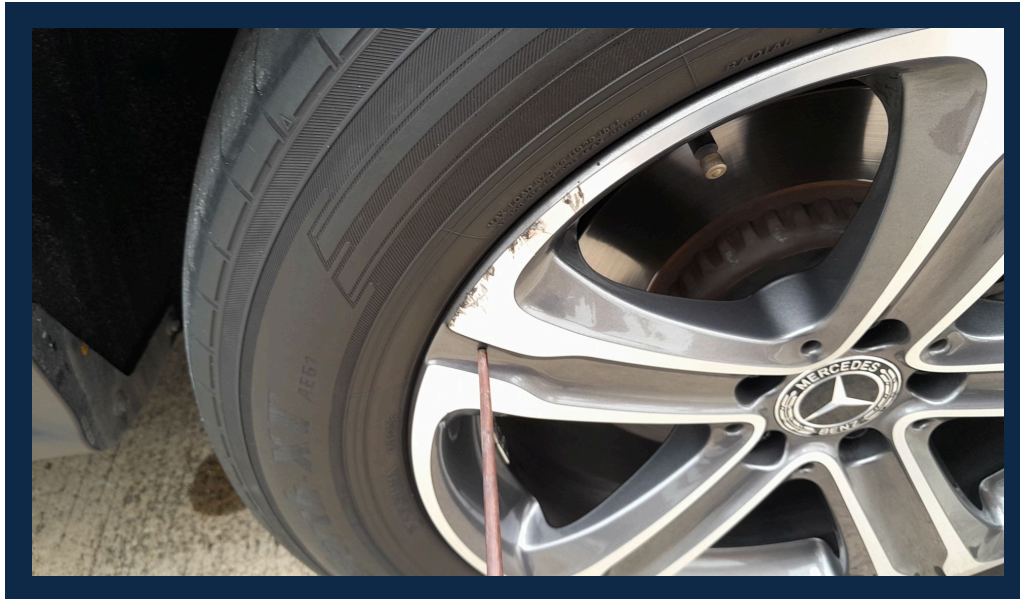
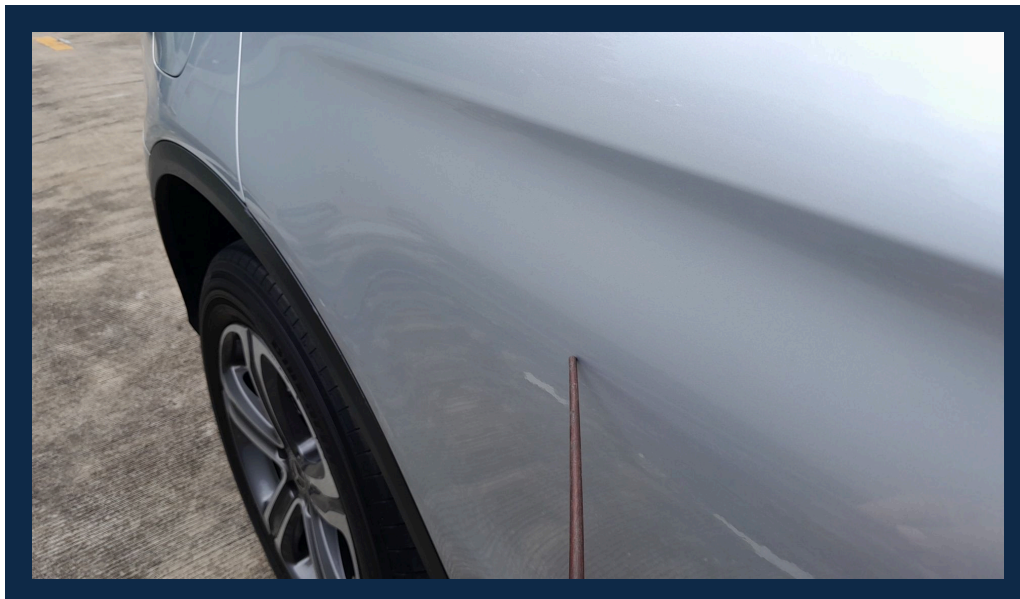
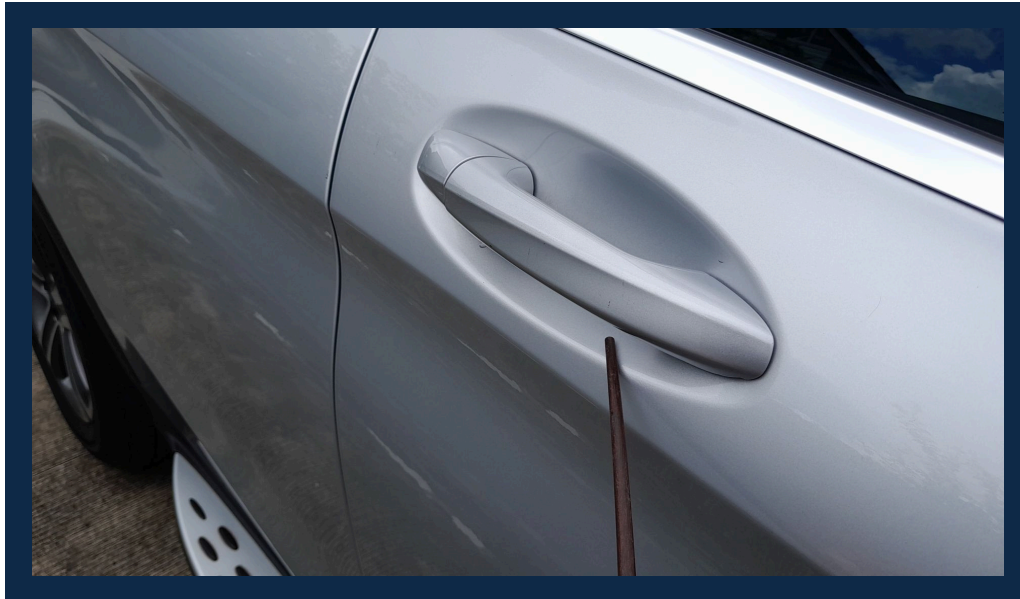
**Vehicle Defect Notices**

**Inspector :** ภายนอก(Exterior) : การตรวจสอบสภาพภายนอกโดยรวมพบหลักฐานการซ่อมแซมทำสีมาบ้างชิ้นฟุ้งซ้าย/สภาพยางทั้ง4เส้น ปี 21 เสื่อมสภาพยางหลังคู่ ล้อแม็กเป็นรอยถลอก ภายใน(Interior) : ภายในเบาะหน้าซ้ายขวา ถลอก/สะอาดเรียบร้อย อุปกรณ์ไฟฟ้า แอร์ วิทยุFM ใช้งานได้สมบูรณ์ครบปกติ เครื่องยนต์(Engine) : เครื่องยนต์ทำงานได้ปกติ วิเคราะห์ปัญหาด้วยเครื่อง OBDII พบสิ่งผิดปกติ แนะนำตรวจเช็คศูนย์บริการ (ไม่ได้ทดสอบขับขึ้น) โครงสร้าง(Frame) : อุบัติเหตุไม่มี โครงสร้างหลักปกติ ไม่มีการซ่อมแซมโครงสร้างหรือมีการชนถึงโครงสร้าง

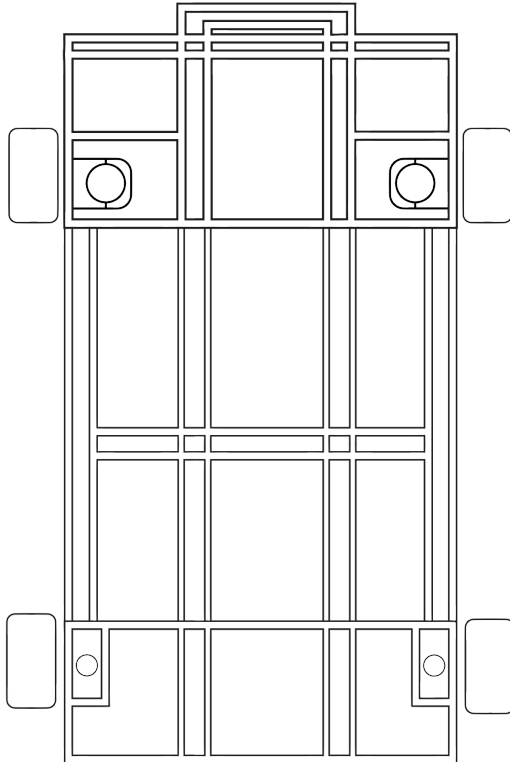
**Chassis Report**

No dent in the under carriage (th)	PASS
No deform chassis or chassis frame (th)	PASS
No visible corrosion on the chassis or chassis frame (th)	PASS
No missing part on the chassis frame (th)	PASS
Half cut Analysis (th)	PASS

Chassis Damage Level	No Damage
----------------------	-----------
