# Preowned Vehicle Inspection Report

Premium Inspection Analysis

| Tel. | : | Lemon Inspection ID | : LEMON24070156 |

| Model | GLA200 | Engine Code - No. | 28291430609077 |

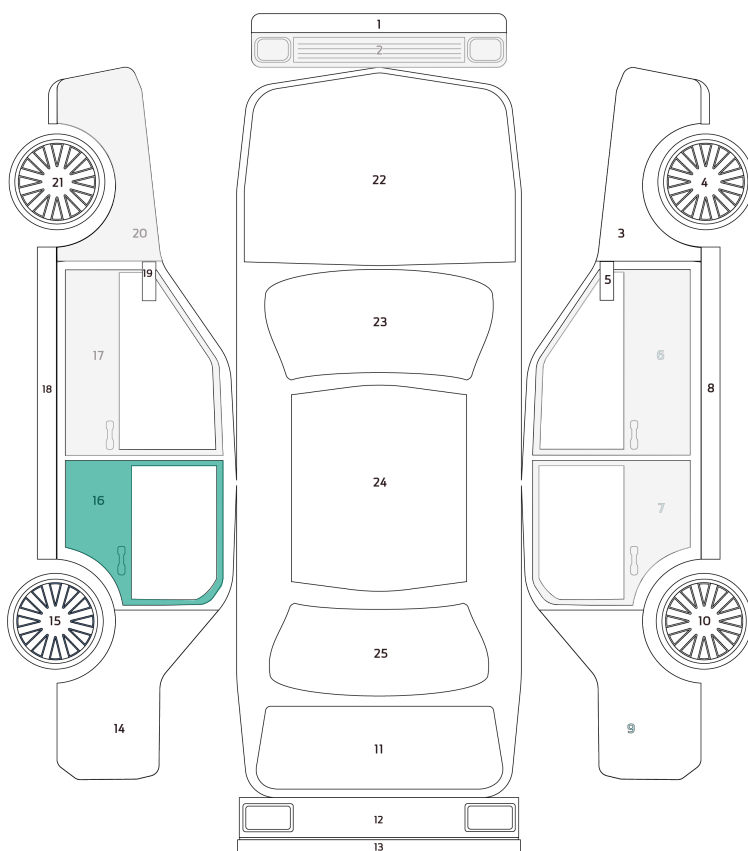
**Exterior Inspection Points**

| 1. Front Skirt | O | 14. Left Skirt | O |
| 2. Front Bumper | O (S2) | 15. Left Wing Mirror | O |
| 5. Front Left Fender | O (S1) | 18. Rear Right Fender | O |
| 9. Front right door | O (S1) | 22. Rear Skirt | O |
| 10. Rear right door | O (S2) | 23. Rear Left Fender | O |
| 12. Rear Left door | N (S1) | 25. Back Windshield | O |
| 13. Front left door | O (S1) | | |

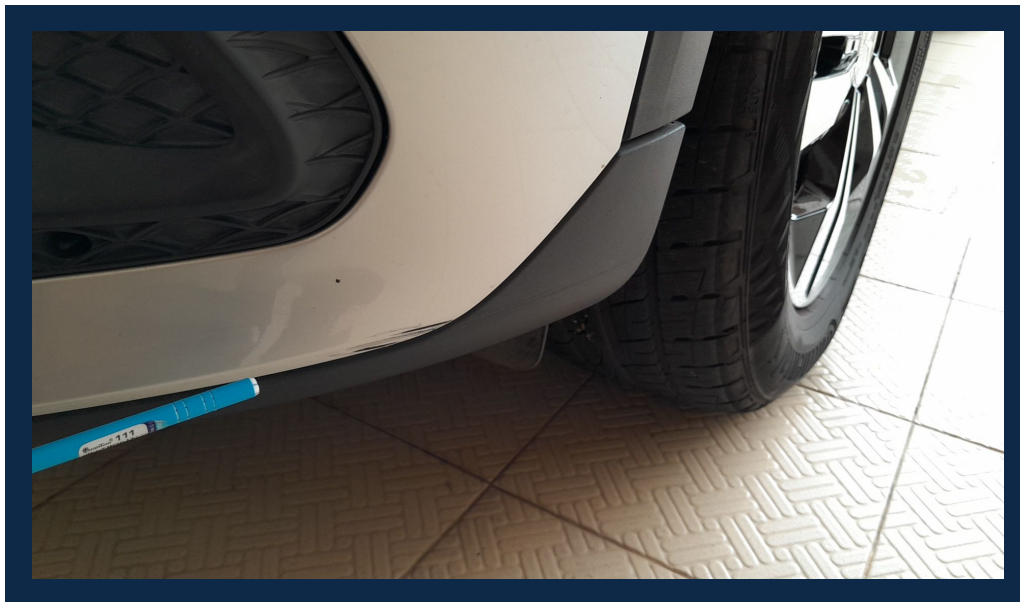
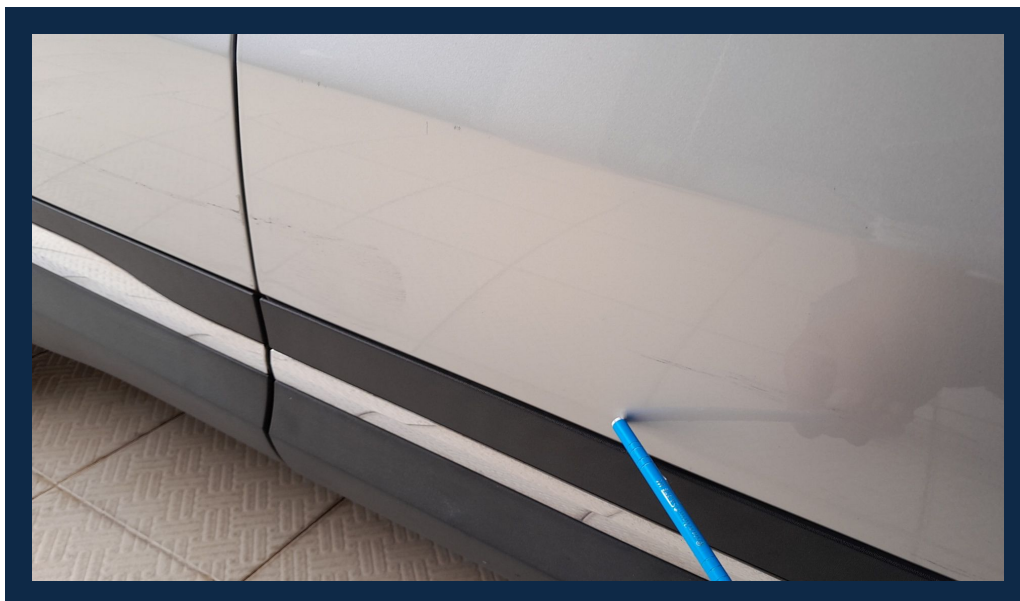
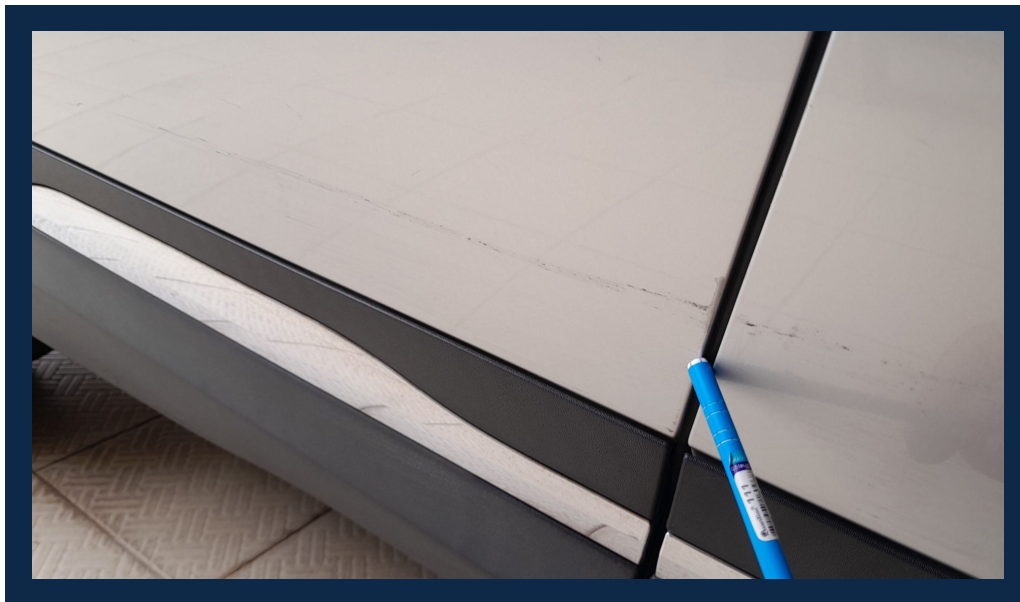
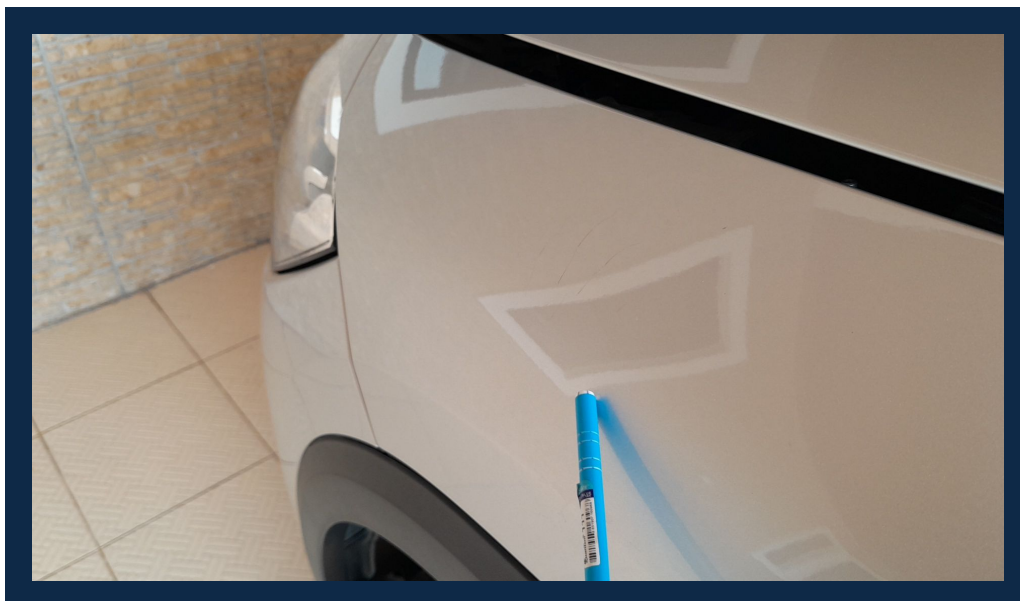
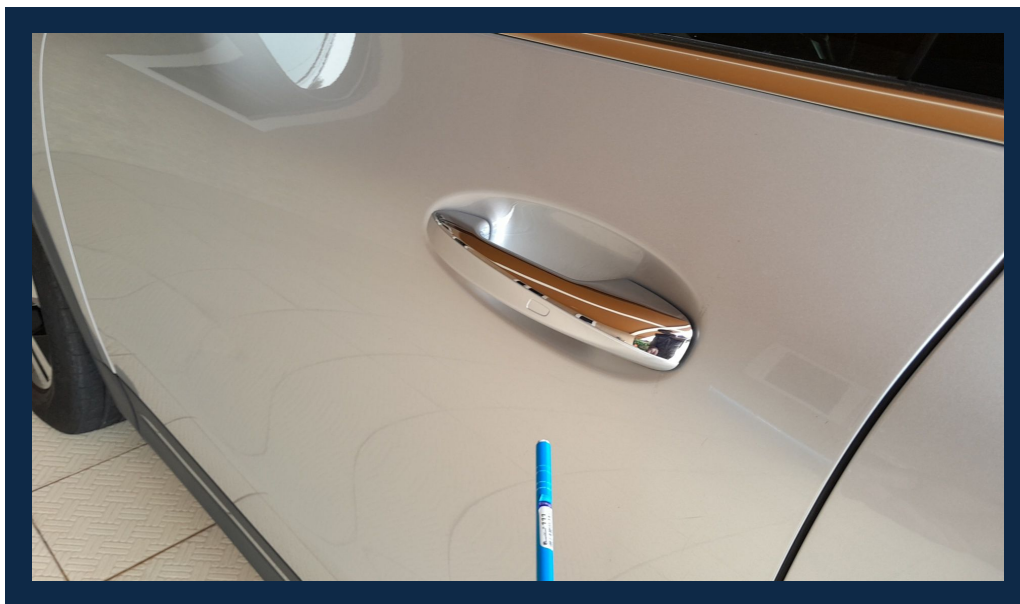
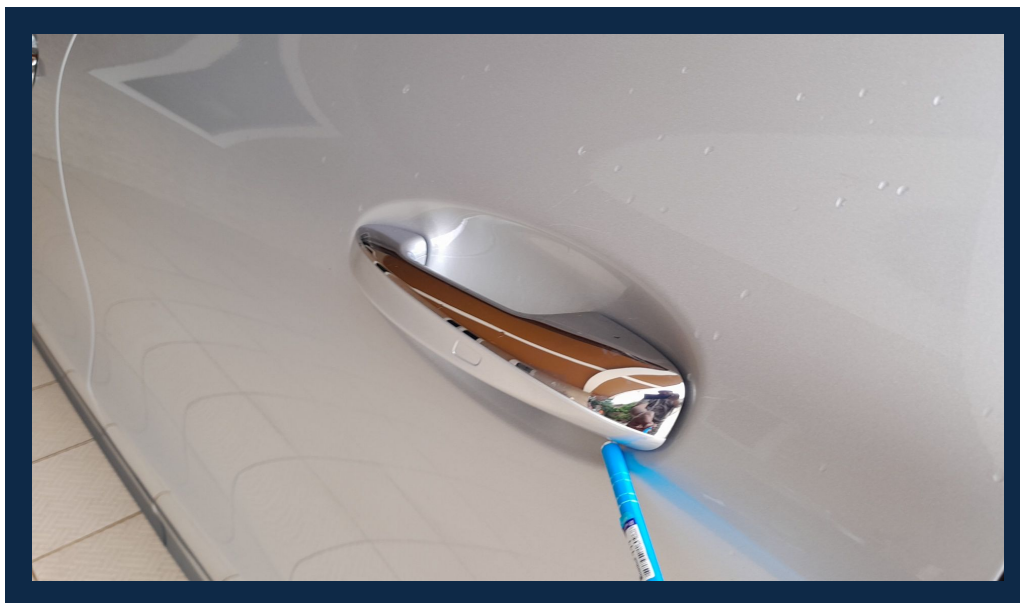
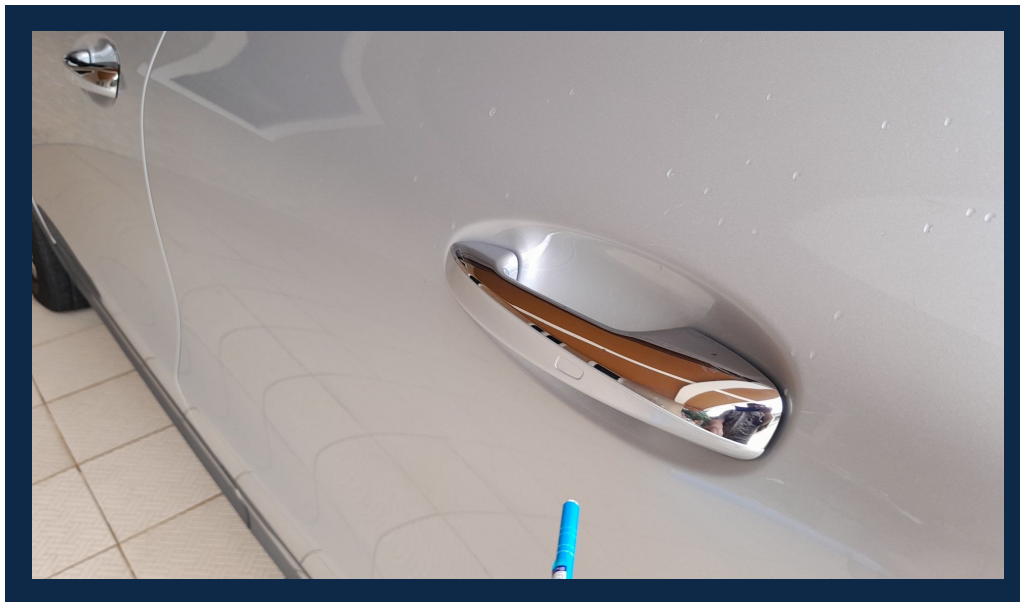
**Vehicle Defect Notices**

**Inspector :** ภายนอก(Exterior) : การตรวจสอบสภาพภายนอกโดยรวมไม่พบหลักฐานการซ่อมแซมทำสี รื้อรอยถลอกเล็กน้อย / สภาพยางปกติทั้ง4เส้น ปี 23 ภายใน(Interior) : ภายในพวงมาลัยเป็นคราบ คอนโซลไฟฟ้าเป็นรอยขีดข่วน สะอาดเรียบร้อย ,อุปกรณ์ไฟฟ้า แอร์ วิทยุFM ใช้งานได้สมบูรณ์ครบปกติ เครื่องยนต์(Engine) : เครื่องยนต์ทำงานได้ปกติ วิเคราะห์ปัญหาด้วยเครื่อง OBDII พบสิ่งผิดปกติ แนะนำตรวจเช็คศูนย์บริการ (ไม่ได้ทดสอบขับขี) โครงสร้าง(Frame) : อุบัติเหตุไม่มี โครงสร้างหลักปกติ ไม่มีการซ่อมแซมโครงสร้างหรือมีการชนถึงโครงสร้าง

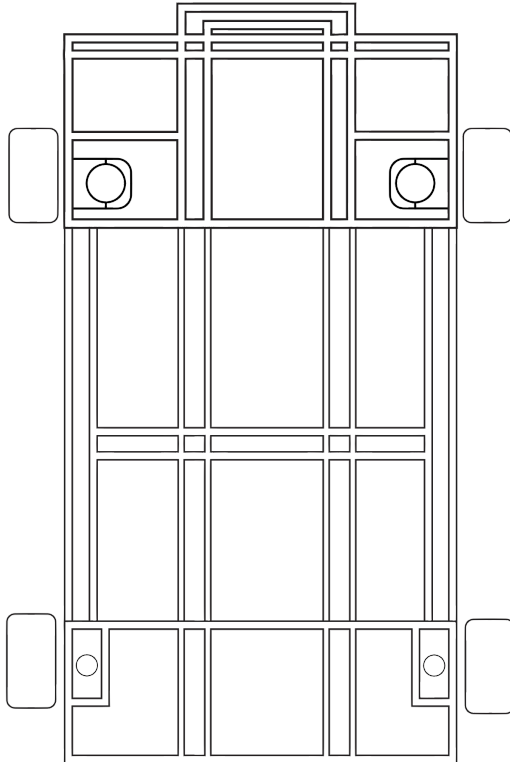
**Chassis Report**

| No dent in the under carriage (th) | PASS |
| No deform chassis or chassis frame (th) | PASS |
| No visible corrosion on the chassis or chassis frame (th) | PASS |
| No missing part on the chassis frame (th) | PASS |
| Half cut Analysis (th) | PASS |

| Chassis Damage Level | No Damage |
