Preowned Vehicle Inspection Report

Premium Inspection Analysis

Customer Name	: MERCEDES-BENZ MOBILITY (THAILAND) CO., LTD.	Inspection Date	: 2024-07-11
Tel.	:	Lemon Inspection ID	: LEMON24070171
Inspector	: แทนรัก ทิพย์อินทร์	Approved By	: ไชยมงคล ไพโรเสียง

Brand	MERCEDES BENZ	Model year	2018
Model	CLA200	Engine Code - No.	27091031720753
Sub-model	URBAN	Registration year	2020-07-21
Registration No.		Chassis No.	WDD1173436L010878
Current Mileage(km.)	283770	Engine Capacity(cc.)	1600

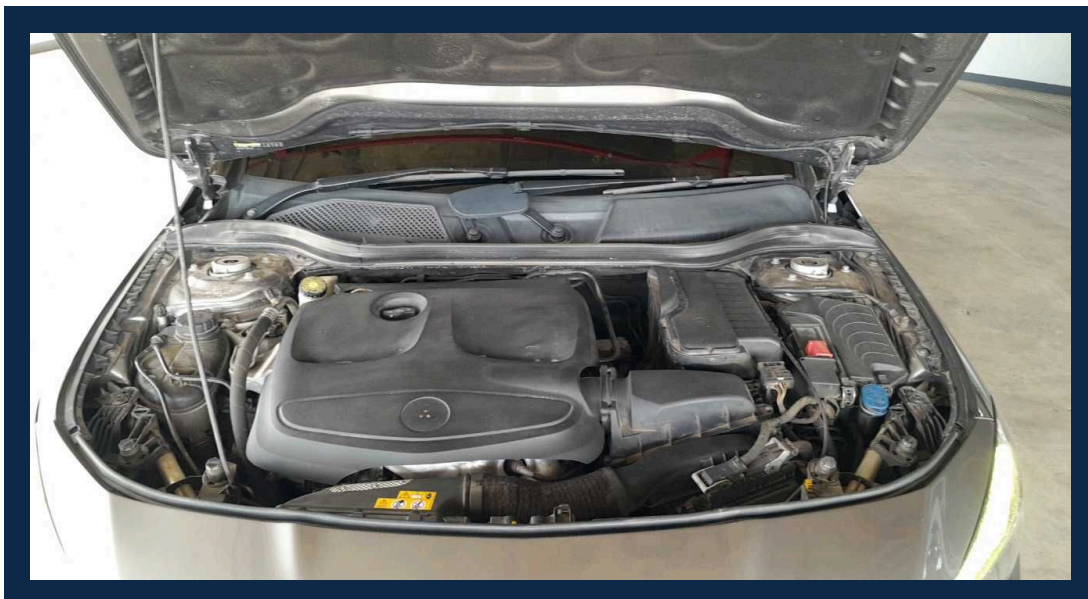
Vehicle Engine Image

เครื่องยนต์(Engine) : เครื่องยนต์ทำงานได้ปกติ ,วิเคราะห์ปัญหาด้วยเครื่อง OBDII ไม่พบสิ่งผิดปกติ (ไม่ได้ทดสอบขับขี) เครื่องมีรอยรั่วน้ำมันเล็กน้อย

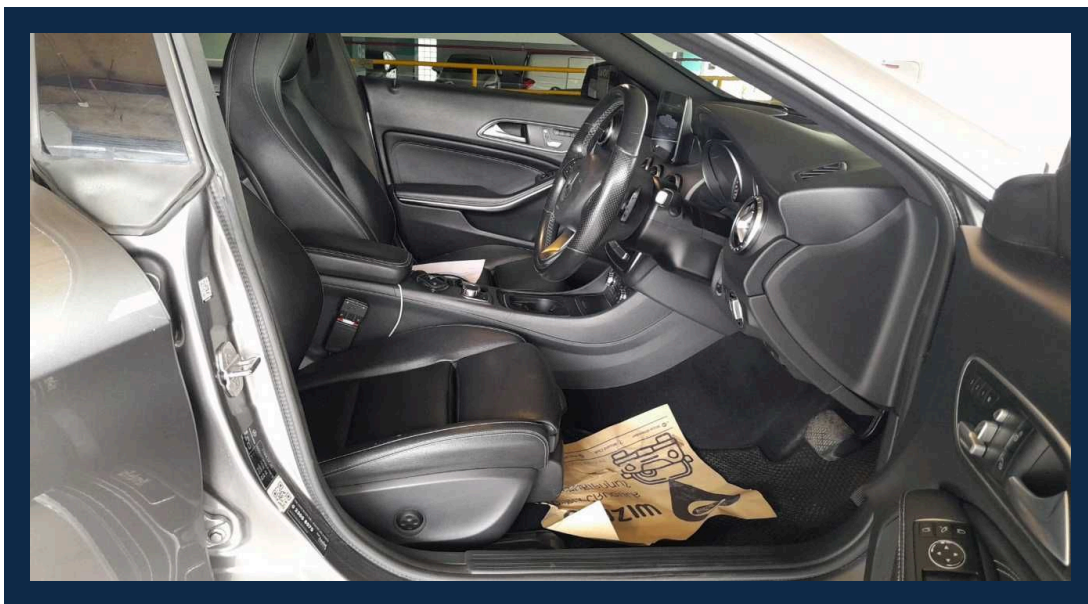
Passenger Front Seat Image

Inspector : ภายนอก(Exterior) : การตรวจสภาพภายนอก โดยรวมพบหลักฐานการซ่อมแซมทำสีมาบ้างชิ้น ไร้รอยถลอกรอบคัน / สภาพยางปกติทั้ง4เส้น ปี 23 ล้อแม็กเป็นรอยถลอก ภายใน(Interior) : ภายในเบาะหน้าขวาเป็นรอยขาด ตัวเปิดเบาะหน้าซ้ายชำรุด สะอาดเรียบร้อย , อุปกรณ์ไฟฟ้า แอร์ วิทยุFM ใช้งานได้ตามมาตรฐานครบปกติ

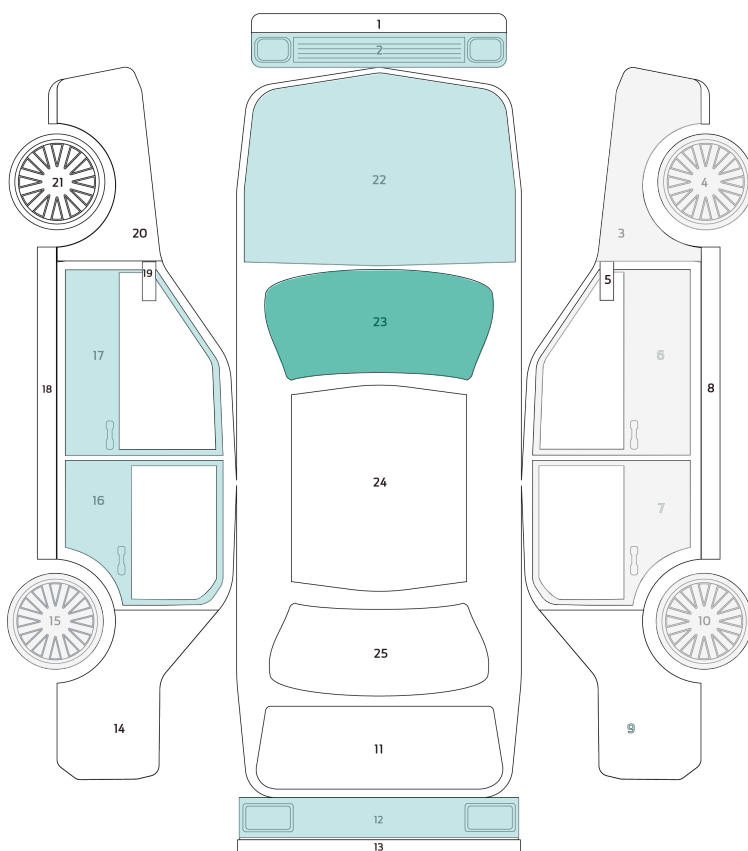
Exterior Inspection Points

1. Front Skirt	O	14. Left Skirt	O
2. Front Bumper	BP (S1,Y)	15. Left Wing Mirror	O
3. Front Right Fender	O (S1)	16. Front windshield	N (G1)
4. Front Right Wheel	O (S1)	17. Roof	O
5. Front Left Fender	O	18. Rear Right Fender	O
6. Front Left Wheel	O	19. Rear Bonnet	O
7. Front bonnet	BP (S1)	20. Back right wheel	O (S1)
8. Right Wing Mirror	O	21. Rear Bumper	BP
9. Front right door	O (S1)	22. Rear Skirt	O
10. Rear right door	O (S1)	23. Rear Left Fender	O
11. Right Skirt	O	24. Back left wheel	O (S1)
12. Rear Left door	BP (S1)	25. Back Windshield	O
13. Front left door	BP

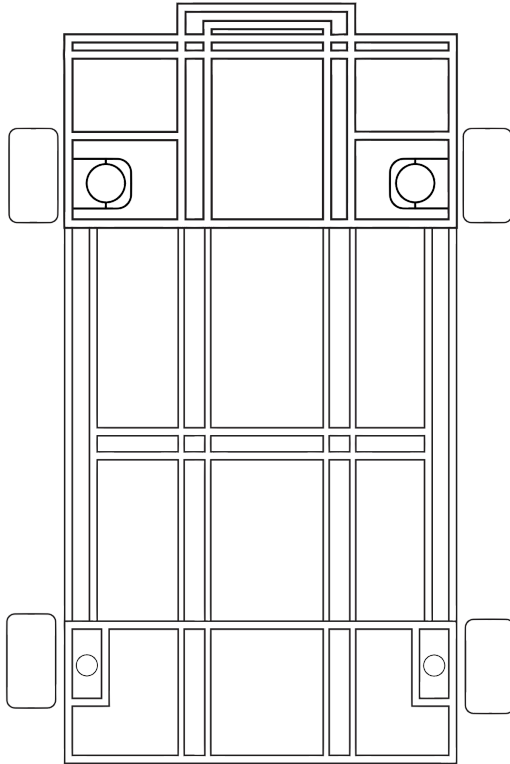
Chassis Report

No dent in the under carriage (th)	PASS
No deform chassis or chassis frame (th)	PASS
No visible corrosion on the chassis or chassis frame (th)	PASS
No missing part on the chassis frame (th)	PASS
Half cut Analysis (th)	PASS

Chassis Damage Level	No Damage
----------------------	-----------
