**Vehicle :** MERCEDES BENZ GLA200

**Chassis number :** W1N2477876L004381

**Inspection date :** 2024-07-15

**Vehicle Certification :** Pass the inspection standard of SCHIC INSPECTION BY LEMON-AIDE

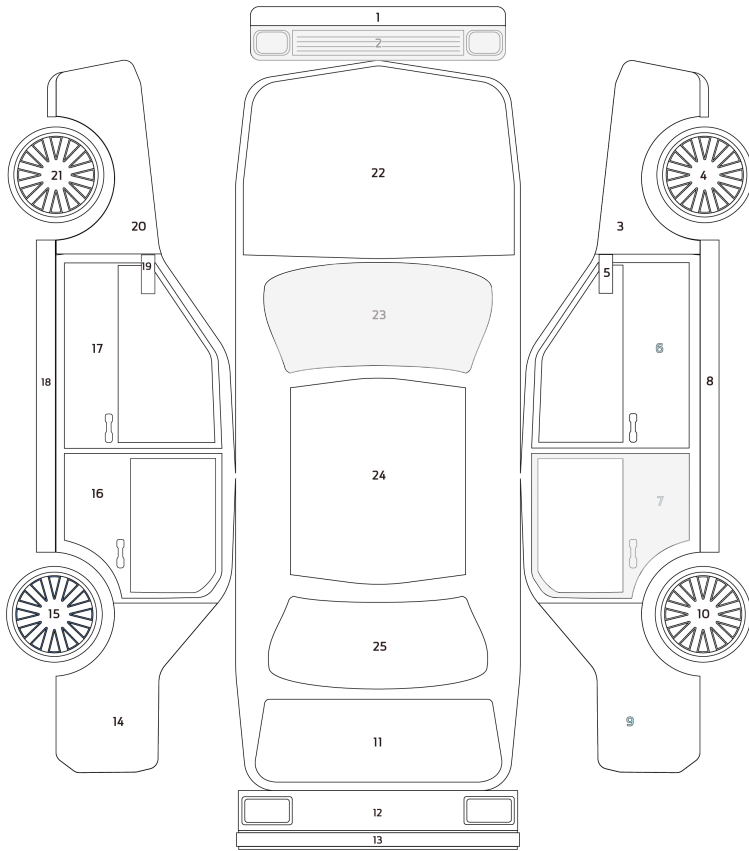
### Exterior Inspection Points

1. Front Skirt	O	14. Left Skirt	O
2. Front Bumper	O (S2)	15. Left Wing Mirror	O
3. Front Right Fender	O	16. Front windshield	O (G2)
4. Front Right Wheel	O	17. Roof	O
5. Front Left Fender	O	18. Rear Right Fender	O
6. Front Left Wheel	O	19. Rear Bonnet	O
7. Front Bonnet	O	20. Back Right Wheel	O
8. Right Wing Mirror	O	21. Rear Bumper	O
9. Front Right Door	O	22. Rear Skirt	O
10. Rear right door	O (S1)	23. Rear Left Fender	O
11. Right Skirt	O	24. Back Left Wheel	O
12. Rear Left Door	O	25. Back Windshield	O
13. Front Left Door	O

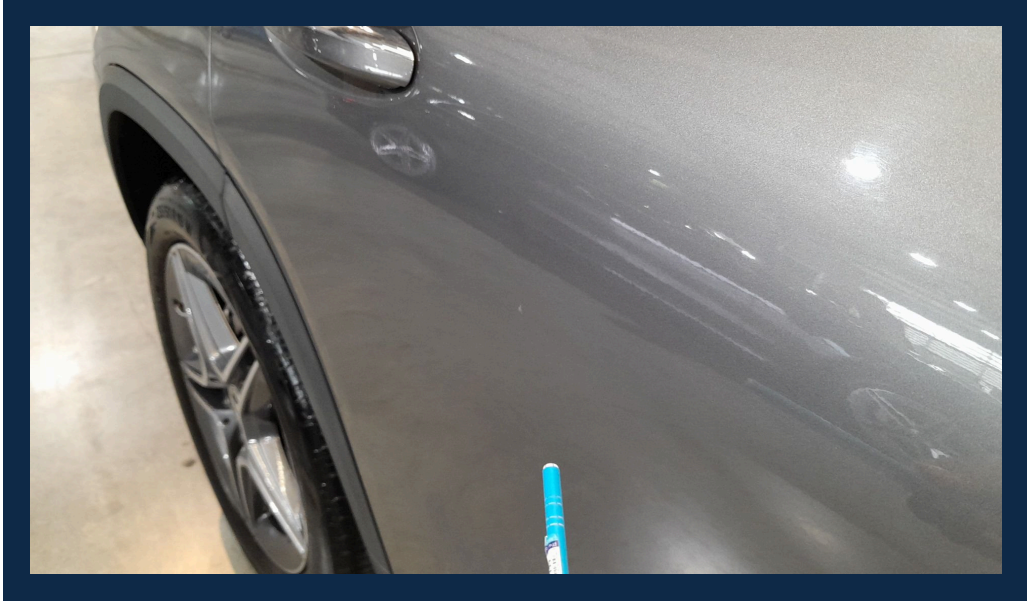
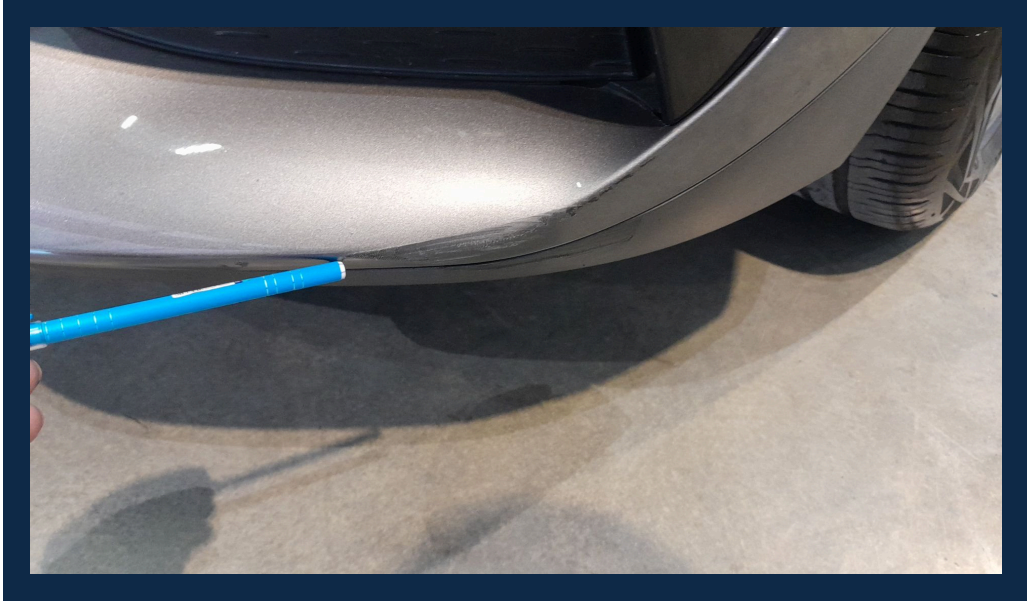
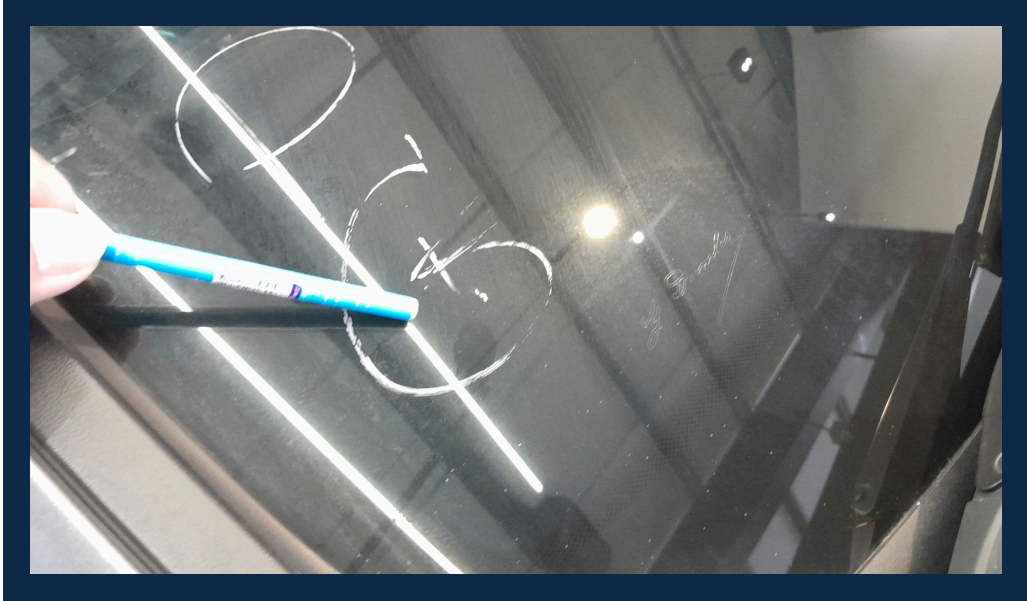
**Vehicle Defect Notices**

**Inspector :** ภายนอก(Exterior) : การตรวจสภาพภายนอกโดยรวมไม่พบหลักฐานการซ่อมแซมทำสี กันชนหน้าเป็นรอยถลอก กระจกเป็นรอยสะเก็ดหิน / สภาพยางปกติทั้ง4เส้น ปี 21 ภายใน(Interior) : ภายในปกติ สะอาดเรียบร้อย ,อุปกรณ์ไฟฟ้า แอร์ วิทยุFM ใช้งานได้สมบูรณ์ครบปกติ เครื่องยนต์(Engine) : เครื่องยนต์ทำงานได้ปกติ ,วิเคราะห์ปัญหาด้วยเครื่อง OBDII ไม่พบสิ่งผิดปกติ (ไม่ได้ทดสอบขับขี) โครงสร้าง(Frame) : อุบัติเหตุไม่มี ,โครงสร้างหลักปกติ ไม่มีการซ่อมแซมโครงสร้างหรือมีการชนถึงโครงสร้าง

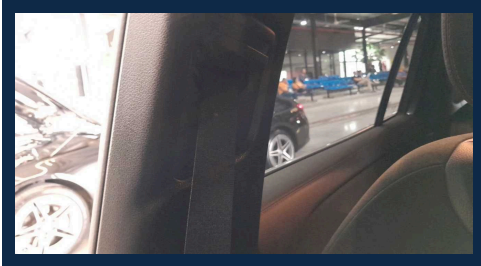
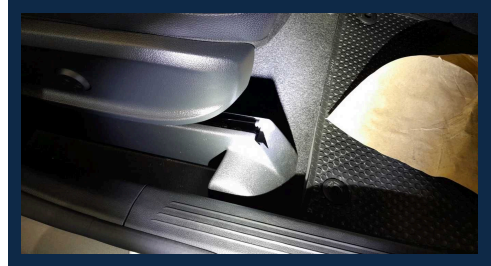
**Flood Report**

Evidence of Flood	No
-------------------	----

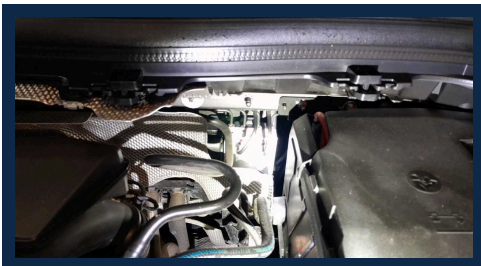
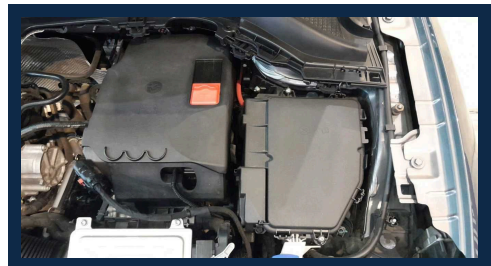
**Fire Report**

Evidence of Fire	No
------------------	----
