Preowned Vehicle Inspection Report

Premium Inspection Analysis

Customer Name	: MERCEDES-BENZ MOBILITY (THAILAND) CO., LTD.	Inspection Date	: 2024-07-16
Tel.	:	Lemon Inspection ID	: LEMON24070255
Inspector	: แทนรัก ทิพย์อินทร์	Approved By	: ไซยมงคล ไพโรสัยง

Brand	MERCEDES BENZ	Model year	2022
Model	C220	Engine Code - No.	65482080055141
Sub-model	d Avantgarde	Registration year	2022-12-21
Registration No.	ป้ายแดง	Chassis No.	W1K2060046L006140
Current Mileage(km.)	39718	Engine Capacity(cc.)	2000

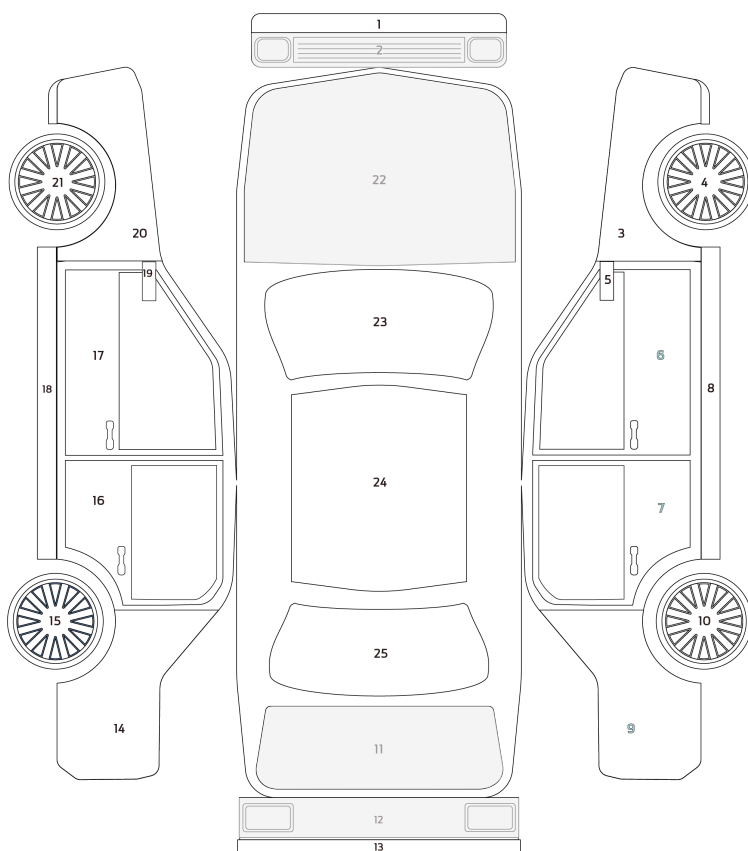
Exterior Inspection Points

1. Front Skirt	O	14. Left Skirt	O
2. Front Bumper	O (S1)	15. Left Wing Mirror	O
3. Front Right Fender	O	16. Front Windshield	O
4. Front Right Wheel	O	17. Roof	O
5. Front Left Fender	O	18. Rear Right Fender	O
6. Front Left Wheel	O	19. Rear Bonnet	O (S1)
7. Front bonnet	O (S1)	20. Back Right Wheel	O
8. Right Wing Mirror	O	21. Rear Bumper	O (S1)
9. Front Right Door	O	22. Rear Skirt	O
10. Rear Right Door	O	23. Rear Left Fender	O
11. Right Skirt	O	24. Back Left Wheel	O
12. Rear Left Door	O	25. Back Windshield	O
13. Front Left Door	O

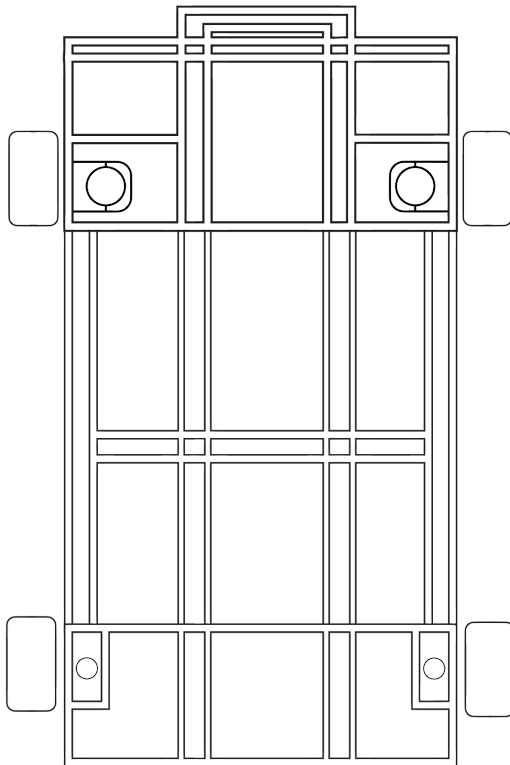
Chassis Report

No dent in the under carriage (th)	PASS
No deform chassis or chassis frame (th)	PASS
No visible corrosion on the chassis or chassis frame (th)	PASS
No missing part on the chassis frame (th)	PASS
Half cut Analysis (th)	PASS

Chassis Damage Level	No Damage
----------------------	-----------
