Preowned Vehicle Inspection Report

Premium Inspection Analysis

| Tel. | : | Lemon Inspection ID | : LEMON24070284 |

| Model | GLC250 | Engine Code - No. | 27492031771509 |

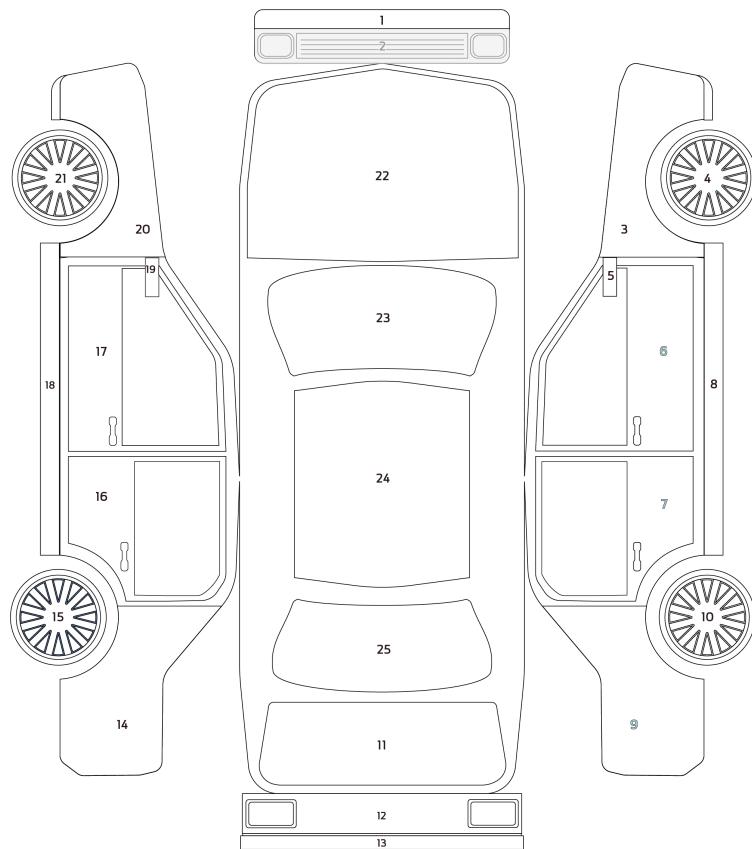
Exterior Inspection Points

| 2. Front Bumper | O (S2) | 15. Left Wing Mirror | O |

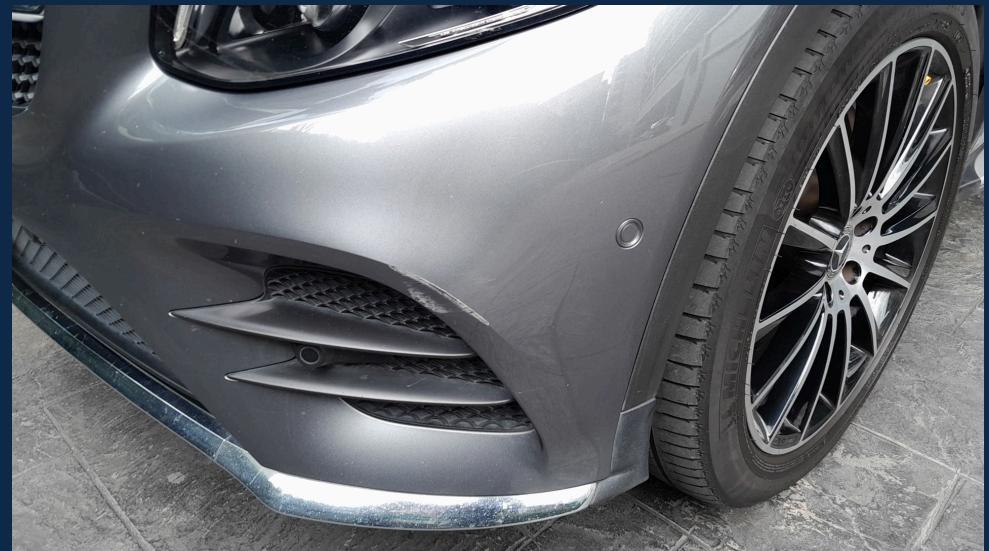
Vehicle Defect Notices

Inspector : ภายนอก(Exterior) : การตรวจสภาพภายนอกโดยรวมไม่พบหลักฐานการซ่อมทำสี/พับกันชนหน้ารถลอก/คั่วล้อหลังข้ามล้อ / สภาพยางปักติดกัน 4 เส้น ปี 22 หลังขวางปี 21 ภายใน(Interior) : ภายในปักติด สะอาดเรียบร้อย , อุปกรณ์ไฟฟ้า แอร์ วิทยุ FM ใช้งานได้ลื่นบูรณาครุปปักติ เครื่องยนต์(Engine) : เครื่องยนต์ทำงานได้ปักติ , วิเคราะห์ปัญหาด้วยเครื่อง OBDII พับสั่งผิดปักติ แนะนำเข้าศูนย์บริการใหม่ได้ทดสอบขับขี่ โครงสร้าง(Frame) : อุบัติเหตุไม่มี , โครงสร้างหลักปักติ ไม่มีการซ่อมแซมโครงสร้างหรือมีการชนถึงโครงสร้าง
