Preowned Vehicle Inspection Report

Premium Inspection Analysis

Customer Name	: MERCEDES-BENZ MOBILITY (THAILAND) CO., LTD.	Inspection Date	: 2024-07-18
Tel.	:	Lemon Inspection ID	: LEMON24070318
Inspector	: ไซบงคล ไพรเลี้ยง	Approved By	: แทนรัก ทิพย์อินทร์

Brand	MERCEDES BENZ	Model year	2019
Model	GLC250	Engine Code - No.	27492031706141
Sub-model	4MATIC AMG PLUS (COUPE)	Registration year	2020-03-24
Registration No.	9กง6594	Chassis No.	WDC2533466L021060
Current Mileage(km.)	30880	Engine Capacity(cc.)	2000

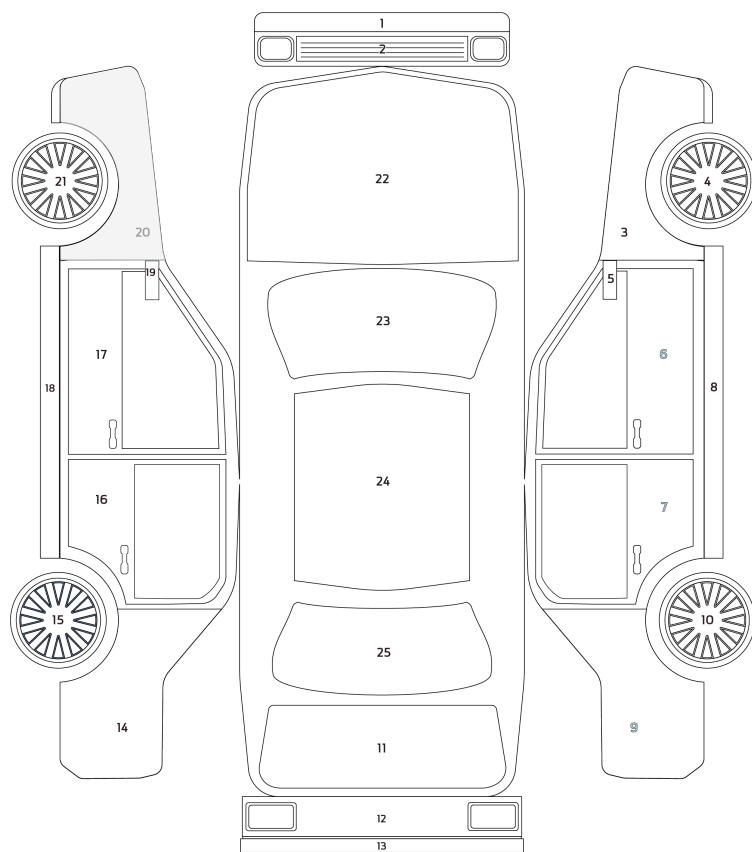
Exterior Inspection Points

1. Front Skirt	O	14. Left Skirt	O
2. Front Bumper	O	15. Left Wing Mirror	O
3. Front Right Fender	O	16. Front Windshield	O
4. Front Right Wheel	O	17. Roof	O
5. Front Left Fender	O (S2)	18. Rear Right Fender	O
6. Front Left Wheel	O	19. Rear Bonnet	O
7. Front Bonnet	O	20. Back Right Wheel	O
8. Right Wing Mirror	O	21. Rear Bumper	O
9. Front Right Door	O	22. Rear Skirt	O
10. Rear Right Door	O	23. Rear Left Fender	O
11. Right Skirt	O	24. Back Left Wheel	O
12. Rear Left Door	O	25. Back Windshield	O
13. Front Left Door	O

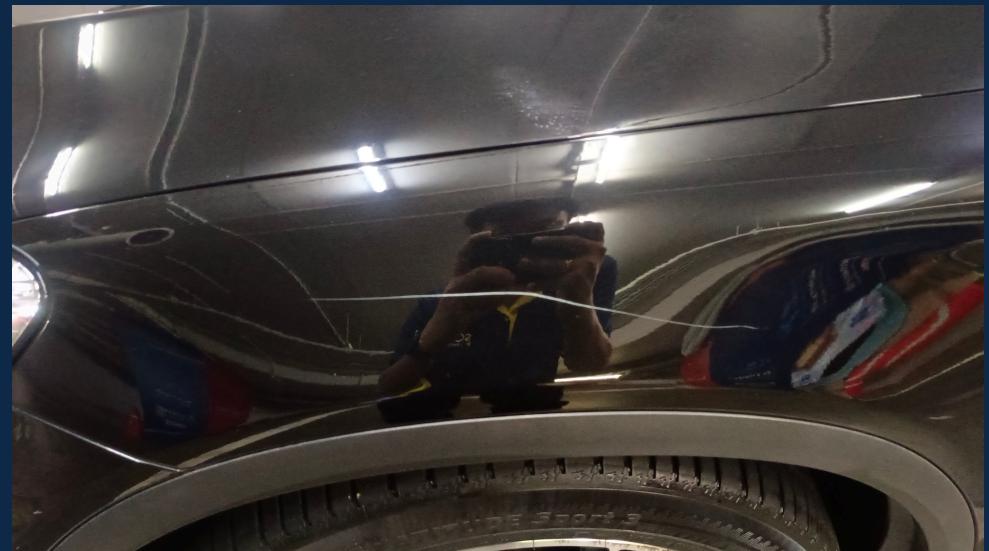
Vehicle Defect Notices

Inspector : ภายนอก(Exterior) : การตรวจสภาพภายนอกโดยรวมไม่พบหลักฐานการซ่อมแซมทำสี /บังโคลนหน้าซ้าย ถลอกฝากระปรงหน้าสีเป็นพดพื้น/ สภาพยางปกติกั้ง4เส้น ปี23 ภายใน(Interior) : ภายในปกติ สะอาดเรียบร้อย ,อุปกรณ์ไฟฟ้า แอร์ วิทยุFM ใช้งานได้สมบูรณ์ครบปกติ เครื่องยนต์(Engine) : เครื่องยนต์ทำงานได้ปกติ ,วิเคราะห์ปัญหาด้วยเครื่อง OBDII ไม่พบสิ่งผิดปกติ (ไม่ได้ทดสอบขับขี่) โครงสร้าง(Frame) : อุบัติเหตุไม่มี ,โครงสร้างหลักปกติ ไม่มีการซ่อมแซมโครงสร้างหรือมีการชนถึงโครงสร้าง
