# Preowned Vehicle Inspection Report

Premium Inspection Analysis

| Tel. | : | Lemon Inspection ID | : LEMON24090043 |

| Model | GLC250 | Engine Code - No. | 27492031706141 |

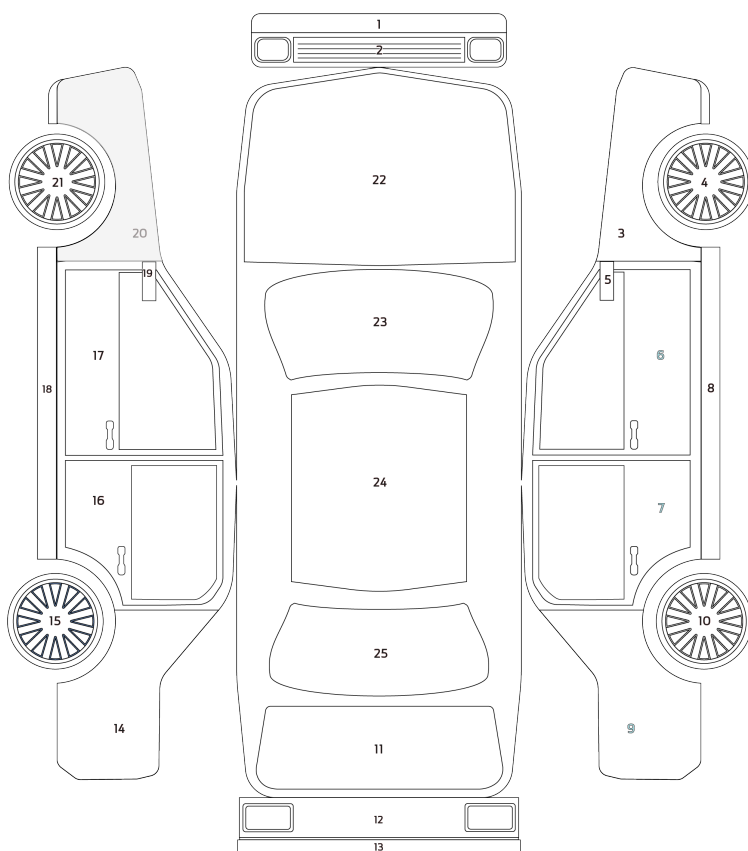
**Exterior Inspection Points**

| 5. Front Left Fender | O (S2) | 18. Rear Right Fender | O |

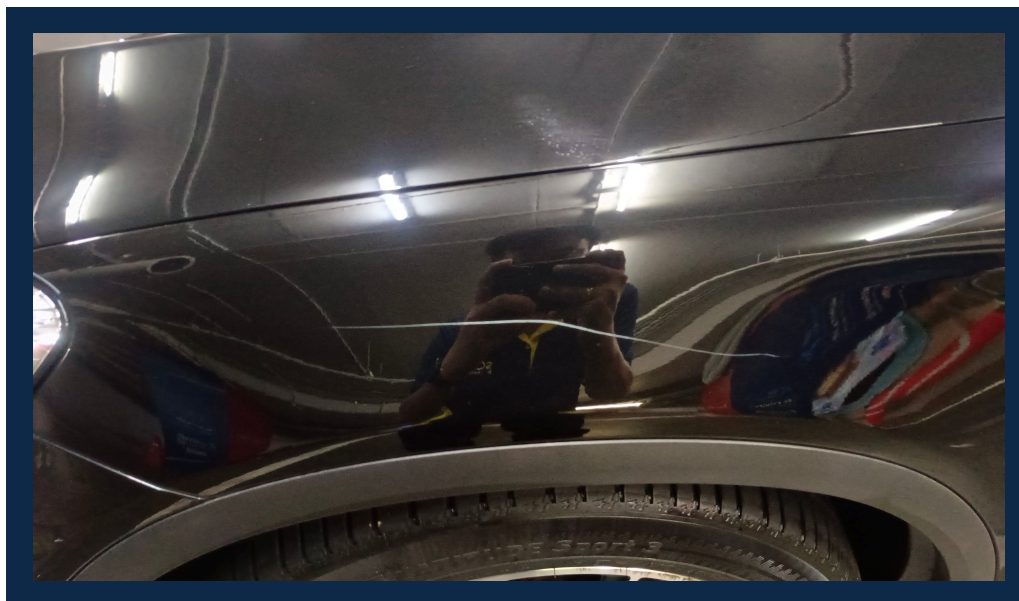
**Vehicle Defect Notices**

**Inspector :** ภายนอก(Exterior) : การตรวจสอบสภาพภายนอกโดยรวมไม่พบหลักฐานการซ่อมแซมทำสี / บังโคลนหน้าซ้าย  
ถลอกฝากระโปรงหน้าสีเป็นผดผื่น/ สภาพยางปกติทั้ง4เส้น ปี23 ภายใน(Interior) : ภายในปกติ สะอาดเรียบร้อย  
อุปกรณ์ไฟฟ้า แอร์ วิทยุFM ใช้งานได้สมบูรณ์ครบปกติ เครื่องยนต์(Engine) : เครื่องยนต์ทำงานได้ปกติ ,วิเคราะห์  
ปัญหาด้วยเครื่อง OBDII ไม่พบสิ่งผิดปกติ (ไม่ได้ทดสอบขับ) โครงสร้าง(Frame) : อุบัติเหตุไม่มี ,โครงสร้างหลักปกติ  
ไม่มีการซ่อมแซมโครงสร้างหรือมีการชนถึงโครงสร้าง

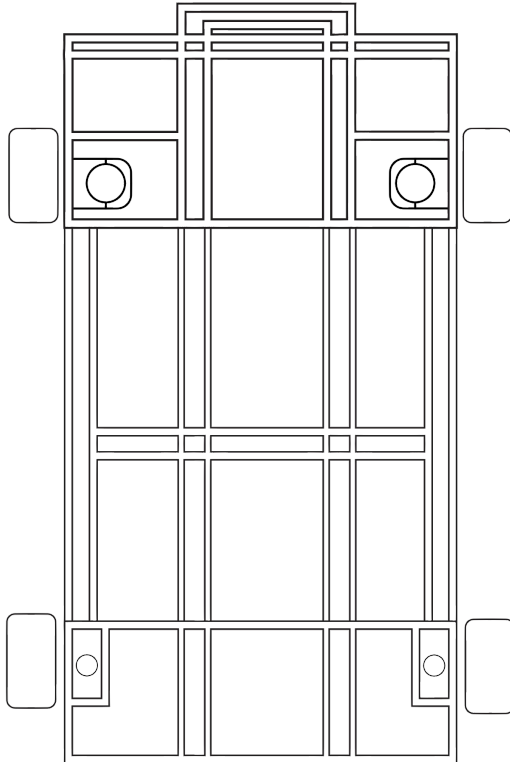
**Chassis Report**

| Chassis Damage Level | No Damage |
