# Preowned Vehicle Inspection Report

Premium Inspection Analysis

| Customer Name | : MERCEDES-BENZ MOBILITY (THAILAND) CO., LTD. | Inspection Date | : 2024-07-20 |

| Brand | MERCEDES BENZ | Model year | 2019 |

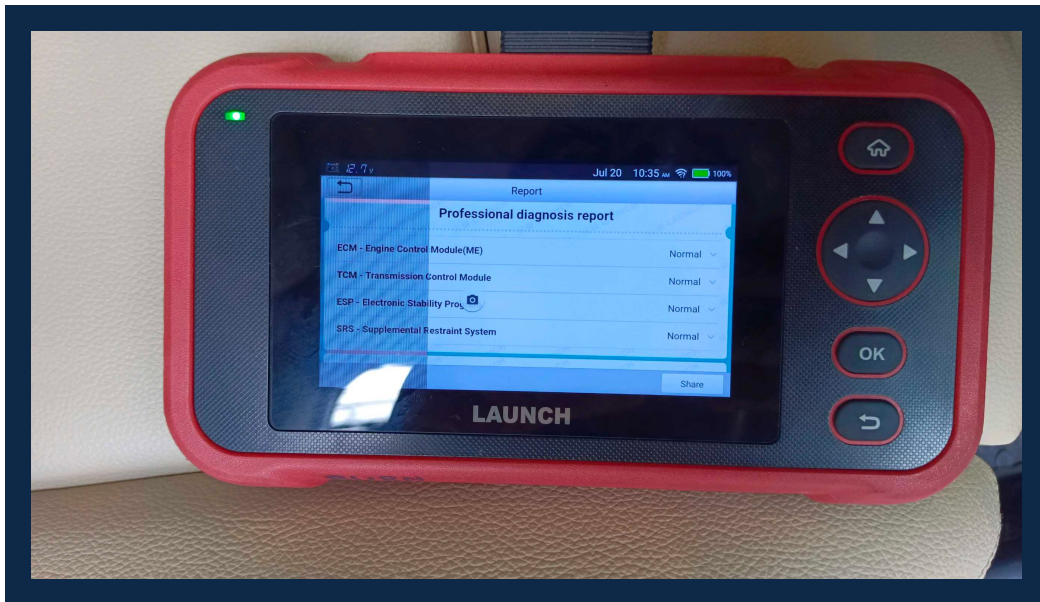
**OBD Vehicle Health Analysis**

**Inspector :** ภายนอก(Exterior) : การตรวจสอบสภาพภายนอกโดยรวมไม่พบหลักฐานการซ่อมแซมทำสี / ประตูหน้าซ้ายบุบ  
ถลอก/ สภาพยางปกติทั้ง4เส้น ปี23 ภายใน(Interior) : ภายในปกติ สะอาดเรียบร้อย , อุปกรณ์ไฟฟ้า แอร์ วิทยุFM ใช้  
งานได้สมบูรณ์ครบปกติ เครื่องยนต์(Engine) : เครื่องยนต์ทำงานได้ปกติ , วิเคราะห์ปัญหาด้วยเครื่อง OBDII ไม่พบสิ่ง  
ผิดปกติ (ไม่ได้ทดสอบขับ) โครงสร้าง(Frame) : อุบัติเหตุไม่มี , โครงสร้างหลักปกติ ไม่มีการซ่อมแซมโครงสร้างหรือมี  
การชนถึงโครงสร้าง

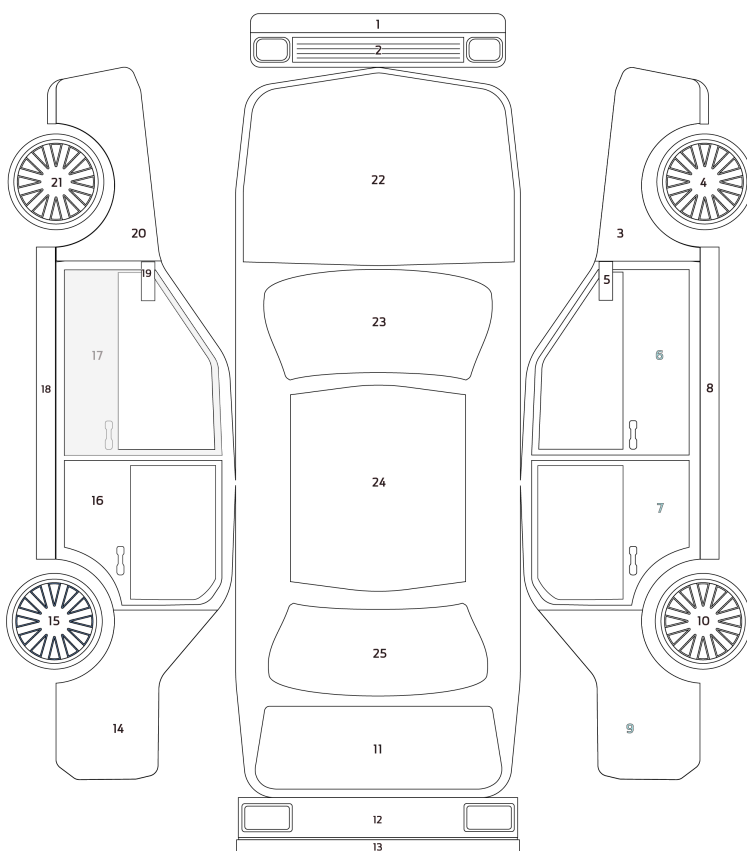
**Exterior Inspection Points**

| 13. Front left door | O (S2) | | |
