# Preowned Vehicle Inspection Report

Premium Inspection Analysis

Customer Name	: MERCEDES-BENZ MOBILITY (THAILAND) CO., LTD.	Inspection Date	: 2024-07-23
Tel.	:	Lemon Inspection ID	: LEMON24070353
Inspector	: ไชยมงคล ไพโรสัยง	Approved By	: แทนรัก ทิพย์อินทร์

Brand	MERCEDES BENZ	Model year	2021
Model	GLC220	Engine Code - No.	65492081113073
Sub-model	d AMG Dynamic	Registration year	2021-11-30
Registration No.		Chassis No.	W1N2539146L035653
Current Mileage(km.)	37687	Engine Capacity(cc.)	2000

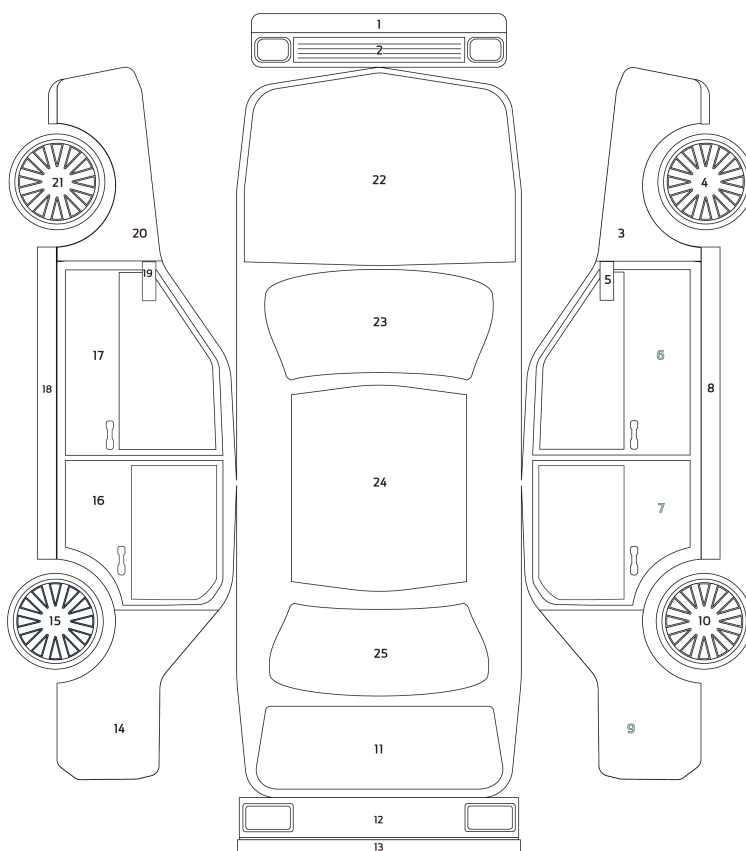
## Exterior Inspection Points

1. Front Skirt	O	14. Left Skirt	O
2. Front Bumper	O	15. Left Wing Mirror	O
3. Front Right Fender	O	16. Front Windshield	O
4. Front Right Wheel	O	17. Roof	O
5. Front Left Fender	O	18. Rear Right Fender	O
6. Front Left Wheel	O	19. Rear Bonnet	O
7. Front Bonnet	O	20. Back Right Wheel	O
8. Right Wing Mirror	O	21. Rear Bumper	O
9. Front Right Door	O	22. Rear Skirt	O
10. Rear Right Door	O	23. Rear Left Fender	O
11. Right Skirt	O	24. Back Left Wheel	O
12. Rear Left Door	O	25. Back Windshield	O
13. Front Left Door	O

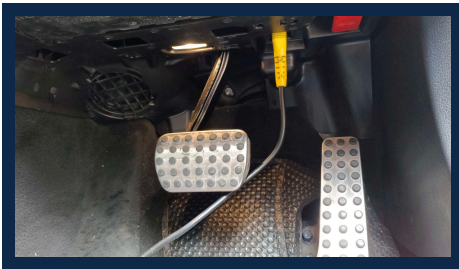
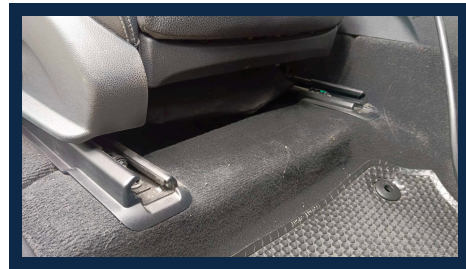
**Flood Report**

Evidence of Flood

No

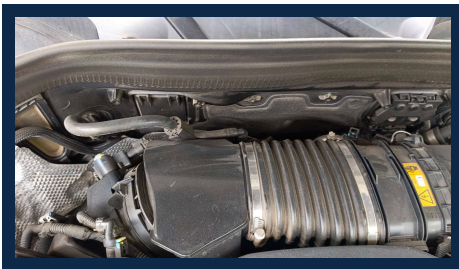
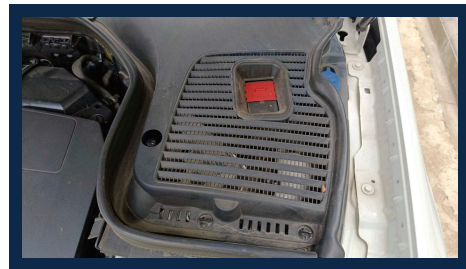
**Fire Report**

Evidence of Fire

No
