Preowned Vehicle Inspection Report

Premium Inspection Analysis

Customer Name	: MERCEDES-BENZ MOBILITY (THAILAND) CO., LTD.	Inspection Date	: 2024-07-23
Tel.	:	Lemon Inspection ID	: LEMON24070357
Inspector	: นายภาบุญยันน์ กัสบุก	Approved By	: ไก่รัก กิพย์อินทร์

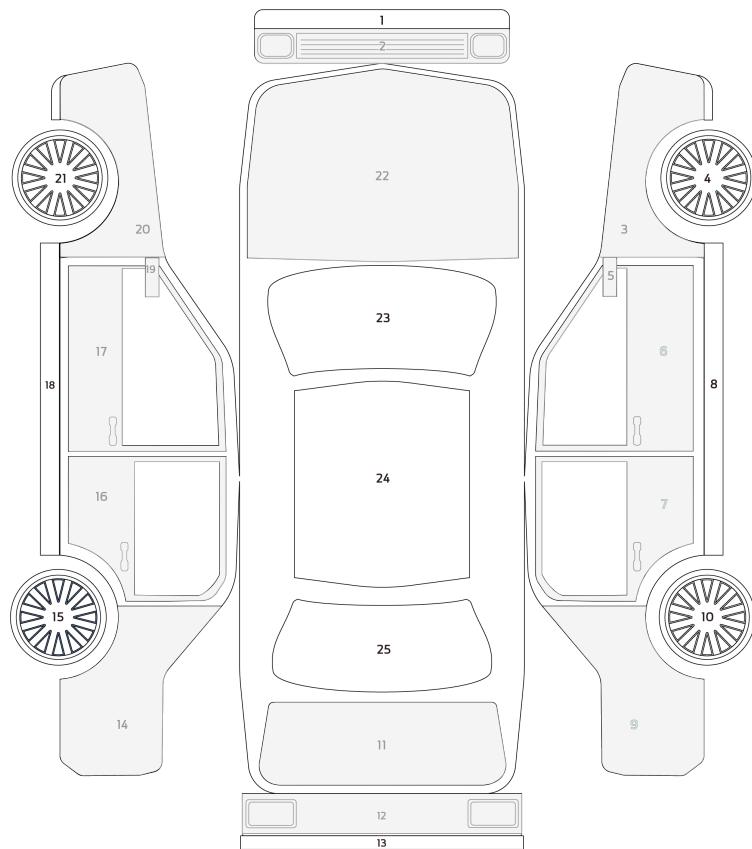
Exterior Inspection Points

1. Front Skirt	O	14. Left Skirt	O
2. Front Bumper	O (S1)	15. Left wing mirror	O (S1)
3. Front Right Fender	O (S1)	16. Front Windshield	O
4. Front Right Wheel	O	17. Roof	O
5. Front Left Fender	O (S1)	18. Rear right fender	O (S2)
6. Front Left Wheel	O	19. Rear Bonnet	O (S1)
7. Front bonnet	O (S1)	20. Back Right Wheel	O
8. Right wing mirror	O (S1)	21. Rear Bumper	O (S1)
9. Front right door	O (S1)	22. Rear Skirt	O
10. Rear right door	O (S1)	23. Rear left fender	O (S1)
11. Right Skirt	O	24. Back Left Wheel	O
12. Rear Left door	O (S2)	25. Back Windshield	O
13. Front left door	O (S2)

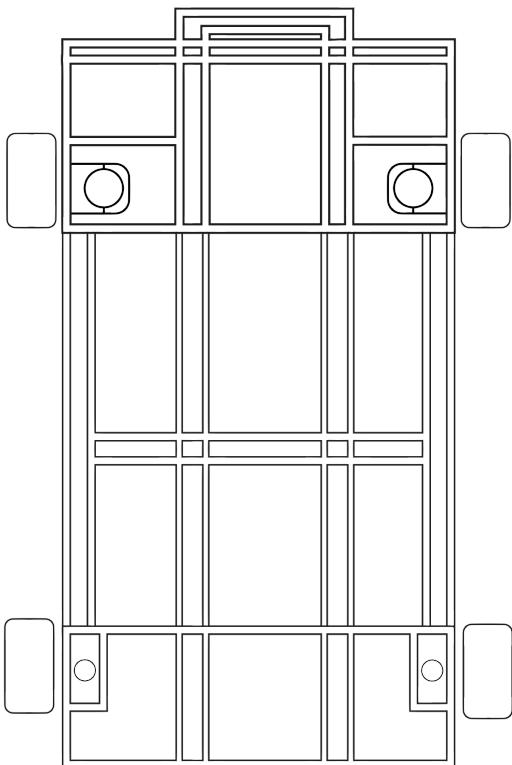
Chassis Report

No dent in the under carriage (th)	PASS
No deform chassis or chassis frame (th)	PASS
No visible corrosion on the chassis or chassis frame (th)	PASS
No missing part on the chassis frame (th)	PASS
Half cut Analysis (th)	PASS

Chassis Damage Level	No Damage
----------------------	-----------

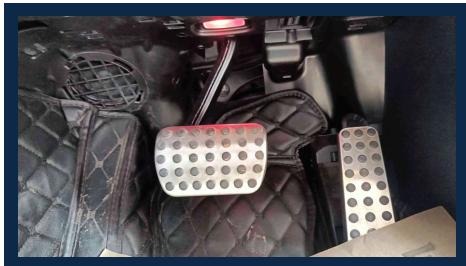
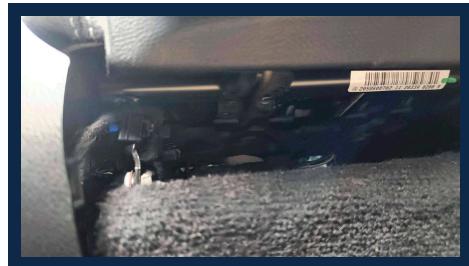
Flood Report

Evidence of Flood

No

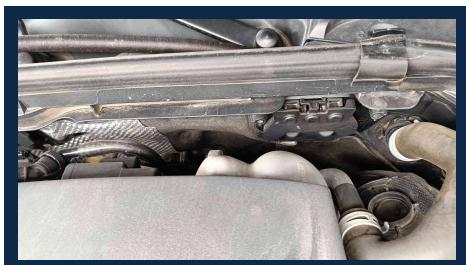
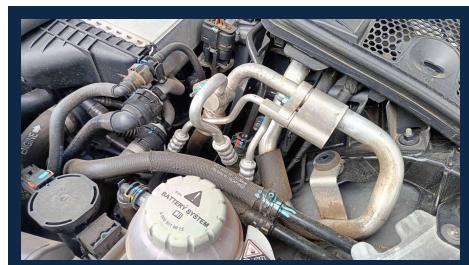
**Fire Report**

Evidence of Fire

No
