# Preowned Vehicle Inspection Report

Customer Name	: MERCEDES-BENZ MOBILITY (THAILAND) CO., LTD.	Inspection Date	: 2024-07-20
Tel.	:	Lemon Inspection ID	: LEMON24070349
Inspector	: นายภาณุวัฒน์ กัสสุภา	Approved By	: แทนรัก ทิพย์อินทร์

Brand	MERCEDES BENZ	Model year	2019
Model	GLA250	Engine Code - No.	27092031899359
Sub-model	AMG Dynamic	Registration year	2020-07-03
Registration No.		Chassis No.	WDC1569446L013527
Current Mileage(km.)	124381	Engine Capacity(cc.)	2000

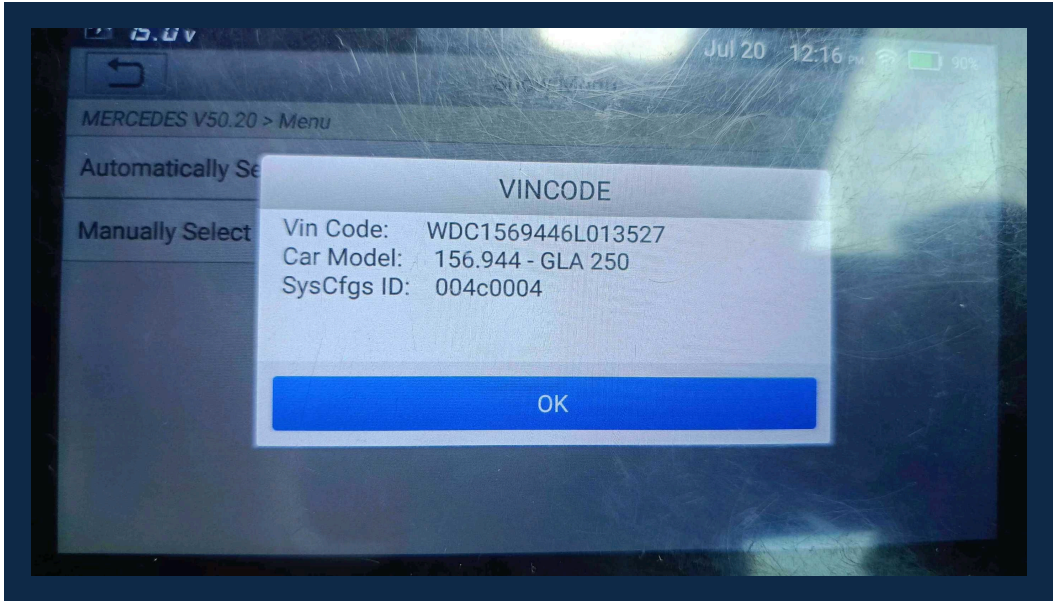
**OBD Vehicle Health Analysis**

1. Vehicle Engine Number Analysis (th)	PASS	14. Air Conditioning and Heating System (th)	PASS
2. Vehicle Chassis Number Analysis (th)	PASS	15. Front and Rear Suspension (th)	PASS
3. Vehicle Original OEM Color Analysis (th)	PASS	16. Drive Axle (th)	PASS
4. Engine System (th)	FAIL	17. High Tech (th)	PASS
5. Transmission System (th)	PASS	18. Passenger Comfort (th)	PASS
6. Electrical System (th)	PASS	19. Security System (th)	PASS
7. Brake System (th)	PASS	20. Safety Active (th)	PASS
8. Steering System (th)	PASS	21. Safety Passive (th)	PASS
9. Fuel System (th)	PASS	22. Original Mileage Analysis (th)	PASS
10. Four-wheel Drive (th)	PASS	23. Overall Chassis Analysis (th)	PASS
11. Turbocharger/Supercharger (th)	PASS	24. Overall Exterior Analysis (th)	PASS
12. Fuel Injection and Engine Management System (th)	PASS	25. Overall Interior Analysis (th)	PASS
13. Engine Cooling System (th)	PASS

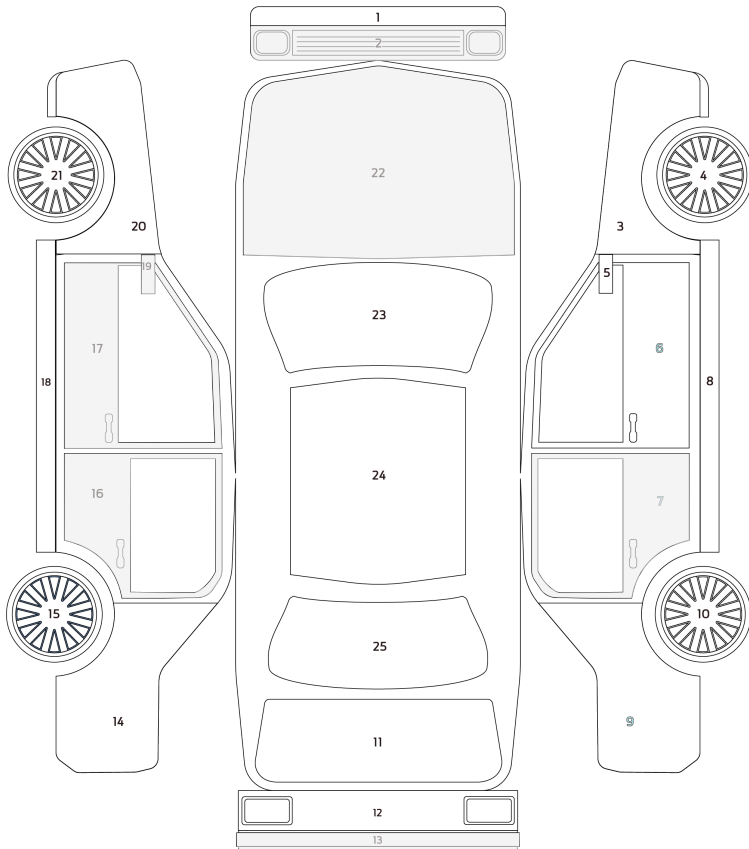
### Exterior Inspection Points

1. Front Skirt	O	14. Left Skirt	O
2. Front Bumper	O (S1)	15. Left wing mirror	O (S1)
3. Front Right Fender	O	16. Front Windshield	O
4. Front Right Wheel	O	17. Roof	O
5. Front Left Fender	O	18. Rear Right Fender	O
6. Front Left Wheel	O	19. Rear Bonnet	O
7. Front bonnet	O (S1)	20. Back Right Wheel	O
8. Right Wing Mirror	O	21. Rear Bumper	O
9. Front Right Door	O	22. Rear skirt	O (S1)
10. Rear right door	O (S1)	23. Rear Left Fender	O
11. Right Skirt	O	24. Back Left Wheel	O
12. Rear Left door	O (S1)	25. Back Windshield	O
13. Front left door	O (S1)

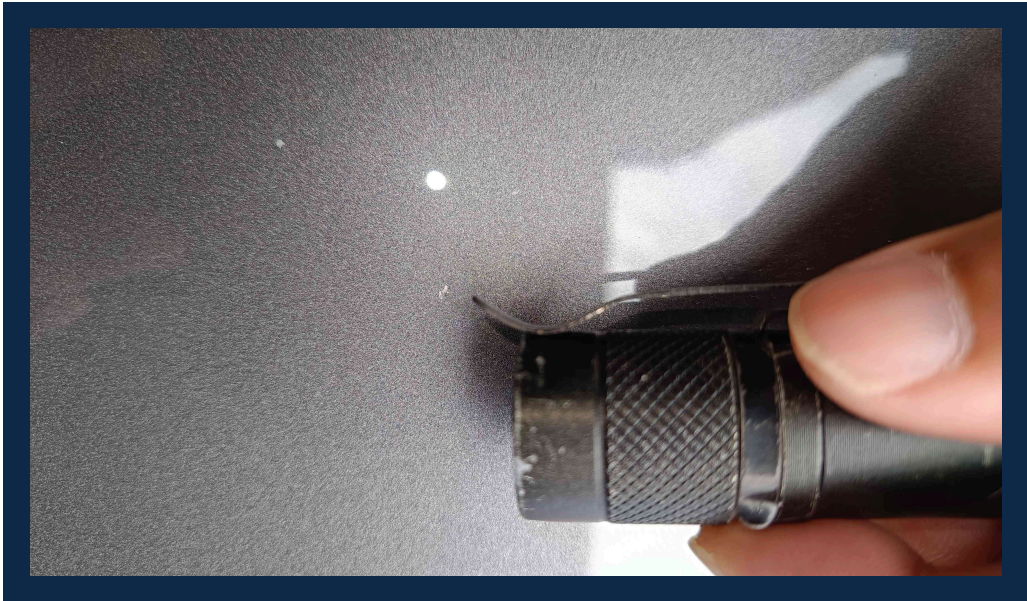
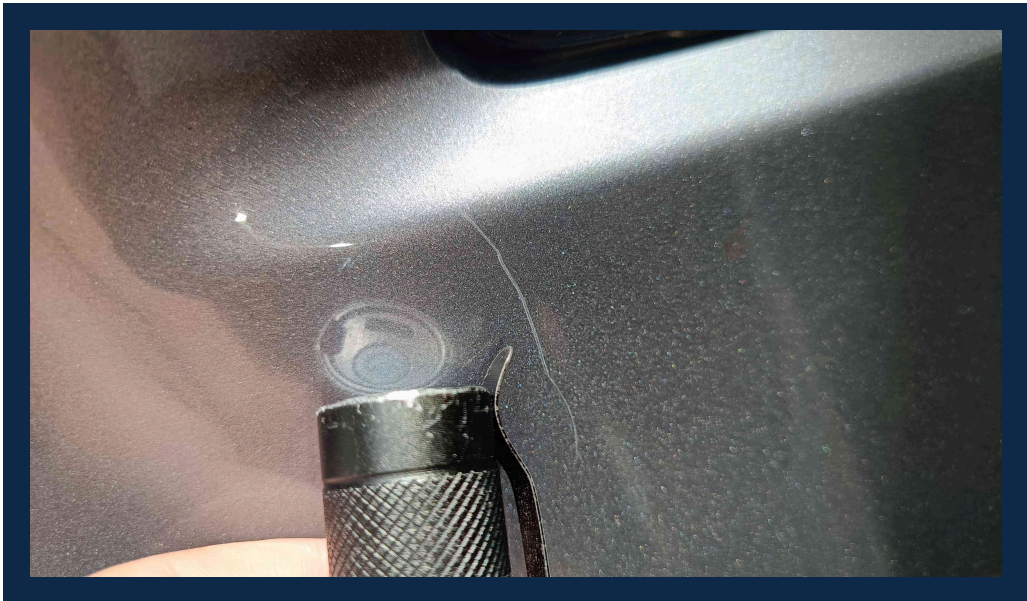
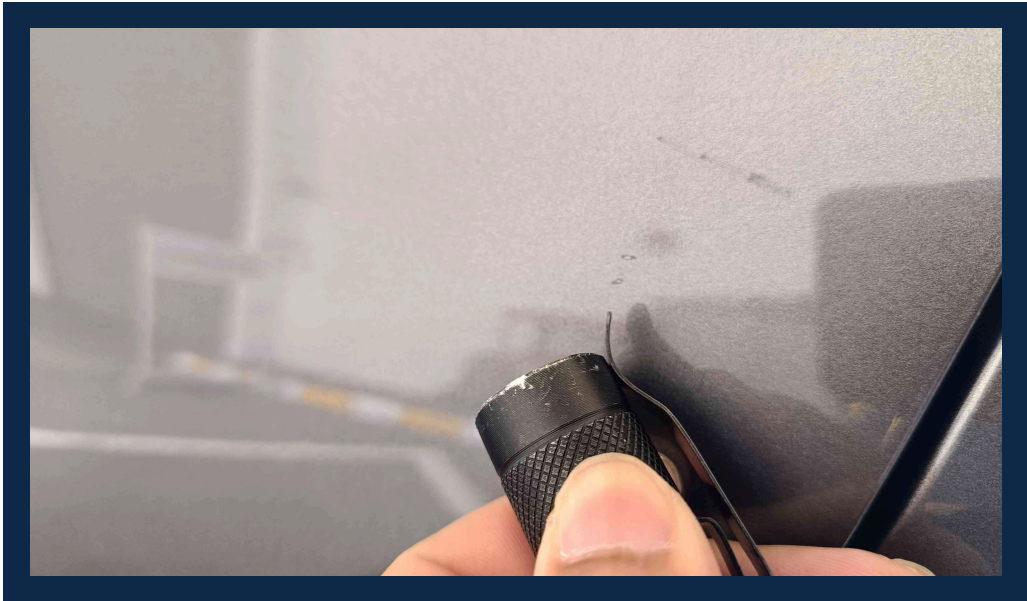
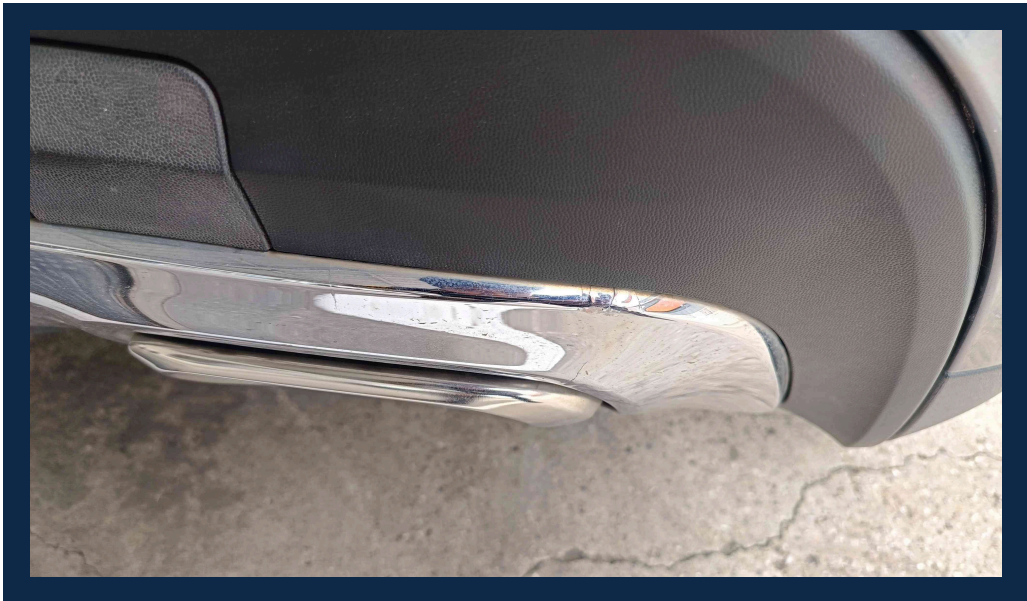
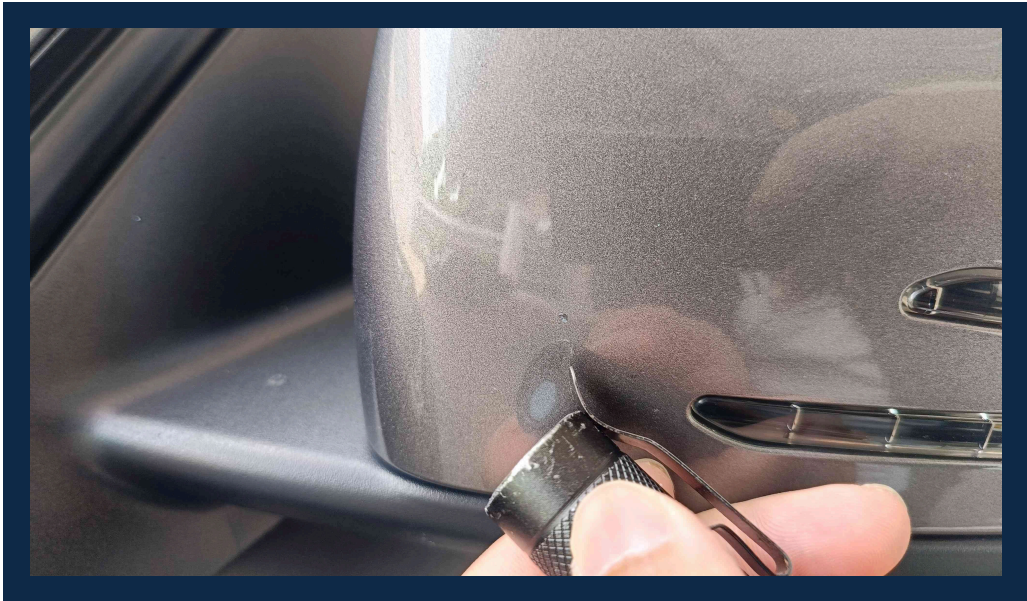
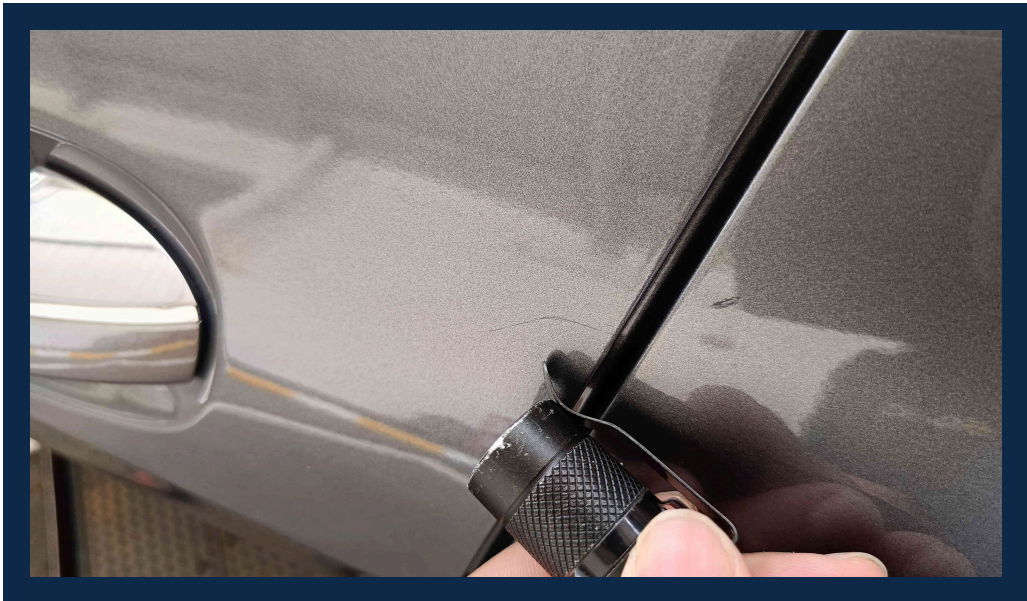
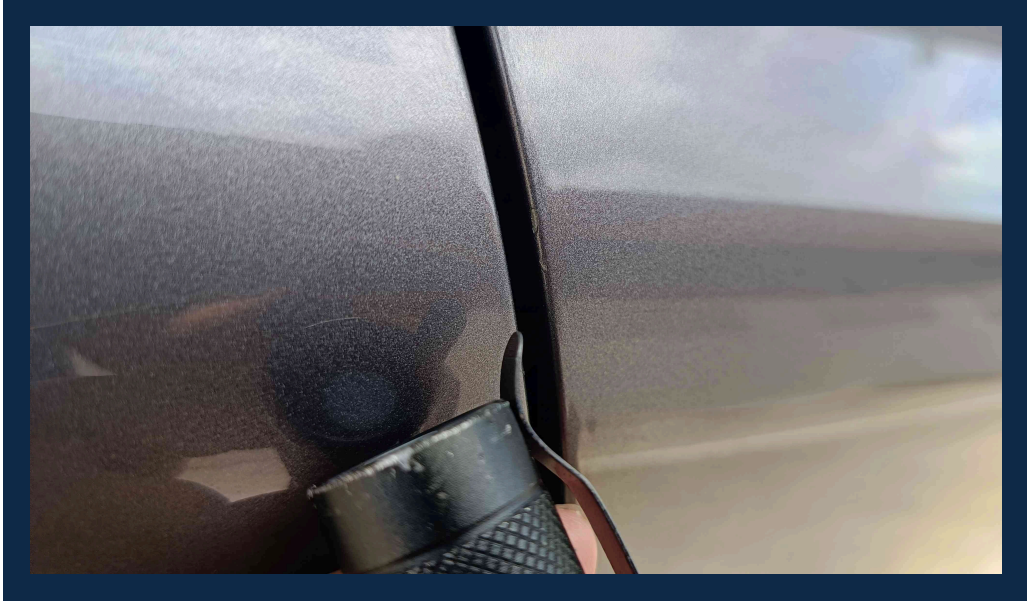
**Vehicle Defect Notices**

**Inspector :** ภายนอก : พบรอยขีดข่วนตลอด ฝากระโปรงหน้า/กันชนหน้า/ขอบประตูหลังขวา/กันชนท้าย /ประตูหลังซ้าย/ประตูหน้าซ้าย/กระจกมองข้างฝั่งซ้าย/สภาพยาง ยางล้อหน้าซ้ายและล้อหน้าขวาเสื่อมสภาพ ยางปี 21 ภายใน : อุปกรณ์อำนวยความสะดวกภายในใช้งานได้ปกติ/ภายในมีคราบสกปรกเล็กน้อยสามารถทำความสะอาดออกได้/ภายในไม่มีกลิ่นอับ/บริเวณแป้นเบรคพวงมาลัยมีรอยถลอกเล็กน้อย เครื่องยนต์และเกียร์ : พบคราบน้ำมันเครื่องรั่วซึมบริเวณท่ออากาศหน้าเครื่อง/ไม่สามารถตรวจสอบด้วยเครื่อง OBD ได้เนื่องจากเวอร์ชันเครื่องตรวจไม่รองรับกับรุ่นนี้/ช่วงล่างใช้งานได้ปกติ โครงสร้าง : โครงสร้างในสภาพปกติไม่พบความเสียหายหนักถึงโครงสร้าง

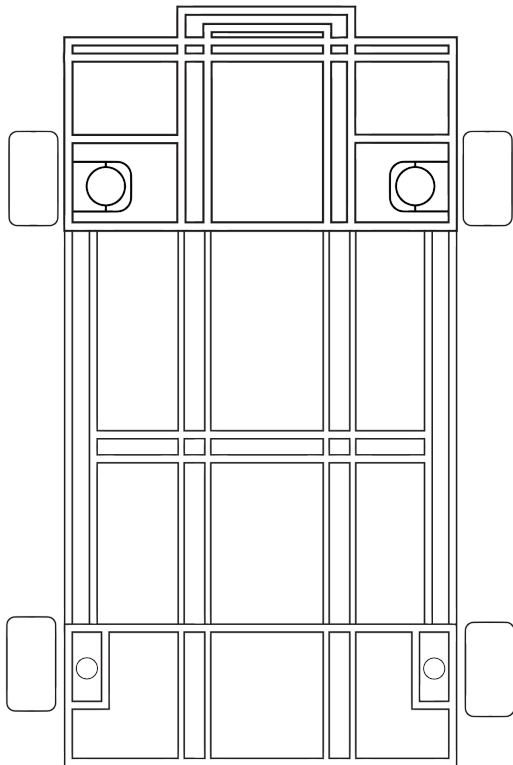
Chassis Report

No dent in the under carriage (th)	PASS
No deform chassis or chassis frame (th)	PASS
No visible corrosion on the chassis or chassis frame (th)	PASS
No missing part on the chassis frame (th)	PASS
Half cut Analysis (th)	PASS

Chassis Damage Level	No Damage
----------------------	-----------
