Preowned Vehicle Inspection Report

Premium Inspection Analysis

Brand	MERCEDES BENZ	Model year	2021
Model	GLA200	Engine Code - No.	28291430608931
Sub-model	AMG Dynamic	Registration year	2022-10-10
Registration No.		Chassis No.	W1N2477876L002105
Current Mileage(km.)	16404	Engine Capacity(cc.)	1300

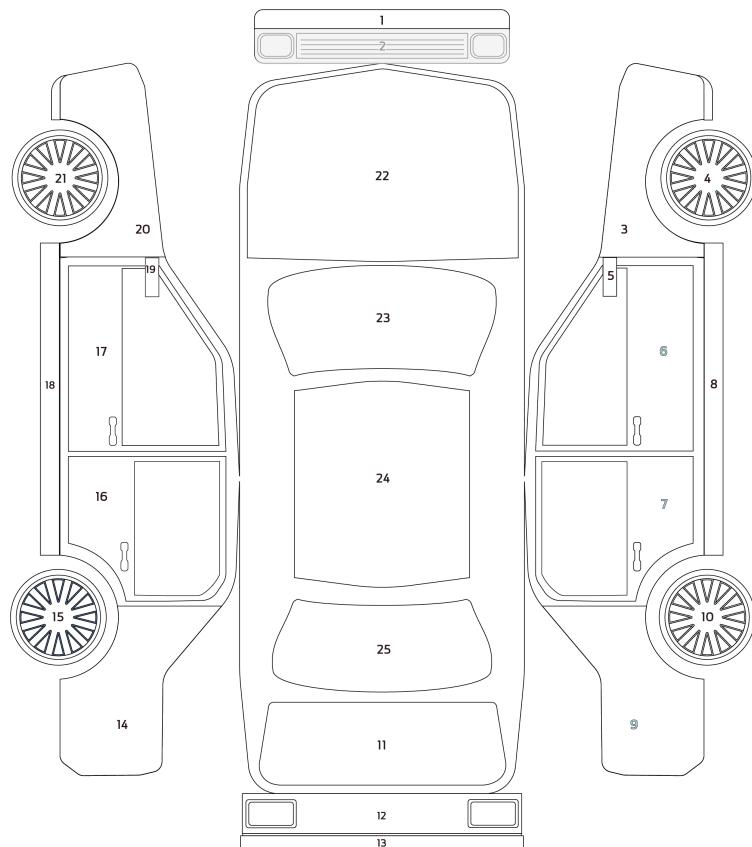
Exterior Inspection Points

1. Front Skirt	O	14. Left Skirt	O
2. Front Bumper	O (S2)	15. Left Wing Mirror	O
3. Front Right Fender	O	16. Front Windshield	O
4. Front Right Wheel	O	17. Roof	O
5. Front Left Fender	O	18. Rear Right Fender	O
6. Front Left Wheel	O	19. Rear Bonnet	O
7. Front Bonnet	O	20. Back Right Wheel	O
8. Right Wing Mirror	O	21. Rear Bumper	O
9. Front Right Door	O	22. Rear Skirt	O
10. Rear Right Door	O	23. Rear Left Fender	O
11. Right Skirt	O	24. Back Left Wheel	O
12. Rear Left Door	O	25. Back Windshield	O
13. Front Left Door	O

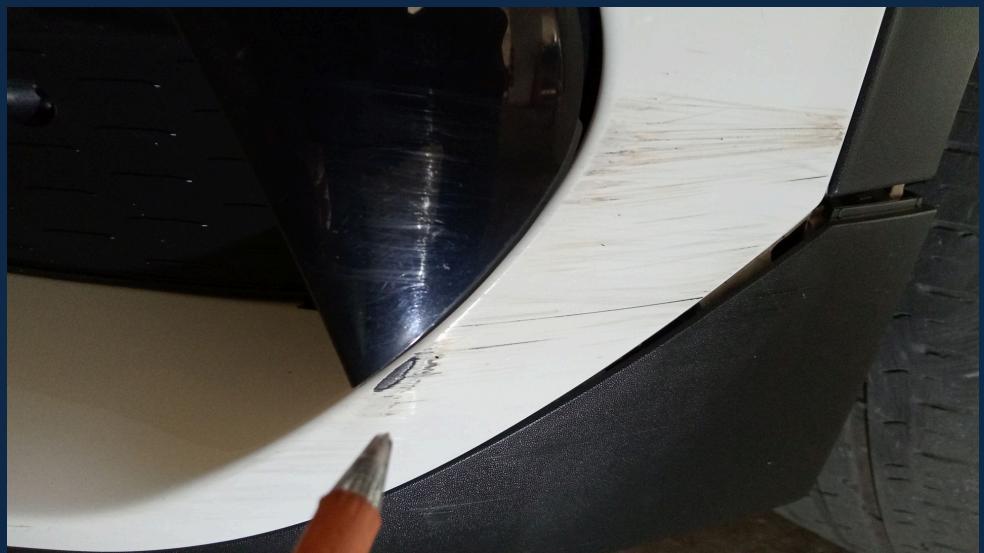
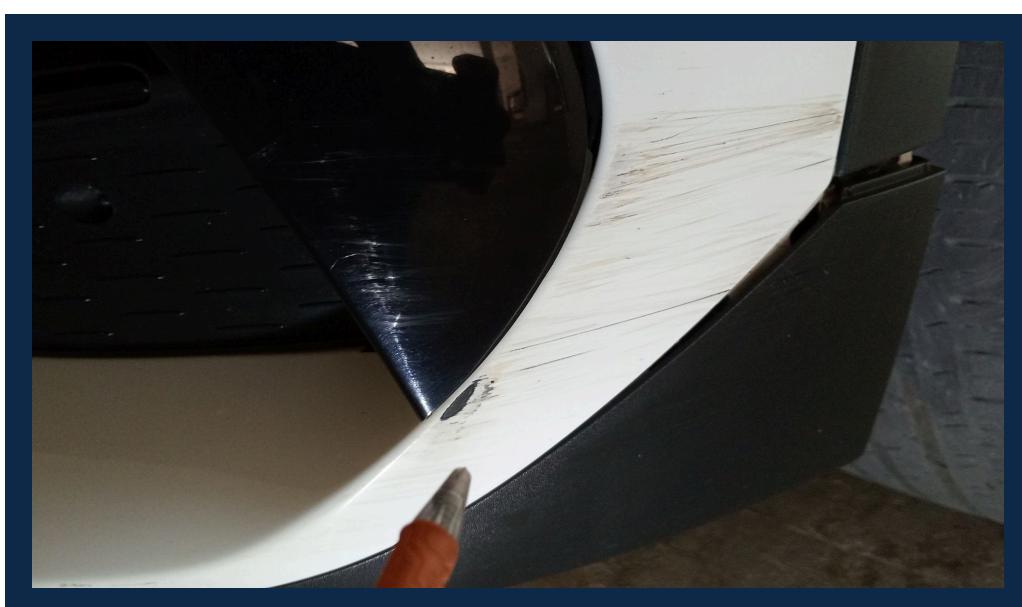
Vehicle Defect Notices

Vehicle : MERCEDES BENZ GLA200**Chassis number :** W1N2477876L002105**Inspection date :** 2024-07-26**Inspector :** ตัวถังภายนอก : พับบริเวณกันชนหน้ามีรอยขีดข่วนกลอก ยางเสื่อมสภาพกั้ง4เส้น ปี20 ภายในห้องโดยสาร : ไม่มีคราบสกปรกวิทยุเครื่องเสียงอุปกรณ์อำนวยความสะดวกใช้งานได้ปกติ เครื่องยนต์กลไก : ตรวจสอบด้วย obd2 ไม่พบโค้ดผิดปกติ โครงสร้าง : ไม่มีความเสียหายถึงโครงสร้างหลัก**Vehicle Certification :** Pass the inspection standard of SCHIC INSPECTION BY LEMON-AIDE
