Customer Name	: MERCEDES-BENZ MOBILITY (THAILAND) CO., LTD.	Inspection Date	: 2024-08-02
Tel.		Lemon Inspection ID	: LEMON24080041
Inspector	: แทนรักษ์ ทิพย์อ่อนร์	Approved By	: ไซย์มงคล ไพรเลี่ยง

Brand	MERCEDES BENZ	Model year	2019
Model	C300	Engine Code - No.	27492031892394
Sub-model	e Avantgarde	Registration year	2024-01-17
Registration No.		Chassis No.	WDD2050536L055707
Current Mileage(km.)	58282	Engine Capacity(cc.)	2000

Vehicle : MERCEDES BENZ C300 5uhn2972**Chassis number :** WDD2050536L055707**Inspection date :** 2024-08-02

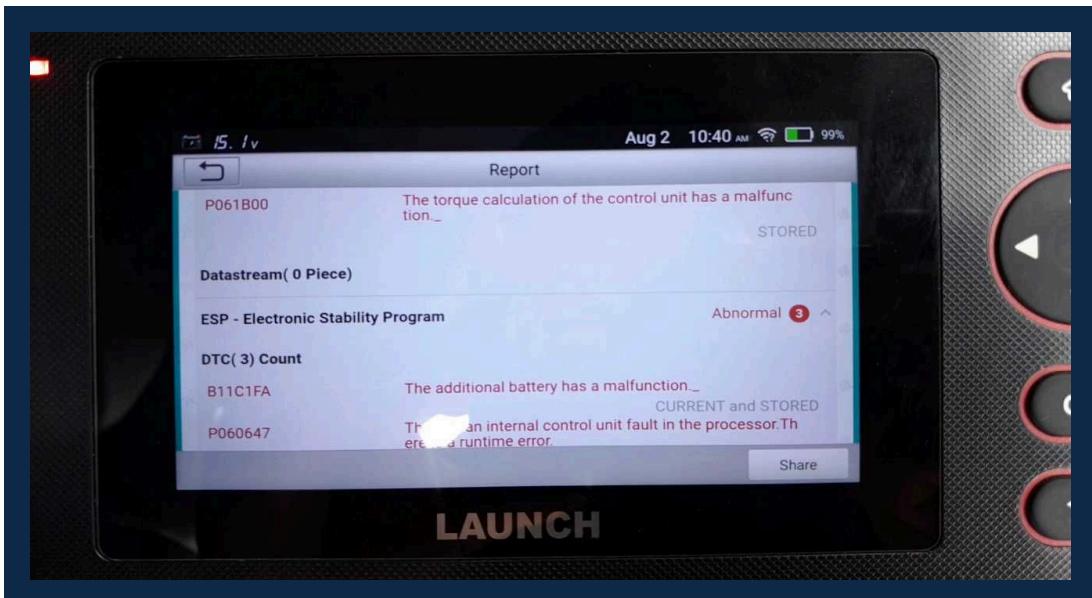
OBD Vehicle Health Analysis

Inspector : ภายนอก(Exterior) : การตรวจสภาพภายนอก โดยรวมพบหลักฐานการซ่อมแซมทำสีมาบางชิ้น ฝ่ากায์ กอดทำสี รั้วรอยขีดข่วนเล็กน้อย / สภาพยางปักติดกัน 4 เส้น ปี 23 กะยใน(Interior) : ภายในเบาะเป็นรอยคลอก พ้าบุ หลังคาเป็นรอยเจมและคราบเปื้อนเล็กน้อย ,อุปกรณ์ไฟฟ้า แอร์ วิทยุFM ใช้งานได้สมบูรณ์ครบปกติ
เครื่องยนต์(Engine) : เครื่องยนต์ทำงานได้ปกติ ,วิเคราะห์ปัญหาด้วยเครื่อง OBDII พบร่องรอยดีบุ๊ค คุณย์บริการ / หน้าปัดแจ้งเตือนแบบเตอร์สำรองเสื่อมสภาพ (ไม่ได้กดสอบขับชี้) **โครงสร้าง(Frame) :** อุบติเหตุไม่มี ,โครงสร้างหลักปกติ ไม่มีการซ่อมแซมโครงสร้างหรือมีการชนถึงโครงสร้าง หมายเหตุ หน้าปัดเรื่องโนิค แจ้งเตือนแบบเตอร์สำรองเสื่อมสภาพ เช็ค ด้วยเครื่อง OBDII พบค็อด B11C1FA / P06047 / P061FF คิดกัน 3 ตัว หน้าจะเกิดจากแรงดันแบบเตอร์สำรองตัว แนะนำตัววิธีเช็คโดยละเอียดอีกครั้ง

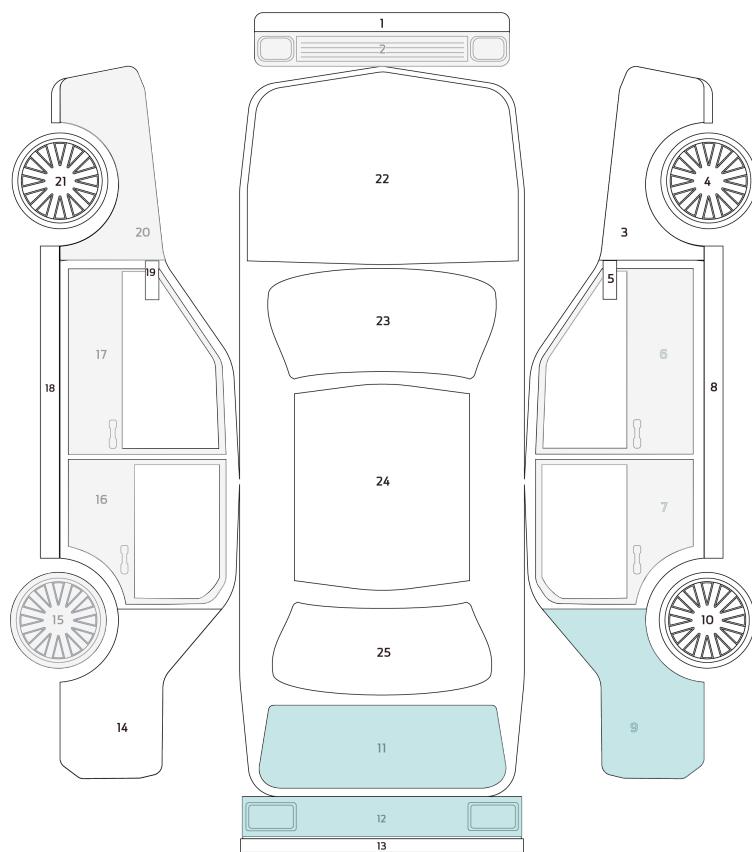
Exterior Inspection Points

1. Front Skirt	O	14. Left Skirt	O
2. Front Bumper	O (S1)	15. Left Wing Mirror	O
3. Front Right Fender	O	16. Front Windshield	O
4. Front Right Wheel	O	17. Roof	O
5. Front Left Fender	O (S1)	18. Rear right fender	BP
6. Front Left Wheel	O	19. Rear Bonnet	BP
7. Front Bonnet	O	20. Back Right Wheel	O
8. Right Wing Mirror	O	21. Rear Bumper	BP
9. Front right door	O (S1)	22. Rear Skirt	O
10. Rear right door	O (S1)	23. Rear Left Fender	O
11. Right Skirt	O	24. Back left wheel	O (S1)
12. Rear Left door	O (S1)	25. Back Windshield	O
13. Front left door	O (S1)

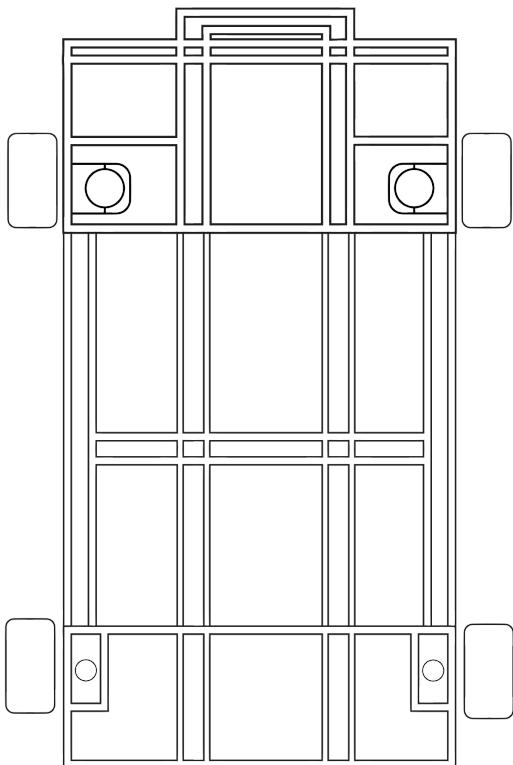
Chassis Report

No dent in the under carriage (th)	PASS
No deform chassis or chassis frame (th)	PASS
No visible corrosion on the chassis or chassis frame (th)	PASS
No missing part on the chassis frame (th)	PASS
Half cut Analysis (th)	PASS

Chassis Damage Level	No Damage
----------------------	-----------
