# Preowned Vehicle Inspection Report

Premium Inspection Analysis

| Brand | MERCEDES BENZ | Model year | 2019 |
| Model | E350 | Engine Code - No. | 27492031705962 |

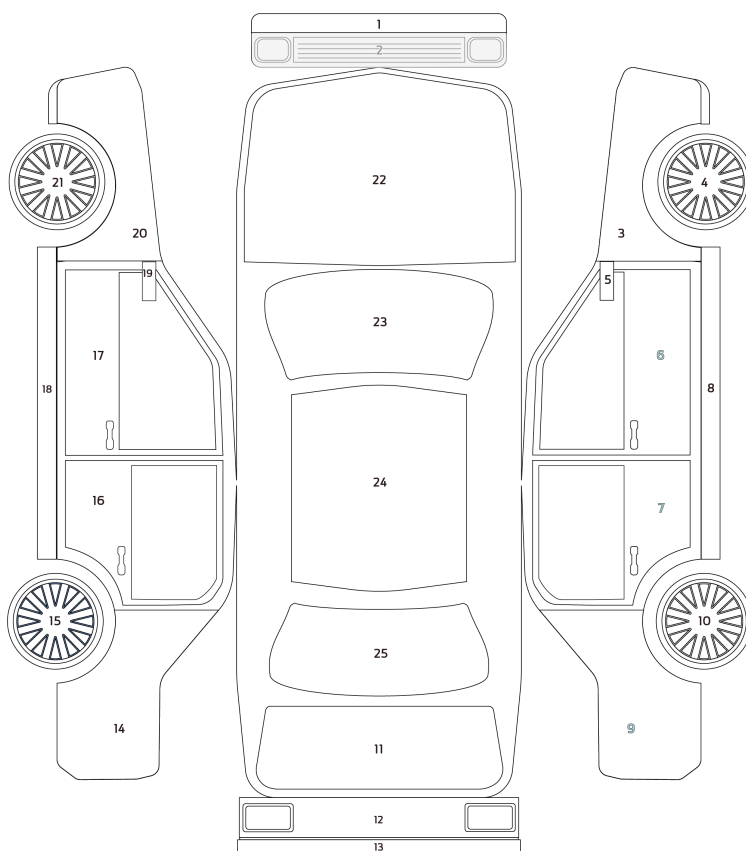
## Exterior Inspection Points

| 2. Front Bumper | O (S1) | 15. Left Wing Mirror | O |

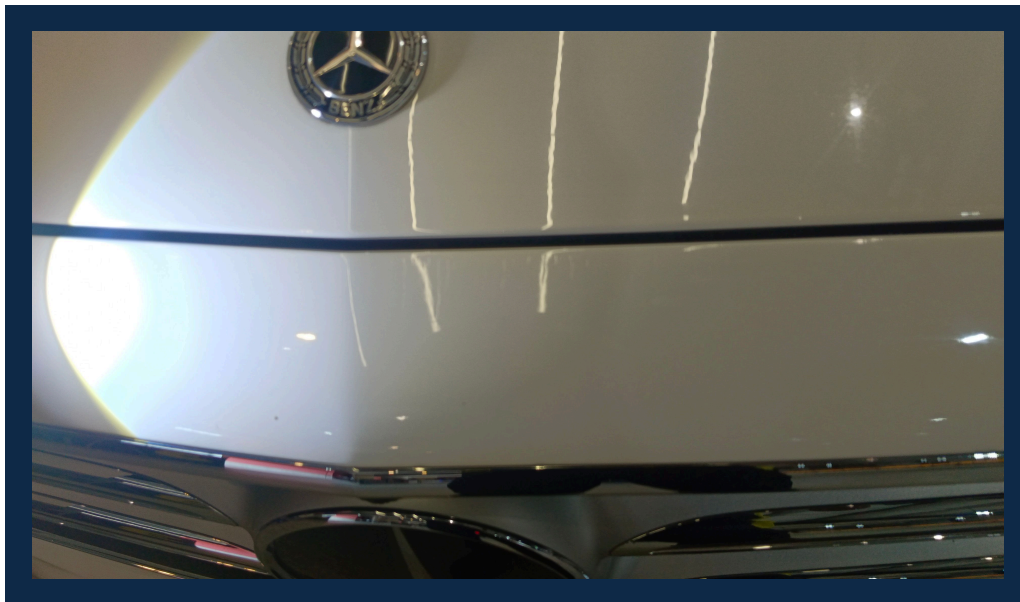
**Vehicle Defect Notices**

**Inspector :** ภายนอก(Exterior) : การตรวจสอบสภาพภายนอกโดยรวมไม่พบหลักฐานการซ่อมแซมทำสี /พบกันชนหน้า  
ถลอกและสีไหลเป็นเส้นที่กระจหน้า/ สภาพยางปกติทั้ง4เส้น ปี22 ภายใน(Interior) : ภายในปกติ สะอาดเรียบร้อย  
,อุปกรณ์ไฟฟ้า แอร์ วิทยุFM ใช้งานได้ตามมาตรฐานครบปกติ เครื่องยนต์(Engine) : เครื่องยนต์ทำงานได้ปกติ ,วิเคราะห์  
ปัญหาด้วยเครื่อง OBDII ไม่พบสิ่งผิดปกติ (ไม่ได้ทดสอบขับ) โครงสร้าง(Frame) : อุบัติเหตุไม่มี ,โครงสร้างหลักปกติ  
ไม่มีการซ่อมแซมโครงสร้างหรือมีการชนถึงโครงสร้าง
