# Preowned Vehicle Inspection Report

Customer Name	: MERCEDES-BENZ MOBILITY (THAILAND) CO., LTD.	Inspection Date	: 2024-08-14
Tel.		Lemon Inspection ID	: LEMON24080196
Inspector	: ไซมมงคล ไพโรเสียง	Approved By	: แทนรัก ทิพย์อินทร์

Brand	MERCEDES BENZ	Model year	2020
Model	A200	Engine Code - No.	28291430394299
Sub-model	AMG Dynamic	Registration year	2022-11-21
License Plate		Chassis No.	W1K1771876L001178
Current Mileage(km.)	82825	Engine Capacity(cc.)	1300

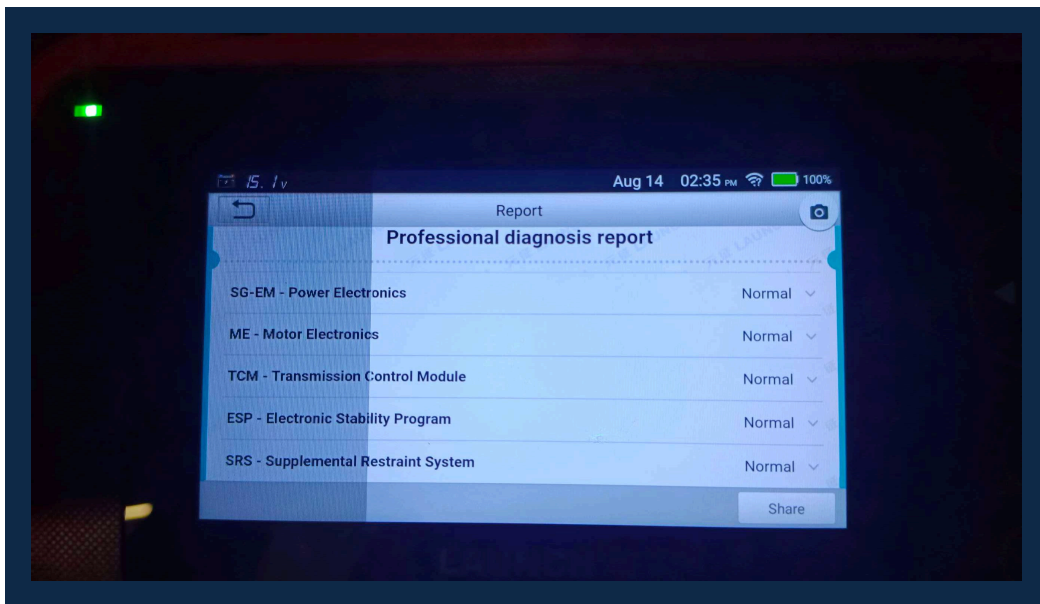
**OBD Vehicle Health Analysis**

เครื่องยนต์(Engine) : เครื่องยนต์ทำงานได้ปกติ ,วิเคราะห์ปัญหาด้วยเครื่อง OBDII ไม่พบสิ่งผิดปกติ (ไม่ได้ทดสอบ  
ขับขี) โครงสร้าง(Frame) : อุบัติเหตุไม่มี ,โครงสร้างหลักปกติ ไม่มีการซ่อมแซมโครงสร้างหรือมีการชนถึงโครงสร้าง

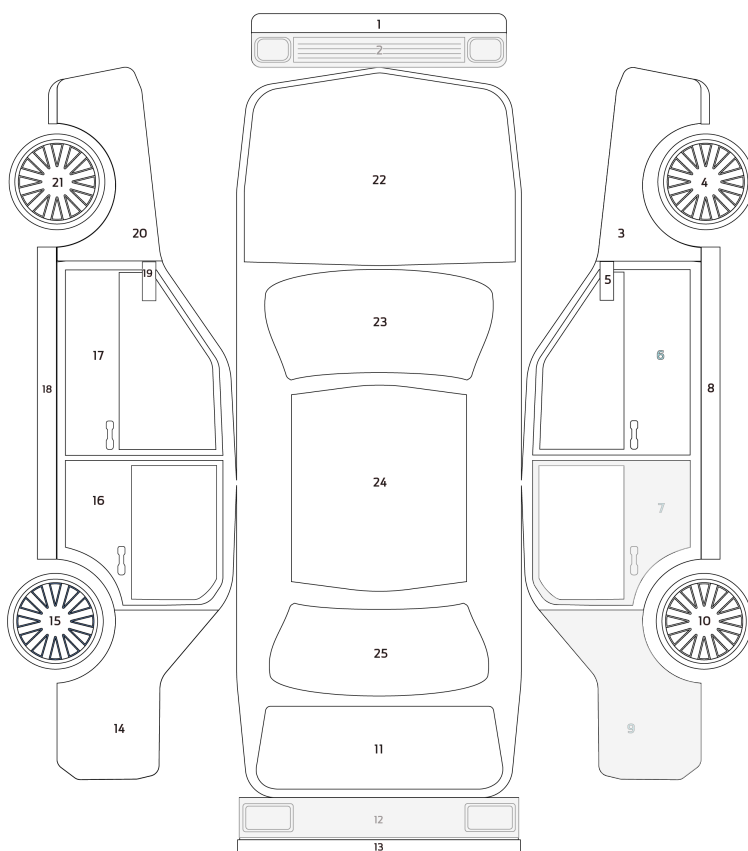
**Exterior Inspection Points**

1. Front Skirt	O	14. Left Skirt	O
2. Front Bumper	O (S2)	15. Left Wing Mirror	O
3. Front Right Fender	O	16. Front Windshield	O
4. Front Right Wheel	O	17. Roof	O
5. Front Left Fender	O	18. Rear right fender	O (S1)
6. Front Left Wheel	O	19. Rear Bonnet	O
7. Front Bonnet	O	20. Back Right Wheel	O
8. Right Wing Mirror	O	21. Rear Bumper	O (S1)
9. Front Right Door	O	22. Rear Skirt	O
10. Rear right door	O (S1)	23. Rear Left Fender	O
11. Right Skirt	O	24. Back Left Wheel	O
12. Rear Left Door	O	25. Back Windshield	O
13. Front Left Door	O

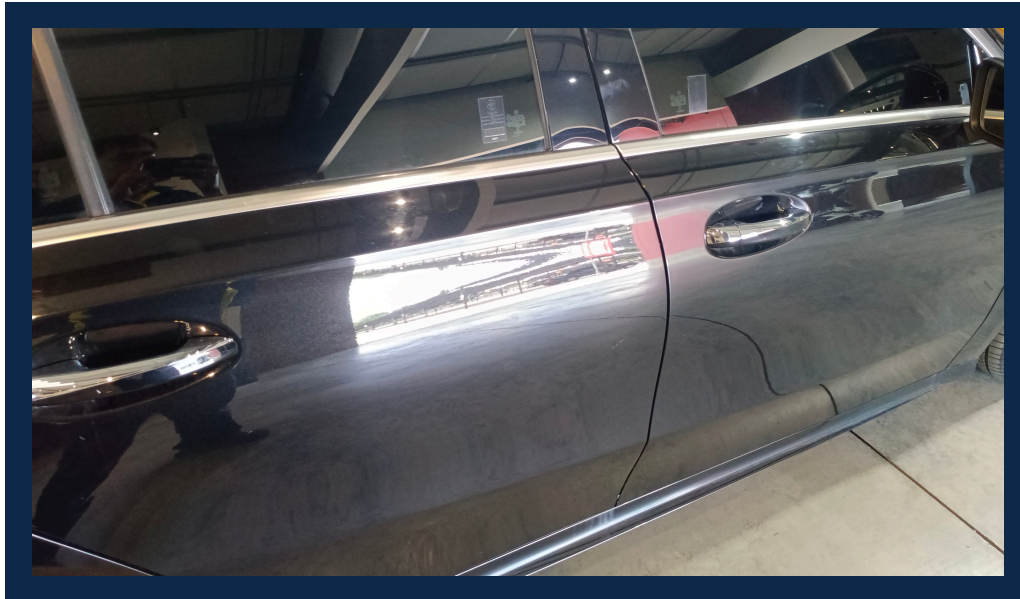
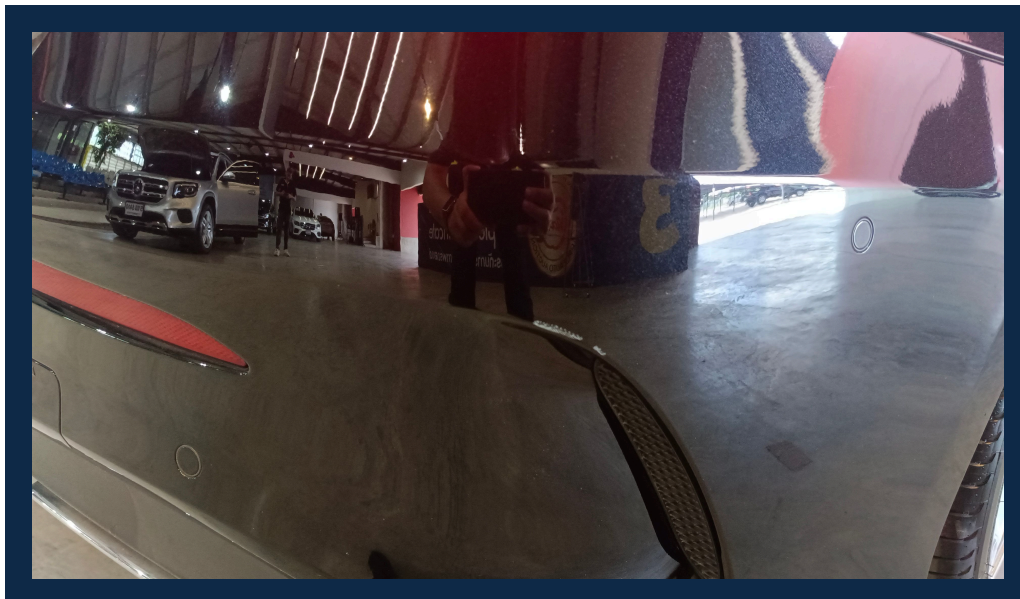
**Vehicle Defect Notices**

**Inspector :** ภายนอก(Exterior) : การตรวจสอบสภาพภายนอกโดยรวมไม่พบหลักฐานการซ่อมแซมทำสี/พบกันชนหน้า  
ถลอก/ประตูหลังขวาบุบเล็กน้อย/บังโคลนหลังขวาบุบเล็กน้อย/กันชนหลังถลอก / สภาพยางปกติทั้ง4เส้น ปี23

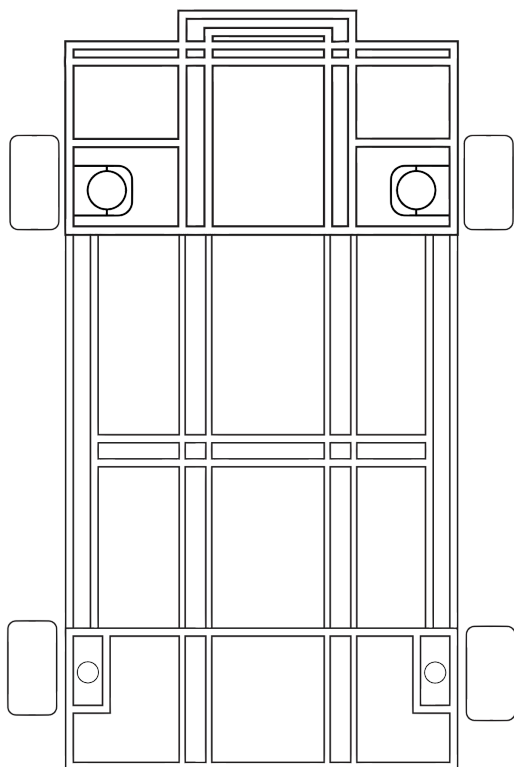
### Chassis Report

No dent in the under carriage (th)	PASS
No deform chassis or chassis frame (th)	PASS
No visible corrosion on the chassis or chassis frame (th)	PASS
No missing part on the chassis frame (th)	PASS
Half cut Analysis (th)	PASS
Chassis Damage Level	No Damage
