Preowned Vehicle Inspection Report

Premium Inspection Analysis

Lemon Inspection ID : LEMON24080194

Brand	MERCEDES BENZ	Model year	2019
Model	GLA200	Engine Code - No.	27091031911618
Sub-model	Urban	Registration year	2020-02-07
License Plate		Chassis No.	WDC1569436L013667
Current Mileage(km.)	44618	Engine Capacity(cc.)	1600

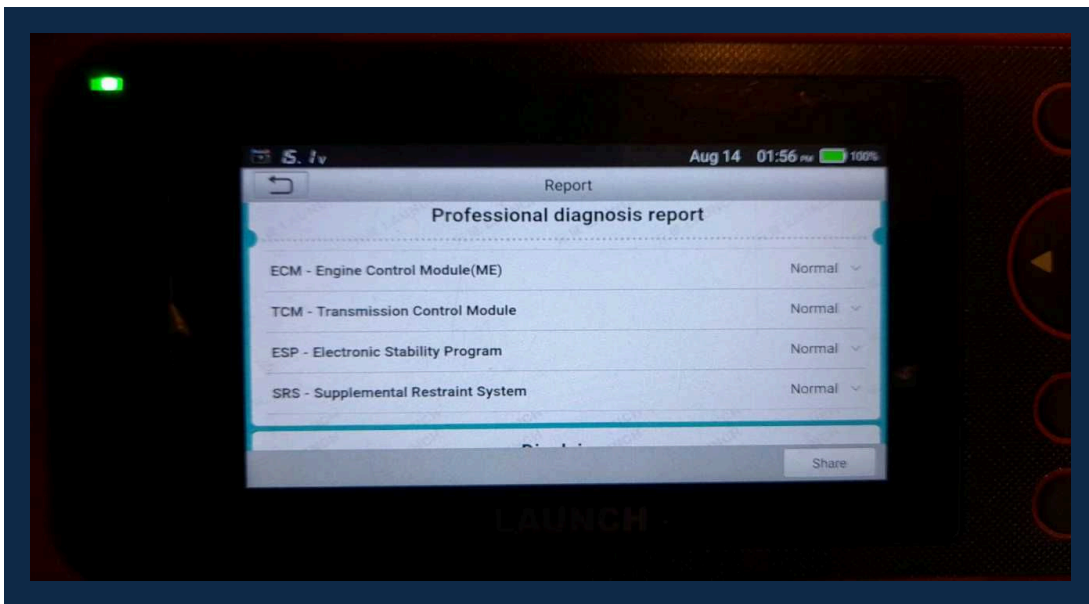
OBD Vehicle Health Analysis

เครื่องยนต์(Electric) : เครื่องยนต์ทำงานได้ปกติ ,วิเคราะห์ปัญหาด้วยเครื่อง OBDII ไม่พบสิ่งผิดปกติ (ไม่ได้ทดสอบ ขับขี่) **โครงสร้าง(Frame) :** อุบัติเหตุไม่มี ,โครงสร้างหลักปกติ ไม่มีการซ่อมแซมโครงสร้างหรือมีการชนถึงโครงสร้าง

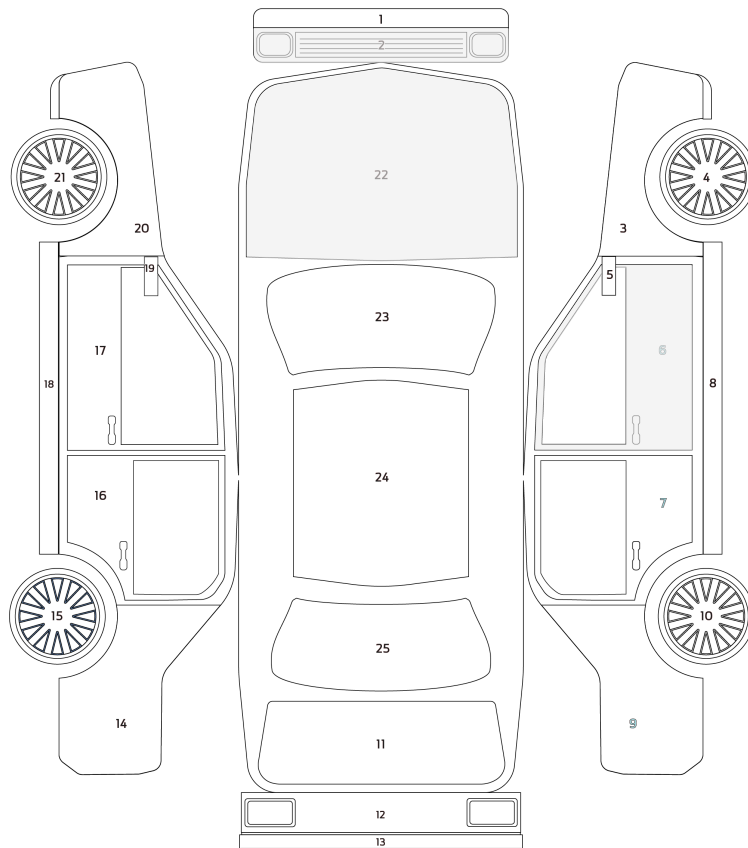
Exterior Inspection Points

1. Front Skirt	O	14. Left Skirt	O
2. Front Bumper	O (S2)	15. Left Wing Mirror	O
3. Front Right Fender	O	16. Front Windshield	O
4. Front Right Wheel	O	17. Roof	O
5. Front Left Fender	O	18. Rear Right Fender	O
6. Front Left Wheel	O	19. Rear Bonnet	O
7. Front bonnet	O (S1)	20. Back Right Wheel	O
8. Right Wing Mirror	O	21. Rear Bumper	O
9. Front right door	O (D1)	22. Rear Skirt	O
10. Rear Right Door	O	23. Rear Left Fender	O
11. Right Skirt	O	24. Back Left Wheel	O
12. Rear Left Door	O	25. Back Windshield	O
13. Front Left Door	O

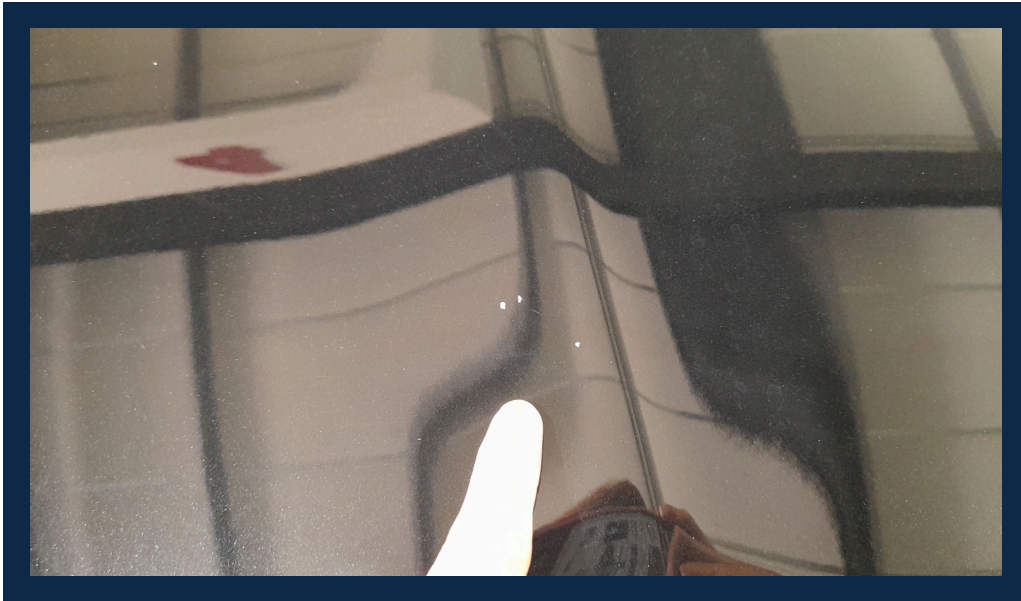
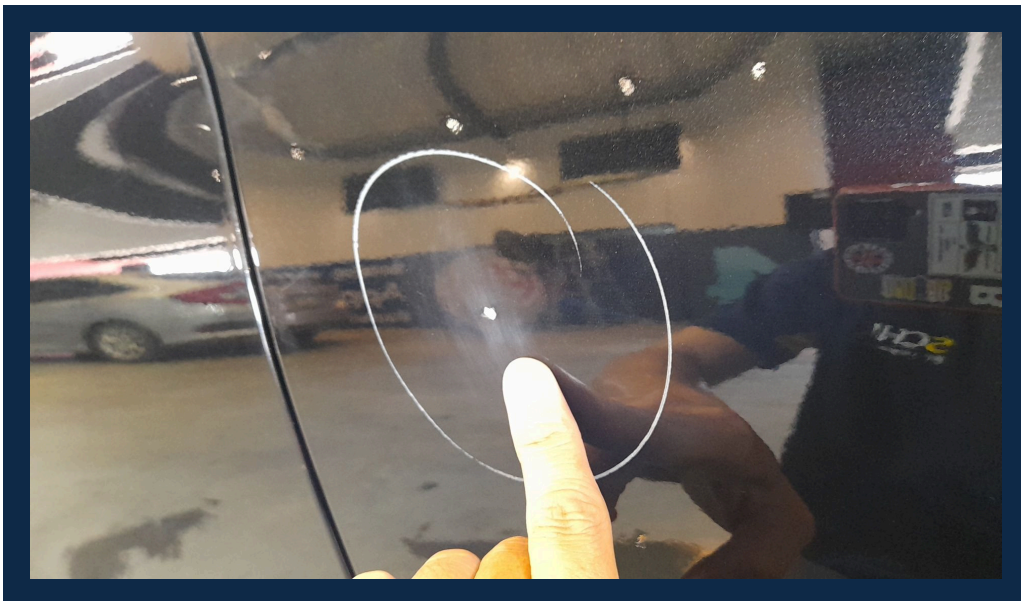
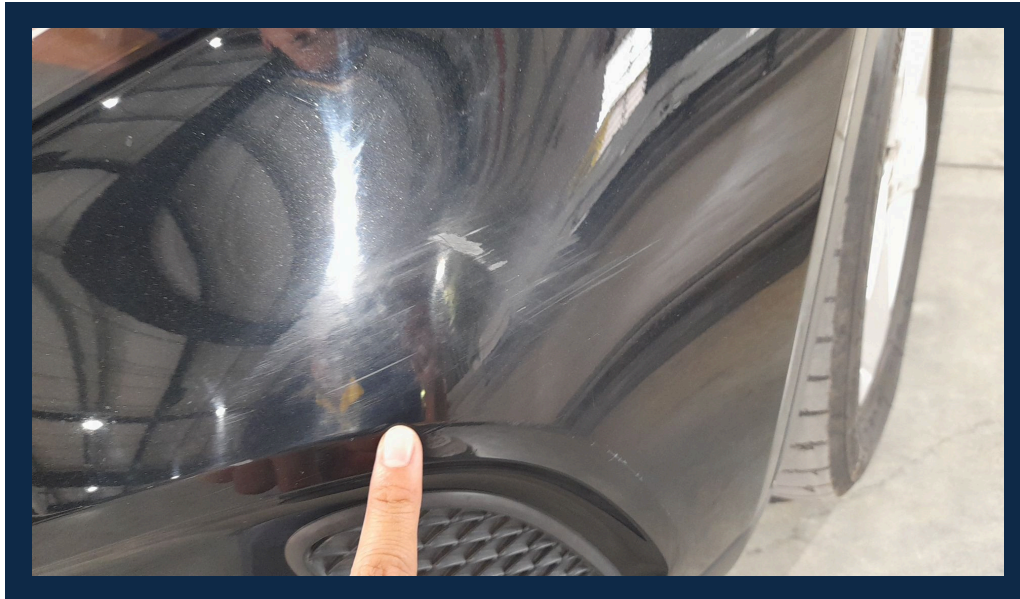
Vehicle Defect Notices

Inspector : หมายเหตุ* ภายนอก(Exterior) : การตรวจสภาพภายนอกโดยรวมไม่พบหลักฐานการซ่อมแซมทำสี กระโปรงหน้ารอยหินกระแทะ ประตูหน้าขวาเป็นรอย กันชนหน้าครูด/ สภาพยางเสื่อม4เส้น ปี19 ภายใน(Interior) : ภายในปกติไม่มีความเสียหาย สะอาดเรียบร้อย ,อุปกรณ์ไฟฟ้า แอร์ วิทยุFM ใช้งานได้สมบูรณ์ครบปกติ
