Preowned Vehicle Inspection Report

Customer Name	: MERCEDES-BENZ MOBILITY (THAILAND) CO., LTD.	Inspection Date	: 2024-08-14
Tel.		Lemon Inspection ID	: LEMON24080195
Inspector	: สุวัฒน์ ทองพิมพ์	Approved By	: แทนรัก ทิพย์อินทร์

Brand	MERCEDES BENZ	Model year	2021
Model	GLB200	Engine Code - No.	28291480523454
Sub-model	Progressive	Registration year	2024-04-11
License Plate		Chassis No.	W1N2476872W113569
Current Mileage(km.)	50977	Engine Capacity(cc.)	1300

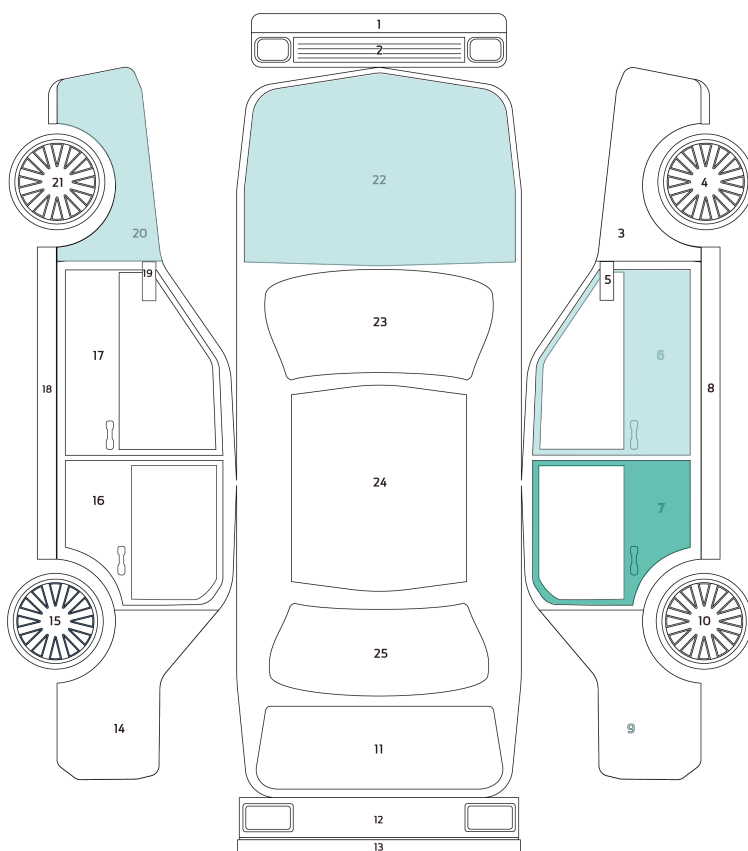
Exterior Inspection Points

1. Front Skirt	O	14. Left Skirt	O
2. Front Bumper	O	15. Left Wing Mirror	O
3. Front Right Fender	O	16. Front Windshield	O
4. Front Right Wheel	O	17. Roof	O
5. Front Left Fender	BP	18. Rear Right Fender	O
6. Front Left Wheel	O	19. Rear Bonnet	O
7. Front bonnet	BP	20. Back Right Wheel	O
8. Right Wing Mirror	O	21. Rear Bumper	O
9. Front right door	BP	22. Rear Skirt	O
10. Rear right door	N	23. Rear Left Fender	O
11. Right Skirt	O	24. Back Left Wheel	O
12. Rear Left Door	O	25. Back Windshield	O
13. Front Left Door	O

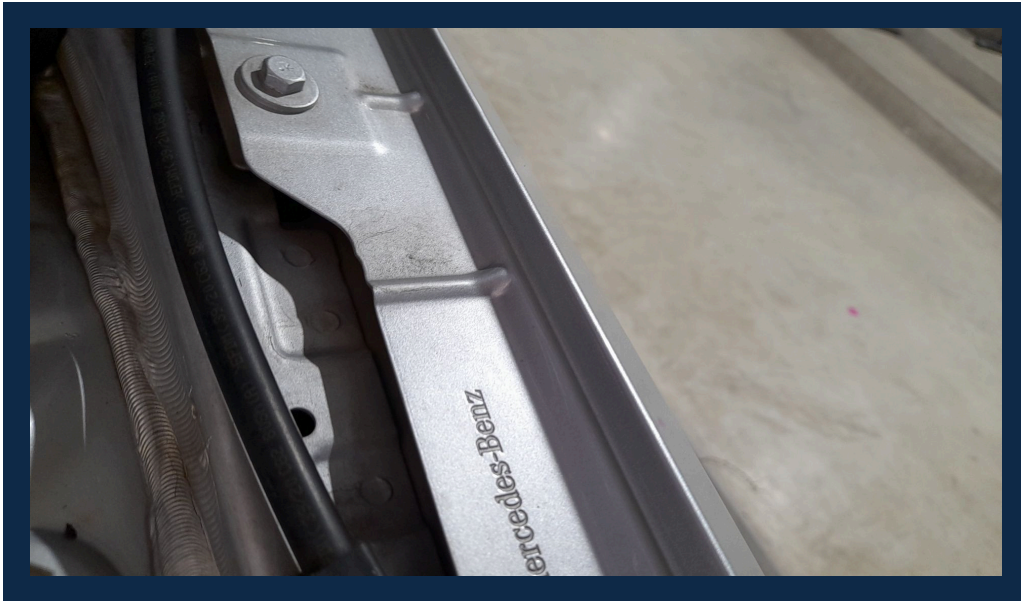
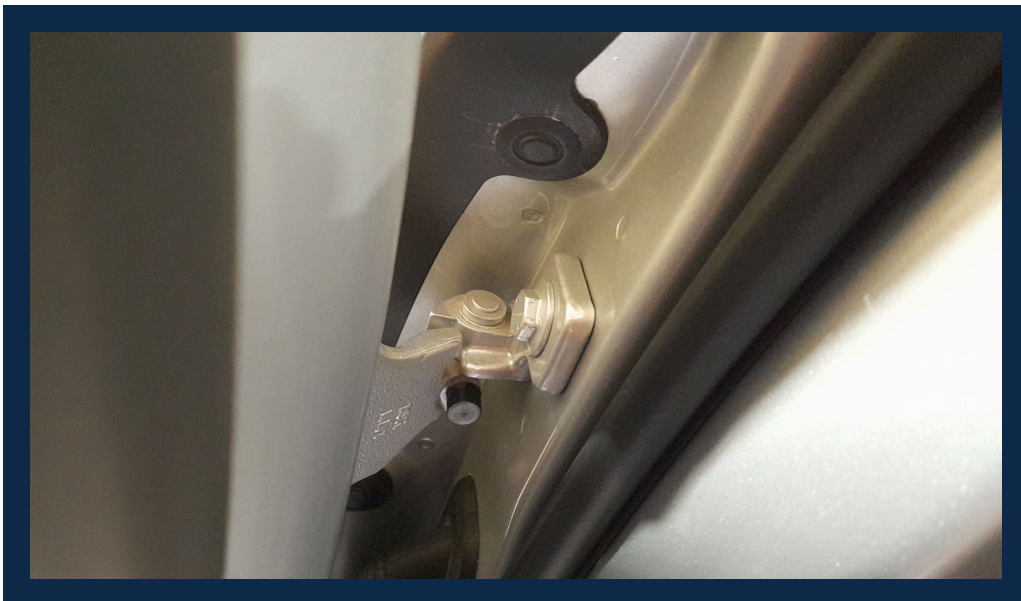
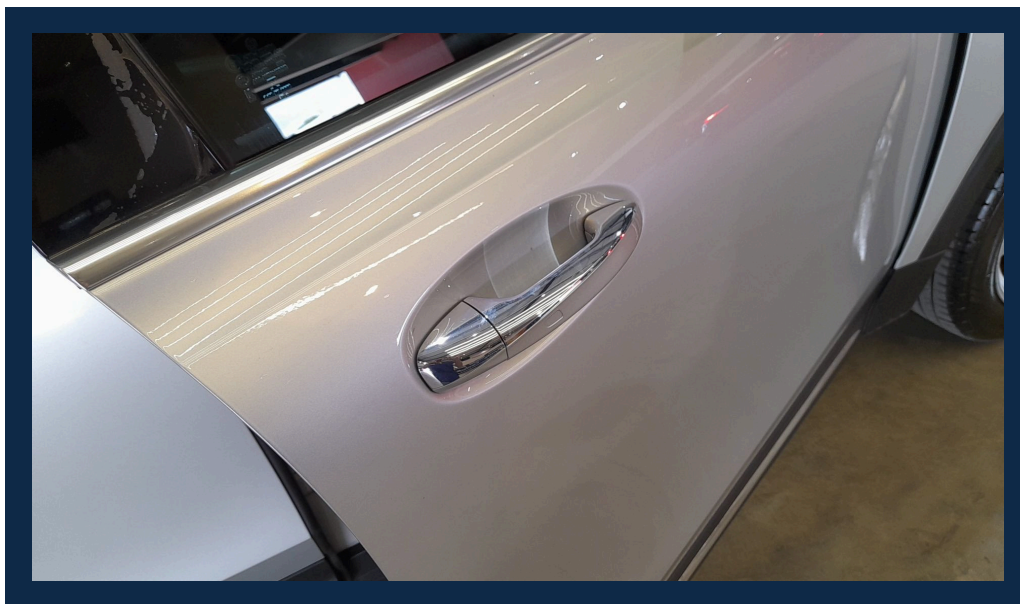
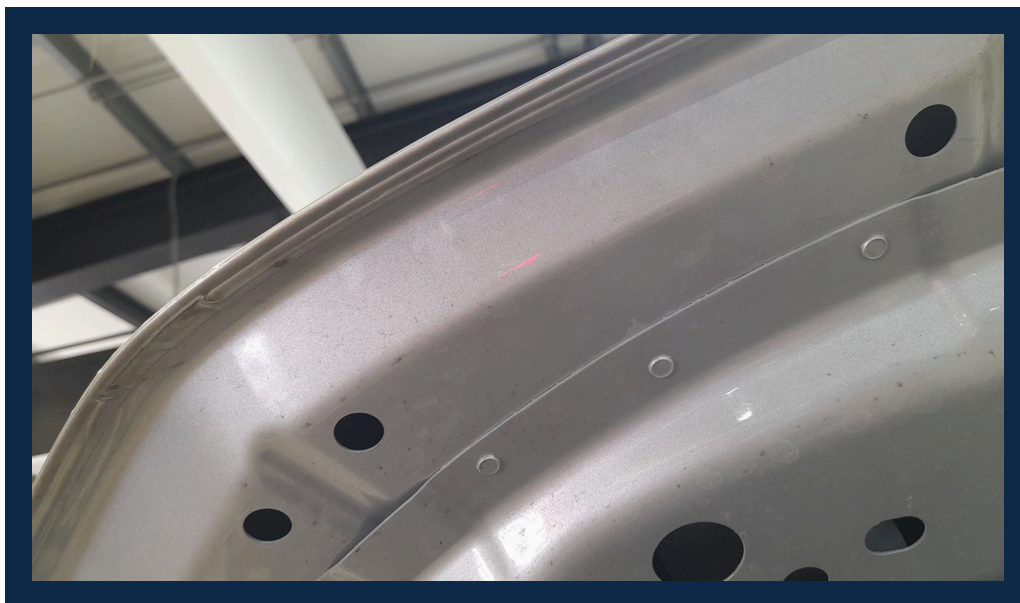
Vehicle Defect Notices

Inspector : หมายเหตุ* ภายนอก(Exterior) : การตรวจสภาพภายนอกโดยรวมพบหลักฐานการซ่อมแซมทำสีคือ ฝากระโปรงหน้า ประตูหน้าหลังขวา แก้มหน้าซ้าย ประตูหลังขวาเปลี่ยน/ สภาพยางปกติทั้ง4เส้น ปี23 ภายใน(Interior) : ภายในปกติไม่มีความเสียหาย สะอาดเรียบร้อย ,อุปกรณ์ไฟฟ้า แอร์ วิทยุFM ใช้งานได้สมบูรณ์ครบปกติ
เครื่องยนต์(Electric) : เครื่องยนต์ทำงานได้ปกติ ,วิเคราะห์ปัญหาด้วยเครื่อง OBDII ไม่พบข้อผิดพลาดปกติ (ไม่ได้ทดสอบขับเคลื่อน) โครงสร้าง(Frame) : อุบัติเหตุไม่มี ,โครงสร้างหลักปกติ ไม่มีการซ่อมแซมโครงสร้างหรือมีการชนถึงโครงสร้าง
