Preowned Vehicle Inspection Report

Customer Name	: MERCEDES-BENZ MOBILITY (THAILAND) CO., LTD.	Inspection Date	: 2024-08-23
Tel.		Lemon Inspection ID	: LEMON24080277
Inspector	: ไซยมงคล ไพระเสียง	Approved By	: Tanrak T

Brand	MERCEDES BENZ	Model year	2020
Model	C200	Engine Code - No.	26492030291359
Sub-model	COUPE AMG DYNAMIC	Registration year	2021-02-08
License Plate		Chassis No.	W1K2053806L061173
Current Mileage(km.)	37686	Engine Capacity(cc.)	2000

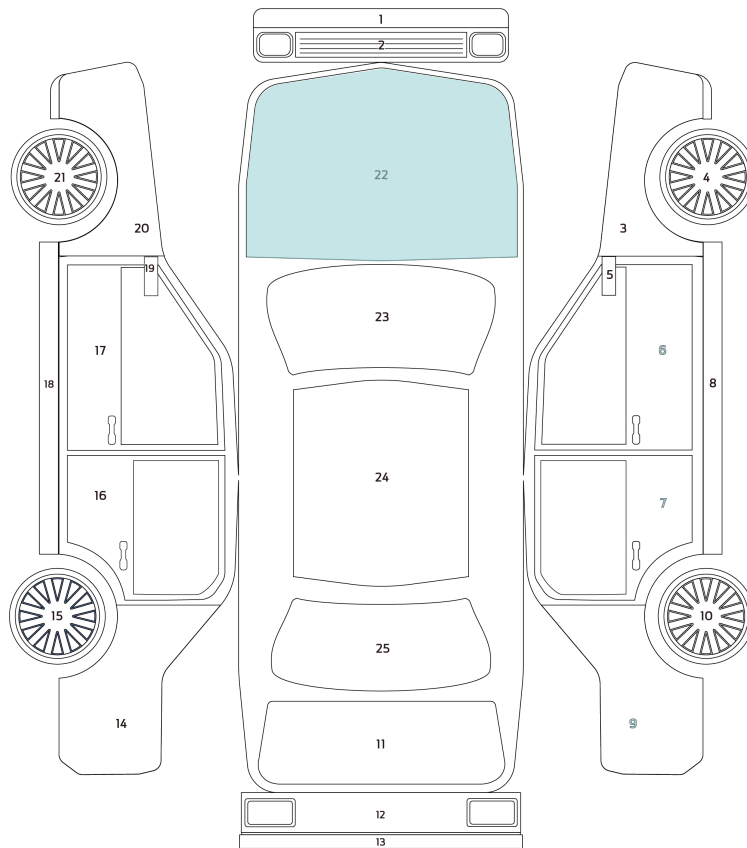
Exterior Inspection Points

1. Front Skirt	O	14. Left Skirt	O
2. Front Bumper	O	15. Left Wing Mirror	O
3. Front Right Fender	O	16. Front Windshield	O
4. Front Right Wheel	O	17. Roof	O
5. Front Left Fender	O	18. Rear Right Fender	O
6. Front Left Wheel	O	19. Rear Bonnet	O
7. Front bonnet	BP	20. Back Right Wheel	O
8. Right Wing Mirror	O	21. Rear Bumper	O
9. Front Right Door	O	22. Rear Skirt	O
10. Rear Right Door	O	23. Rear Left Fender	O
11. Right Skirt	O	24. Back Left Wheel	O
12. Rear Left Door	O	25. Back Windshield	O
13. Front Left Door	O

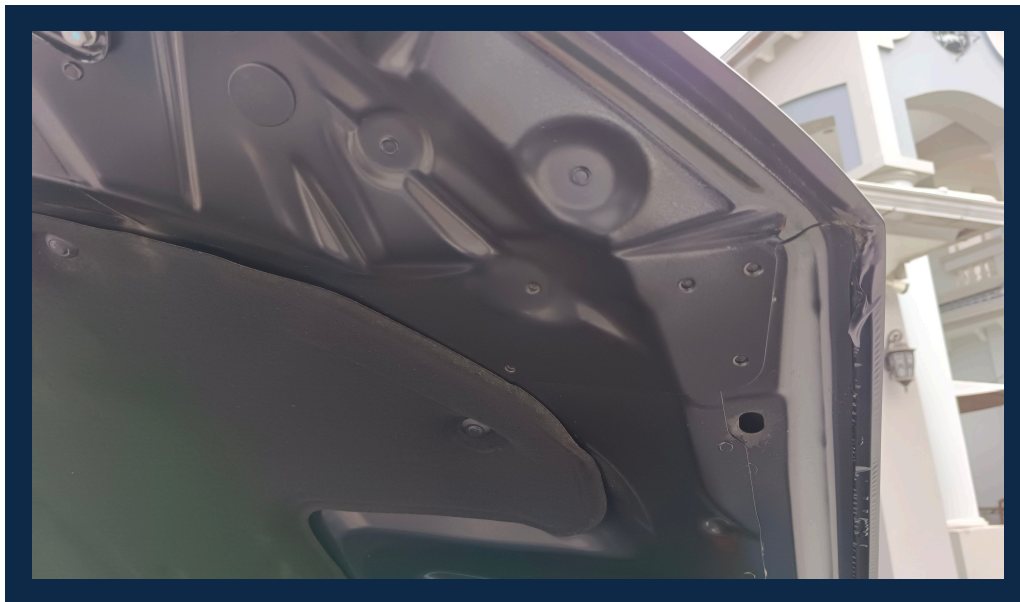
Vehicle Defect Notices

Inspector : ภายนอก(Exterior) : การตรวจสอบสภาพภายนอกโดยรวมพบหลักฐานการซ่อมแซมทำสี ฟากระโปรงหน้า / ตัวรถมีการรีปสติกเกอร์กันรอยรอบคัน / สภาพยางปกติทั้ง4เส้น ปี23 ภายใน(Interior) : ภายในปกติ สะอาด เรียบร้อย ,อุปกรณ์ไฟฟ้า แอร์ วิทยุFM ใช้งานได้สมบูรณ์ครบปกติ เครื่องยนต์(Engine) : เครื่องยนต์ทำงานได้ปกติ ,วิเคราะห์ปัญหาด้วยเครื่อง OBDII ไม่พบสิ่งผิดปกติ (ไม่ได้ทดสอบขับ) โครงสร้าง(Frame) : อุบัติเหตุไม่มี ,โครงสร้างหลักปกติ ไม่มีการซ่อมแซมโครงสร้างหรือมีการชนถึงโครงสร้าง

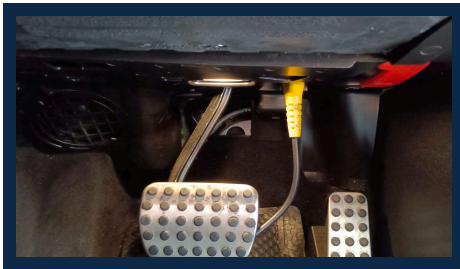
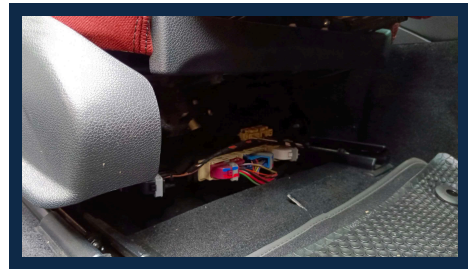
Flood Report

Evidence of Flood

No

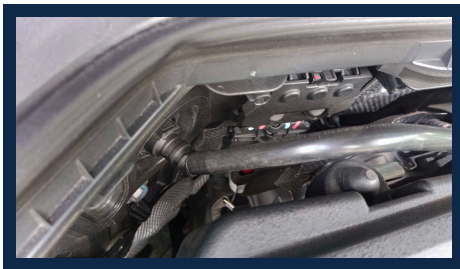
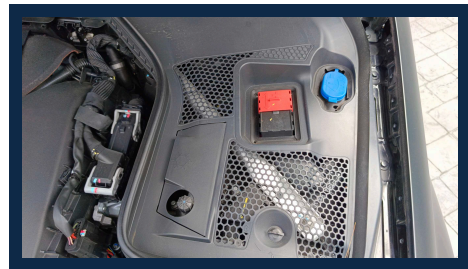
Fire Report

Evidence of Fire

No
