# Preowned Vehicle Inspection Report

Premium Inspection Analysis

| Tel. | : | Lemon Inspection ID | : LEMON24080317 |

| Brand | MERCEDES BENZ | Model year | 2020 |

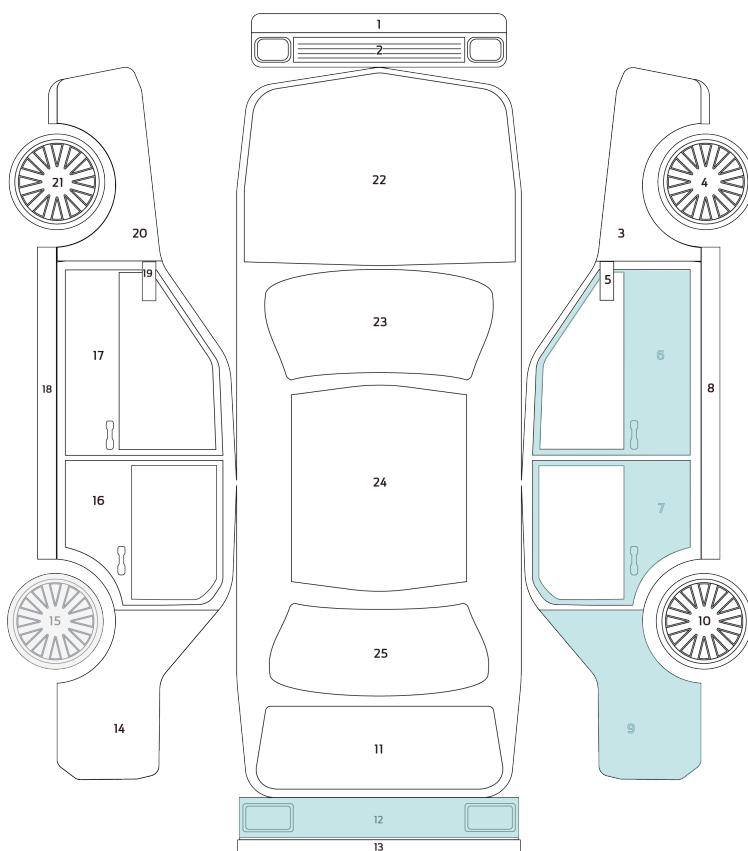
## Exterior Inspection Points

| 5. Front Left Fender | O | 18. Rear right fender | BP |
| 8. Right Wing Mirror | O | 21. Rear Bumper | BP |
| 9. Front right door | BP | 22. Rear Skirt | O |
| 10. Rear right door | BP | 23. Rear Left Fender | O |
| 11. Right Skirt | O | 24. Back left wheel | O (S1) |

**Inspector :** ภายนอก(Exterior) : การตรวจสอบสภาพภายนอกโดยรวมพบหลักฐานการซ่อมแซมทำสี ประตูหน้า หลัง ขวาทันโกลนหลังขวา กันชนหลัง/ สภาพยางเสื่อมสภาพ4เส้น ปี20 ภายใน(Interior) : ภายในปกติ สะอาดเรียบร้อย อุปกรณ์ไฟฟ้า แอร์ วิทยุFM ใช้งานได้สมบูรณ์ครบปกติ เครื่องยนต์(Engine) : เครื่องยนต์ทำงานได้ปกติ ,วิเคราะห์ปัญหาด้วยเครื่อง OBDII พบสิ่งผิดปกติ ขึ้นโค้ด P126EFD เป็นสัญญาณพวง P126F11 ระบบ start/stop ทำงานผิดปกติ B1A5A96 เซ็นเซอร์ Keyless-GO ด้านคนขับทำงานผิดปกติ B1A5B96 เซ็นเซอร์ Keyless-GO ฟังก์ชันโดยสารทำงานผิดปกติ U044200 เป็นสัญญาณพวง (ไม่ได้ทดสอบขั้วขี้) โครงสร้าง(Frame) : อุบัติเหตุไม่มี ,โครงสร้างหลักปกติ ไม่มีการซ่อมแซมโครงสร้างหรือมีการชนถึงโครงสร้าง
