Preowned Vehicle Inspection Report

Premium Inspection Analysis

Brand	MERCEDES BENZ	Model year	2021
Model	C300	Engine Code - No.	27492031969629
Sub-model	e AMG Sport	Registration year	2022-07-04
License Plate		Chassis No.	W1K2050536L063390
Current Mileage(km.)	55097	Engine Capacity(cc.)	2000

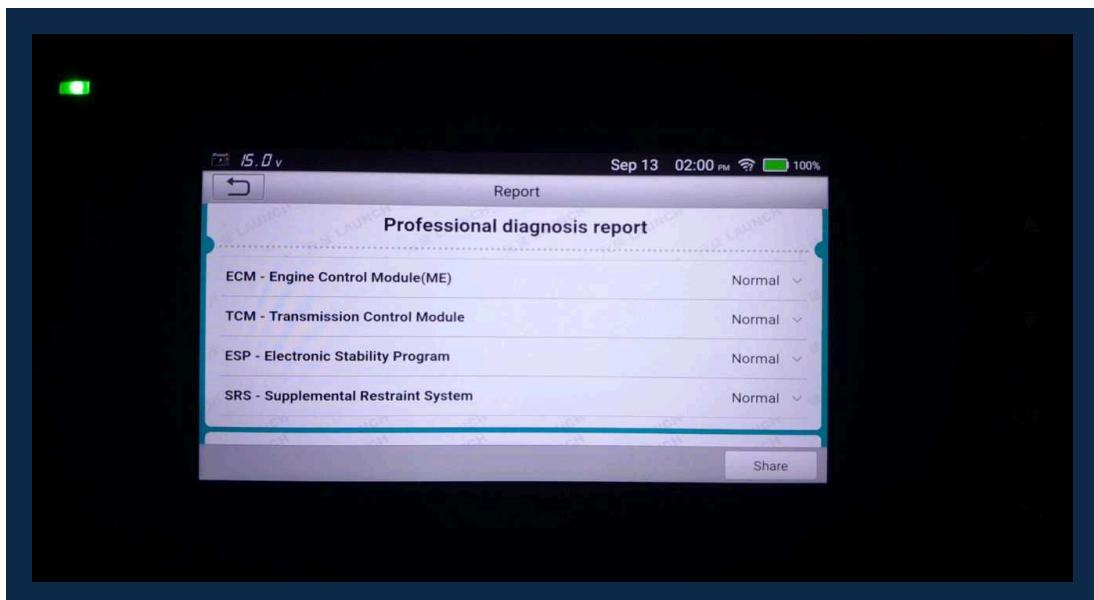
OBD Vehicle Health Analysis

เครื่องยนต์(Engine) : วิเคราะห์ปัญหาด้วยเครื่อง OBDII ไม่พบสิ่งผิดปกติ (ไม่ได้ทดสอบขับขี่) **โครงสร้าง(Frame) :** โครงสร้างหลักปกติ**Vehicle Certification :** Pass the inspection standard of SCHIC INSPECTION BY LEMON-AIDE

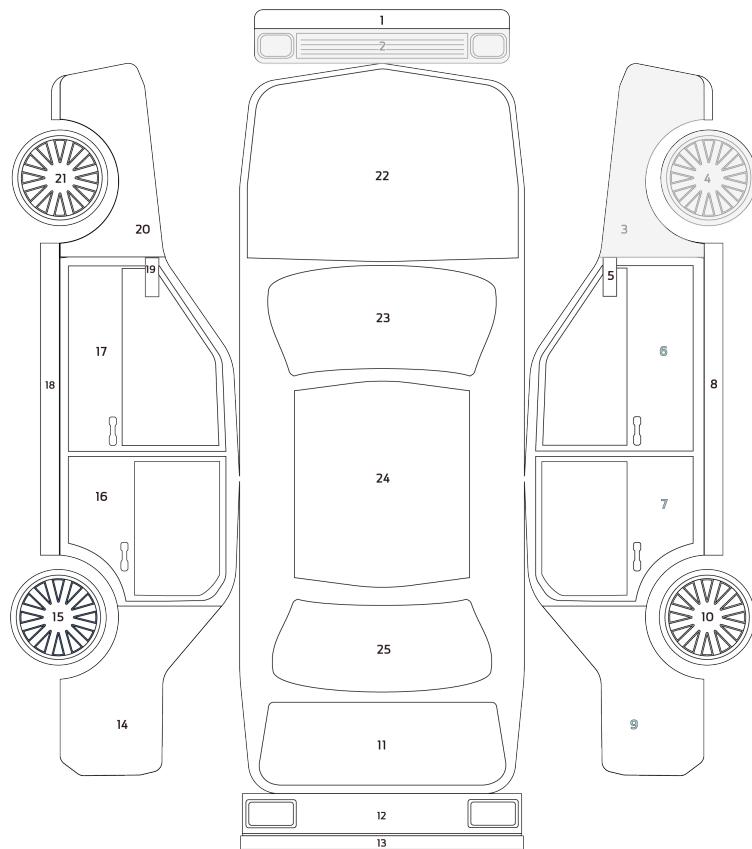
Exterior Inspection Points

1. Front Skirt	O	14. Left Skirt	O
2. Front Bumper	O (S1)	15. Left Wing Mirror	O
3. Front Right Fender	O (S1)	16. Front Windshield	O
4. Front Right Wheel	O (S1)	17. Roof	O
5. Front Left Fender	O	18. Rear Right Fender	O
6. Front Left Wheel	O	19. Rear Bonnet	O
7. Front Bonnet	O	20. Back Right Wheel	O
8. Right Wing Mirror	O	21. Rear Bumper	O
9. Front Right Door	O	22. Rear Skirt	O
10. Rear Right Door	O	23. Rear Left Fender	O
11. Right Skirt	O	24. Back Left Wheel	O
12. Rear Left Door	O	25. Back Windshield	O
13. Front Left Door	O

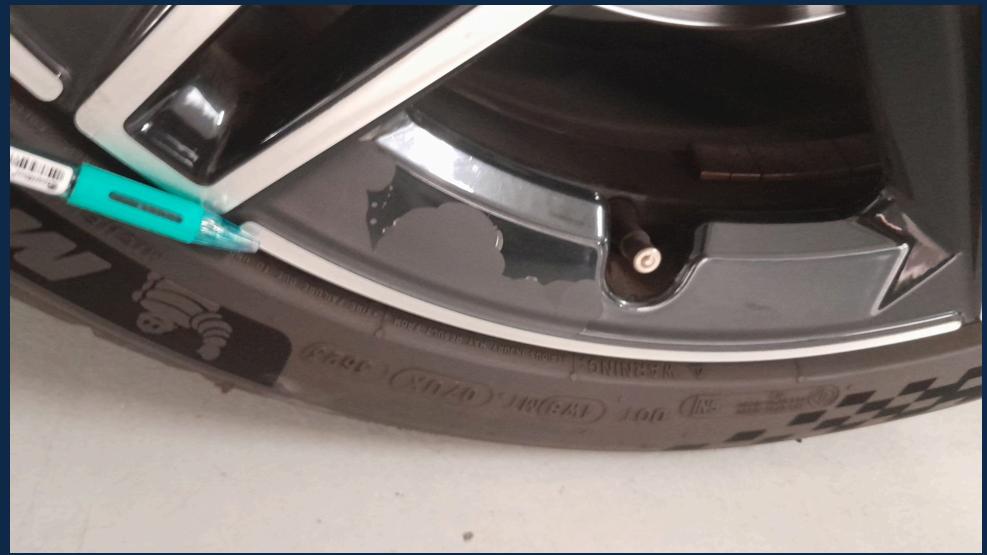
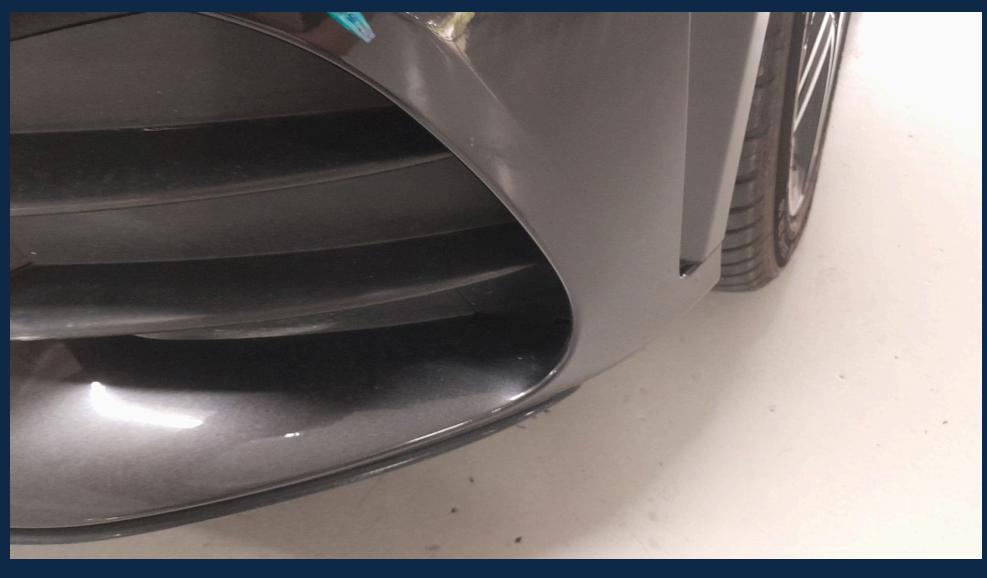
Vehicle Defect Notices

Vehicle : MERCEDES BENZ C300**Chassis number :** W1K2050536L063390**Inspection date :** 2024-09-13**Inspector :** ภายนอก(Exterior) : รีวอร์ดรอยด์ลอกเล็กน้อย / ล้อแม็กเป็นรอยลอก / รถมีเก็บสีแก้มหน้าซ้าย
