Preowned Vehicle Inspection Report

Customer Name	: MERCEDES-BENZ MOBILITY (THAILAND) CO., LTD.	Inspection Date	: 2024-09-16
Tel.	:	Lemon Inspection ID	: LEMON24090142
Inspector	: ไซยมงคล ไพโรเสียง	Approved By	: Yoskongsak B

Brand	MERCEDES BENZ	Model year	2019
Model	GLC250	Engine Code - No.	27492031771509
Sub-model	4MATIC AMG PLUS (COUPE)	Registration year	2019-08-30
License Plate		Chassis No.	WDC2533466L023605
Current Mileage(km.)	80434	Engine Capacity(cc.)	1991

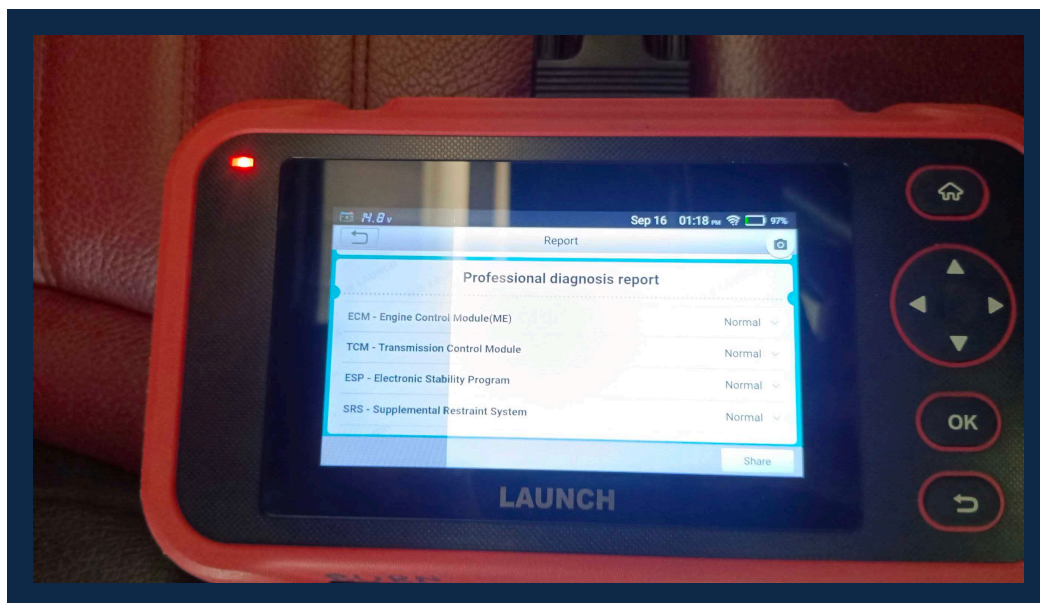
OBD Vehicle Health Analysis

Inspector : ภายนอก(Exterior) : รถมีการรีปสติ๊กเกอร์กันรอยมา/พบกันชนหน้าถลอก/ล้อแม็กหลังซ้ายถลอกอย่าง
สภาพบดมา/สภาพยางคู่หลังเสื่อมสภาพปี 21 ภายใน(Interior) : - เครื่องยนต์(Engine) : วิเคราะห์ปัญหาด้วยเครื่อง
OBDII ไม่พบสิ่งผิดปกติ (ไม่ได้ทดสอบขับเคลื่อน) โครงสร้าง(Frame) :-

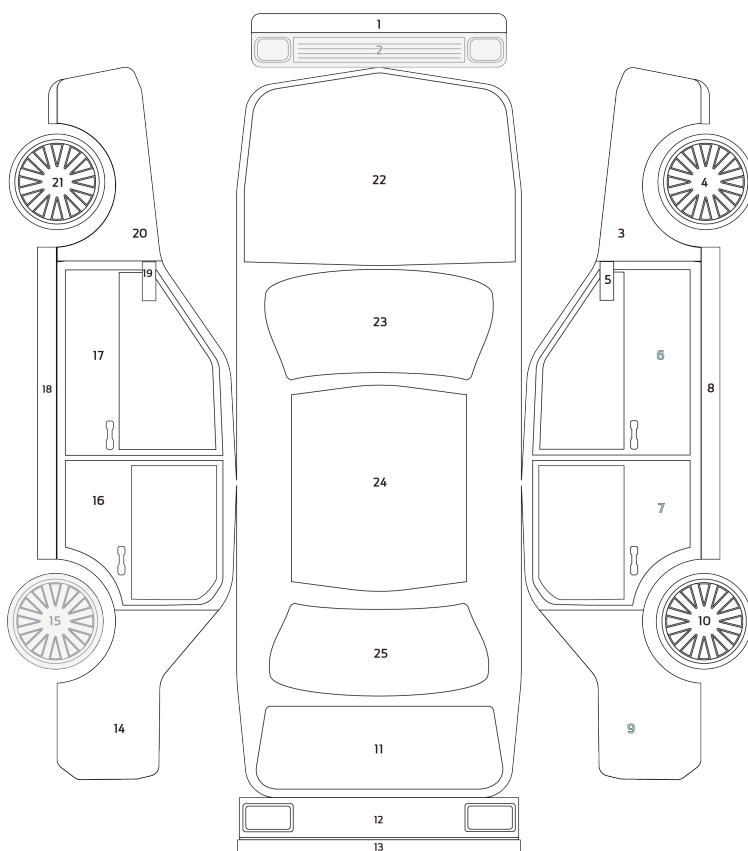
Exterior Inspection Points

1. Front Skirt	O	14. Left Skirt	O
2. Front Bumper	O (S2)	15. Left Wing Mirror	O
3. Front Right Fender	O	16. Front Windshield	O
4. Front Right Wheel	O	17. Roof	O
5. Front Left Fender	O	18. Rear Right Fender	O
6. Front Left Wheel	O	19. Rear Bonnet	O
7. Front Bonnet	O	20. Back Right Wheel	O
8. Right Wing Mirror	O	21. Rear Bumper	O
9. Front Right Door	O	22. Rear Skirt	O
10. Rear Right Door	O	23. Rear Left Fender	O
11. Right Skirt	O	24. Back left wheel	O (S2)
12. Rear Left Door	O	25. Back Windshield	O
13. Front Left Door	O

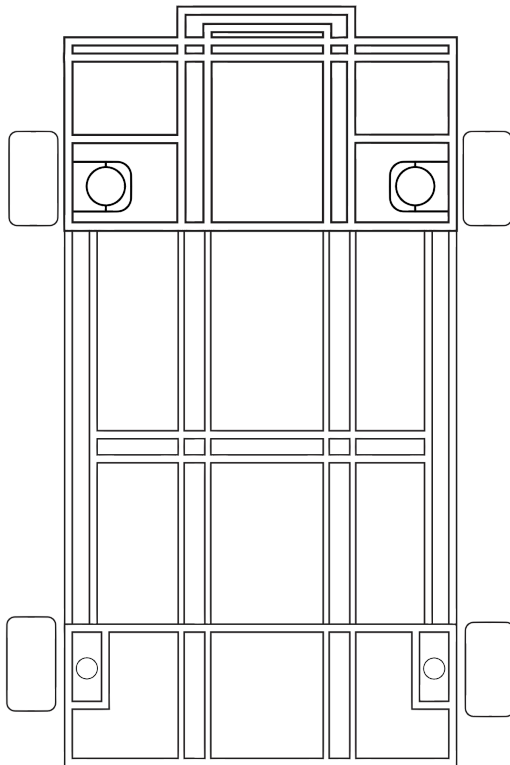
Chassis Report

No dent in the under carriage	PASS
No deform chassis or chassis frame	PASS
No visible corrosion on the chassis or chassis frame	PASS
No missing part on the chassis frame	PASS
Half cut Analysis	PASS

Chassis Damage Level	No Damage
----------------------	-----------
