# Preowned Vehicle Inspection Report

Customer Name	: MERCEDES-BENZ MOBILITY (THAILAND) CO., LTD.	Inspection Date	: 2024-09-17
Tel.	: _____	Lemon Inspection ID	: LEMON24090149
Inspector	: ແກນຮັກ ທີພຍົມອົບນົກ	Approved By	: Yoskongsak B

Brand	MERCEDES BENZ	Model year	2020
Model	E300	Engine Code - No.	27492031902429
Sub-model	e AMG Dynamic	Registration year	2021-08-02
License Plate		Chassis No.	W1K2130536L031163
Current Mileage(km.)	180866	Engine Capacity(cc.)	1991

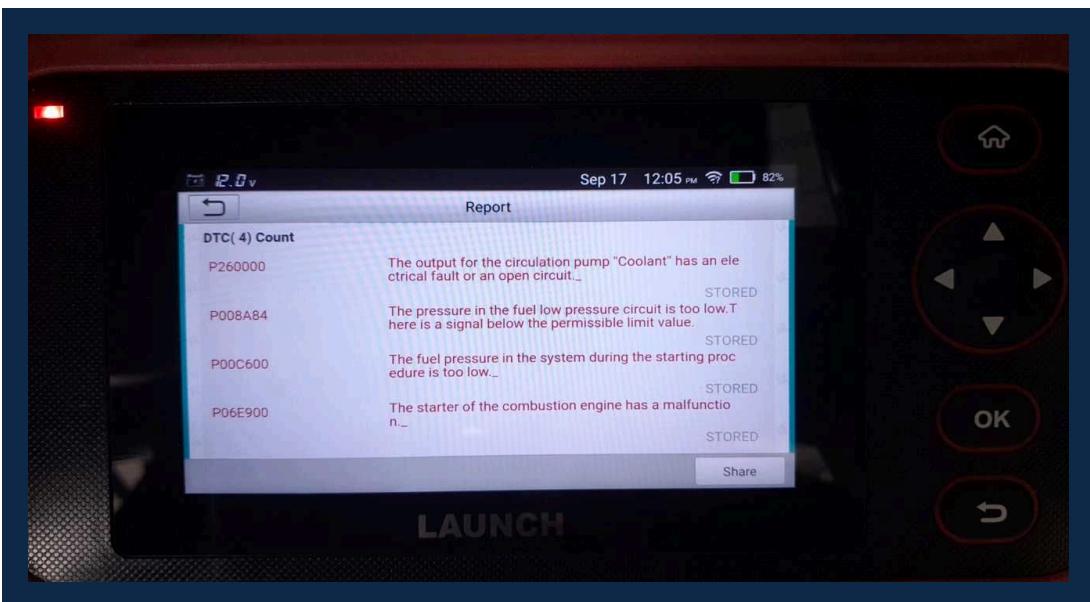
## OBD Vehicle Health Analysis

**Inspector :** ภายนอก(Exterior) : พบรการกำลังไฟกระปองหน้า 1 ชั้น / รั้วรอยขีดข่วนเล็กน้อย / ยางเสื่อมสภาพ 2 เส้น  
แม็กเป็นรอยคลอก ภายใน(Interior) : เบาะหน้าขวาเป็นรอยคลอกเล็กน้อย เครื่องยนต์(Engine) : วิเคราะห์ปัญหาด้วย  
เครื่อง OBDII พบร่องผิดปกติ P26000 P008A84 P00C600 P06E900 แบบนำตรวจเช็ค (ไม่ได้ทดสอบขับขี่) /  
แบบเตอร์สำรองเสื่อมสภาพ โครงสร้าง(Frame) : -

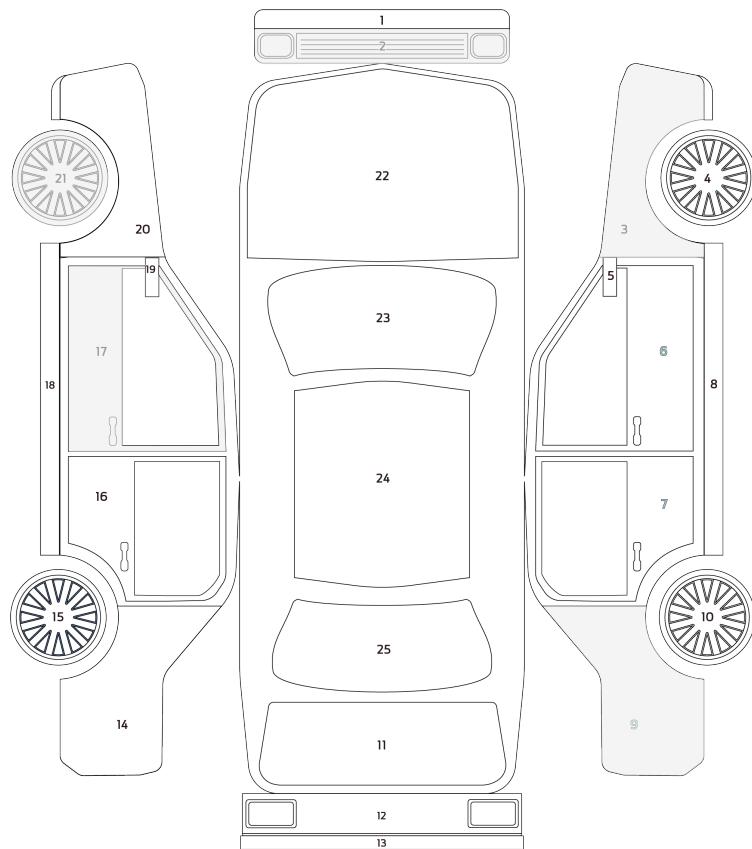
## Exterior Inspection Points

1. Front Skirt	O	14. Left Skirt	O
2. Front Bumper	O (S1)	15. Left Wing Mirror	O
3. Front Right Fender	O (S1)	16. Front Windshield	O
4. Front Right Wheel	O	17. Roof	O
5. Front Left Fender	O	18. Rear right fender	O (S1)
6. Front Left Wheel	O (S1)	19. Rear Bonnet	O
7. Front Bonnet	O	20. Back Right Wheel	O
8. Right Wing Mirror	O	21. Rear Bumper	O
9. Front Right Door	O	22. Rear Skirt	O
10. Rear Right Door	O	23. Rear Left Fender	O
11. Right Skirt	O	24. Back Left Wheel	O
12. Rear Left Door	O	25. Back Windshield	O
13. Front left door	O (S1)

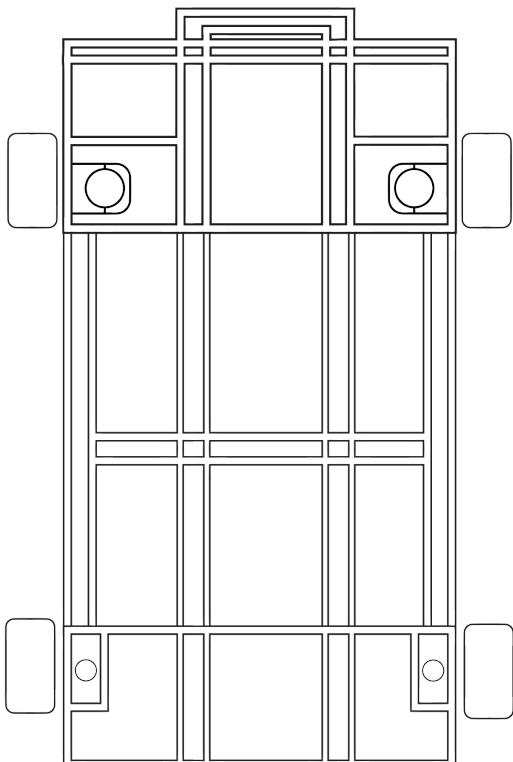
## Chassis Report

No dent in the under carriage	PASS
No deform chassis or chassis frame	PASS
No visible corrosion on the chassis or chassis frame	PASS
No missing part on the chassis frame	PASS
Half cut Analysis	PASS

Chassis Damage Level	No Damage
----------------------	-----------
