Preowned Vehicle Inspection Report

Premium Inspection Analysis

| Tel. | : | Lemon Inspection ID | : LEMON24090148 |

| Model | GLA250 | Engine Code - No. | 27092031813710 |

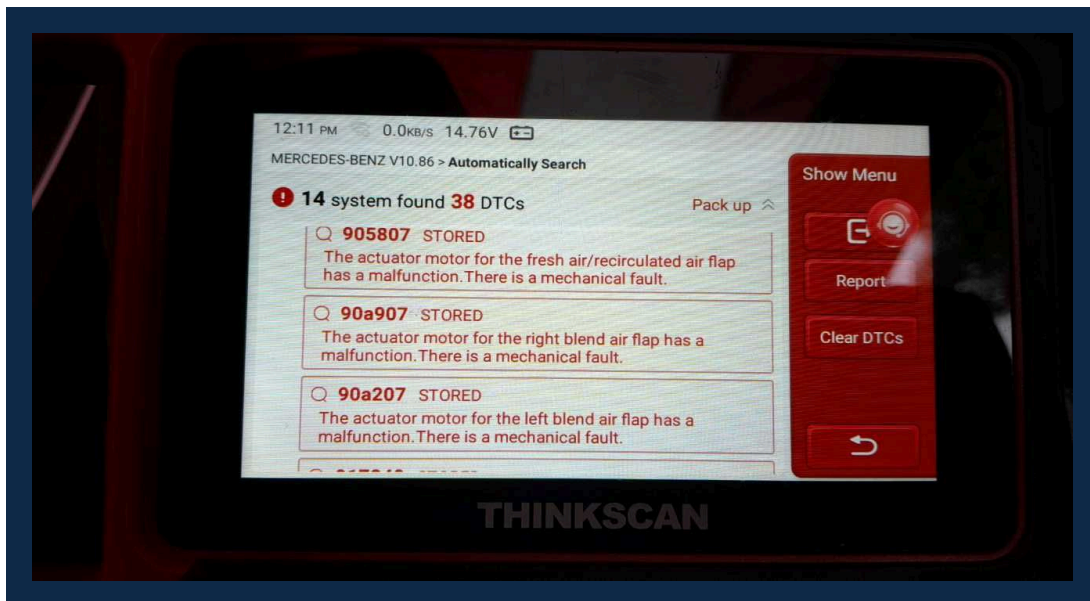
OBD Vehicle Health Analysis

Inspector : ภายนอก : กันชนท้ายแตก ขอบประตูหลังซ้ายถลอก ประตูหน้าซ้ายขีดข่วน ภายใน : แพงหลังคามีรอยเข็ม เครื่องยนต์กลไก : ไฟเครื่องโชว์ ตรวจสอบด้วยเครื่อง OBD พบ Code a10d00 / P056200 แรงดันน้ำมันเชื้อเพลิง ผิดปกติ 056200 /051300 แรงดันไฟฟ้าต่ำ B229D77 /B210C16 /B21A11C /B210C77 ระบบเบรกจอดผิดปกติ CO10000 แรงดันไฟฟ้าต่ำเกินไป B210D00 /U119800 แห้งจ่ายไฟผิดปกติ B1F4500 /B22A31C /U141E00 /B210C16 /B219500 /B219400 /P126F11 /P25567B /U11A302 /U118A02 สัญญาณกล่องควบคุมSAM ผิดปกติ B210F16 /B210316 แรงดันไฟฟ้าต่ำไป B210A84 /B210D16 /U012187 แรงดันไฟฟ้าต่ำเกินไป 90a907 90a207 917849 905849 90a949 90a249 ระบบปรับอากาศแรงดันไฟฟ้าต่ำ B22A31C สัญญาณควบคุมภายในผิดปกติ โครงสร้าง : - other : แบตเตอรี่หมดไม่สามารถวัดค่าเริ่มก่อนสตาร์ทได้

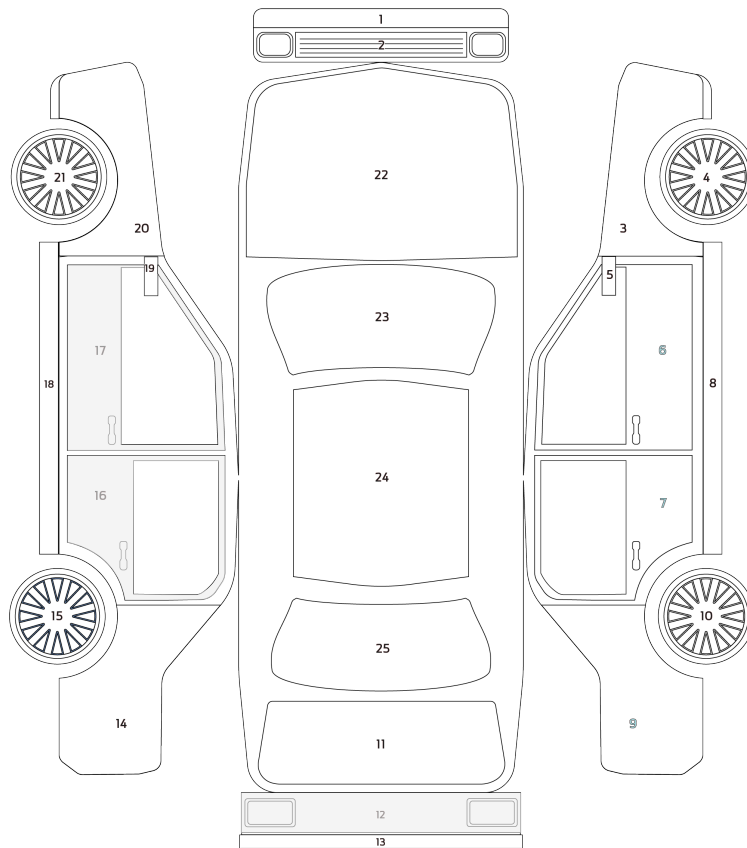
Exterior Inspection Points

| 8. Right Wing Mirror | O | 21. Rear Bumper | O (Y) |
| 12. Rear Left door | O (S1) | 25. Back Windshield | O |
| 13. Front left door | O (S1) | | |
