# Preowned Vehicle Inspection Report

Premium Inspection Analysis

Customer Name	: MERCEDES-BENZ MOBILITY (THAILAND) CO., LTD.	Inspection Date	: 2024-09-17
Tel.	: <a href="tel:08123456789">08123456789</a>	Lemon Inspection ID	: LEMON24090155
Inspector	: ເອກົງລົງ ປັສີລາວ	Approved By	: Chaimongkol C

Brand	MERCEDES BENZ	Model year	2022
Model	C43	Engine Code - No.	27682331150726
Sub-model	AMG 4MATIC (Coupe)	Registration year	2023-03-15
License Plate		Chassis No.	W1K2053646L066435
Current Mileage(km.)	21155	Engine Capacity(cc.)	3000

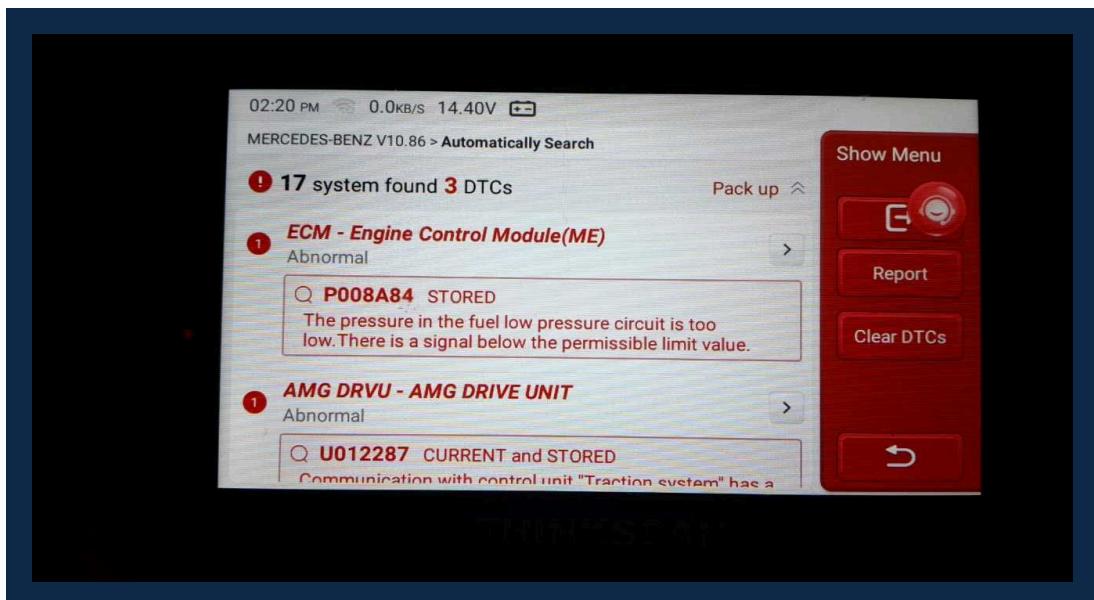
## OBD Vehicle Health Analysis

**Inspector :** ภายนอก : ไม่พบหลักฐานการทำสีเก็บสี กันชนก้ายหัดข่วน สภาพยางปักติกั้ง 4 เส้น ปี 23 ภายใน : โดยรวมสะอาดเรียบร้อย อุปกรณ์ไฟฟ้าทำงานได้ปกติ เครื่องยนต์ : เครื่องยนต์สามารถทำงานได้ครบปกติ ไม่พบคราบน้ำมันรั่วซึม ตรวจสอบด้วย OBD wu code /P008A84 แรงดันในวงจรแรงดันต่ำ เชือเพลิงมากเกินไปต่ำ มีสัญญาณต่ำกว่าค่าจำกัดที่ได้รับอนุญาต /U012287 ระบบควบคุมความเร็วอัตโนมัติผิดปกติ /P1C5C00 Battery แรงดันแบบเตอร์ผิดปกติ โครงสร้างหลักปกติ ไม่พบหลักฐานการซ่อมแซม
