# Preowned Vehicle Inspection Report

Premium Inspection Analysis

| Tel. | : | Lemon Inspection ID | : LEMON24090163 |

| Model | C300 | Engine Code - No. | 27492031798482 |

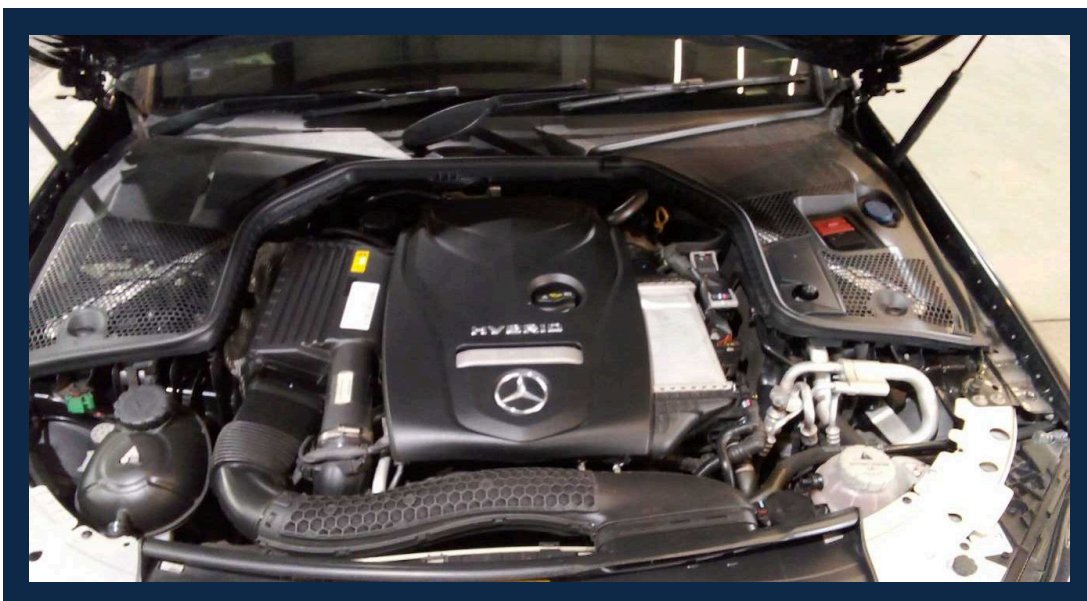
**Vehicle Engine Image**

| Conditions Report | Details |
|---|---|
| 1. Battery Status | Fail |
| 2. Resting Voltage(V.) | 11 |
| 3. Charging Voltage(V.) | 11 |

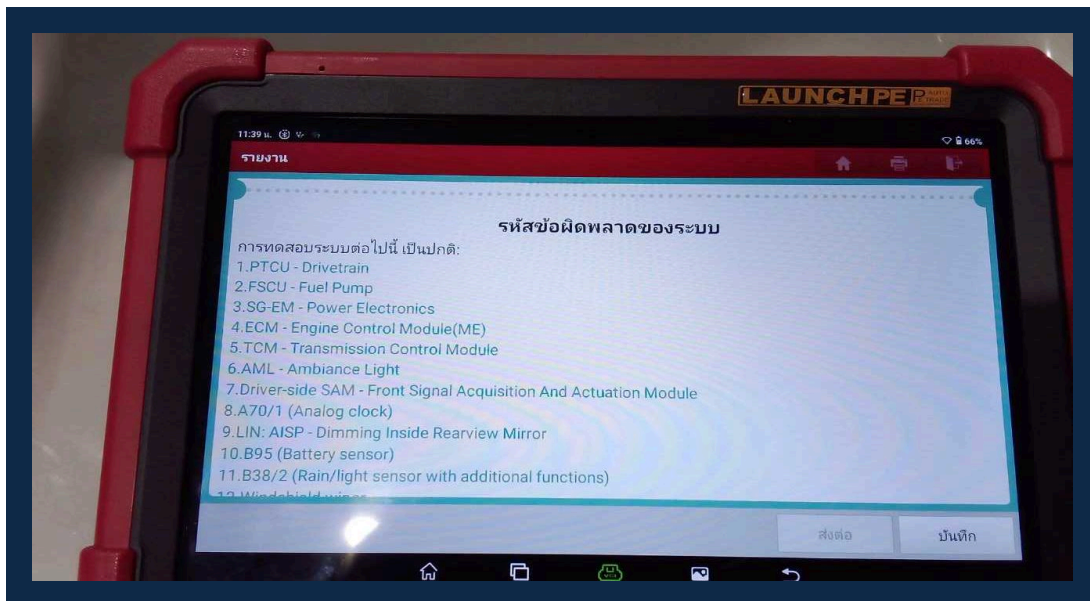
**OBD Vehicle Health Analysis**

**Inspector :** ภายนอก(Exterior) : บังโคลนหลังขวาบุบ สภาพยางเสื่อมทั้ง4เส้น ปี18 ภายใน(Interior) : -  
เครื่องยนต์(Engine) : แบบเตอरीเสื่อมสภาพ / วิเคราะห์ปัญหาด้วยเครื่อง OBDII ไม่พบสิ่งผิดปกติ (ไม่ได้ทดสอบขับเคลื่อน)  
โครงสร้าง(Frame) : -

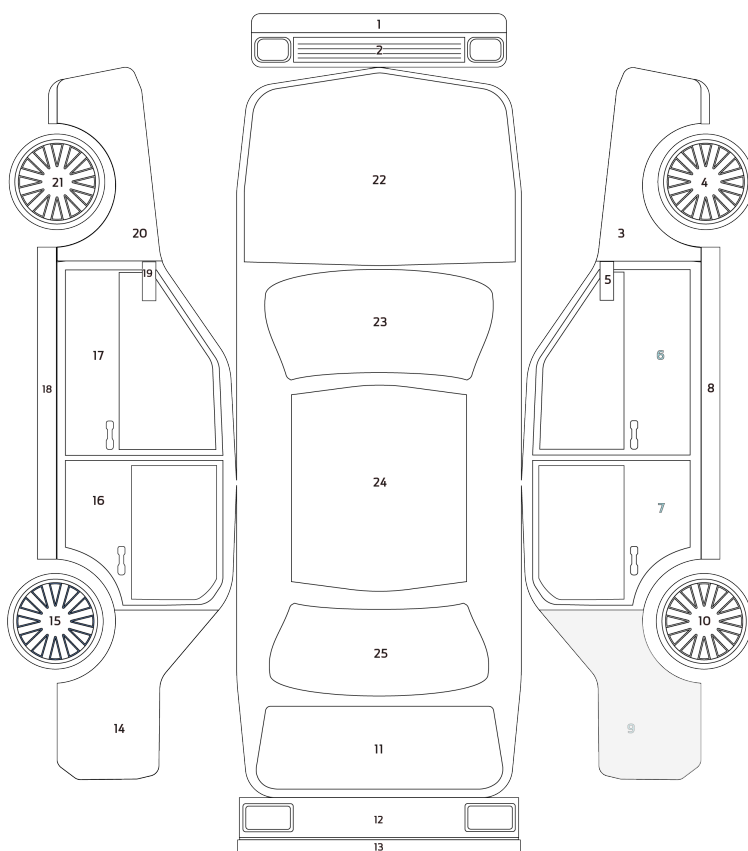
## Exterior Inspection Points

| 5. Front Left Fender | O | 18. Rear right fender | O (D2) |
