Preowned Vehicle Inspection Report

Premium Inspection Analysis

Customer Name	: MERCEDES-BENZ MOBILITY (THAILAND) CO., LTD.	Inspection Date	: 2024-04-12
Tel.	: 0873663242	Lemon Inspection ID	: LEMON24040088
Inspector	: Aekkawit Tee Bunleng	Approved By	:

Brand	MERCEDES BENZ	Model year	2021
Model	GLA200	Engine Code - No.	28291430636010
Sub-model	URBAN	Registration year	2021-12-01
Registration No.	1UQ1924	Chassis No.	W1N2477876L003158
Current Mileage(km.)	84957	Engine Capacity(cc.)	1300

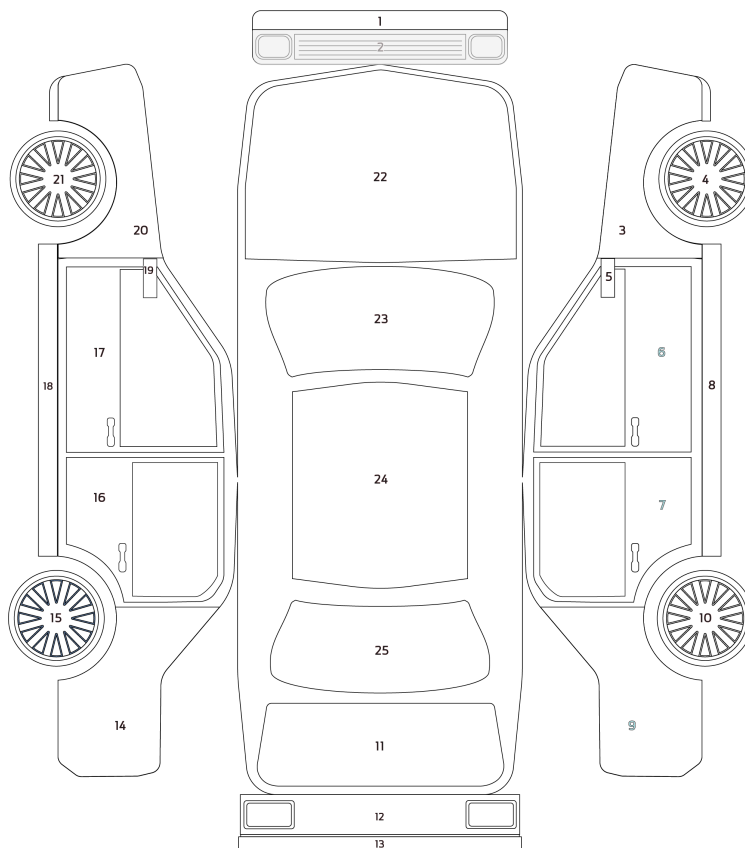
Exterior Inspection Points

1. Front Skirt	O	14. Left Skirt	O
2. Front Bumper	O (D2)	15. Left Wing Mirror	O
3. Front Right Fender	O	16. Front Windshield	O
4. Front Right Wheel	O	17. Roof	O
5. Front Left Fender	O	18. Rear Right Fender	O
6. Front Left Wheel	O	19. Rear Bonnet	O
7. Front Bonnet	O	20. Back Right Wheel	O
8. Right Wing Mirror	O	21. Rear Bumper	O
9. Front Right Door	O	22. Rear Skirt	O
10. Rear Right Door	O	23. Rear Left Fender	O
11. Right Skirt	O	24. Back Left Wheel	O
12. Rear Left Door	O	25. Back Windshield	O
13. Front Left Door	O
