Preowned Vehicle Inspection Report

Premium Inspection Analysis

Customer Name	: MERCEDES-BENZ MOBILITY (THAILAND) CO., LTD.	Inspection Date	: 2024-07-11
Tel.	:	Lemon Inspection ID	: LEMON24070171
Inspector	: แทนรัก ทิพย์อินทร์	Approved By	: ไชยมงคล ไพโรเสียง

Brand	MERCEDES BENZ	Model year	2018
Model	CLA200	Engine Code - No.	27091031720753
Sub-model	URBAN	Registration year	2020-07-21
Registration No.		Chassis No.	WDD1173436L010878
Current Mileage(km.)	283770	Engine Capacity(cc.)	1600

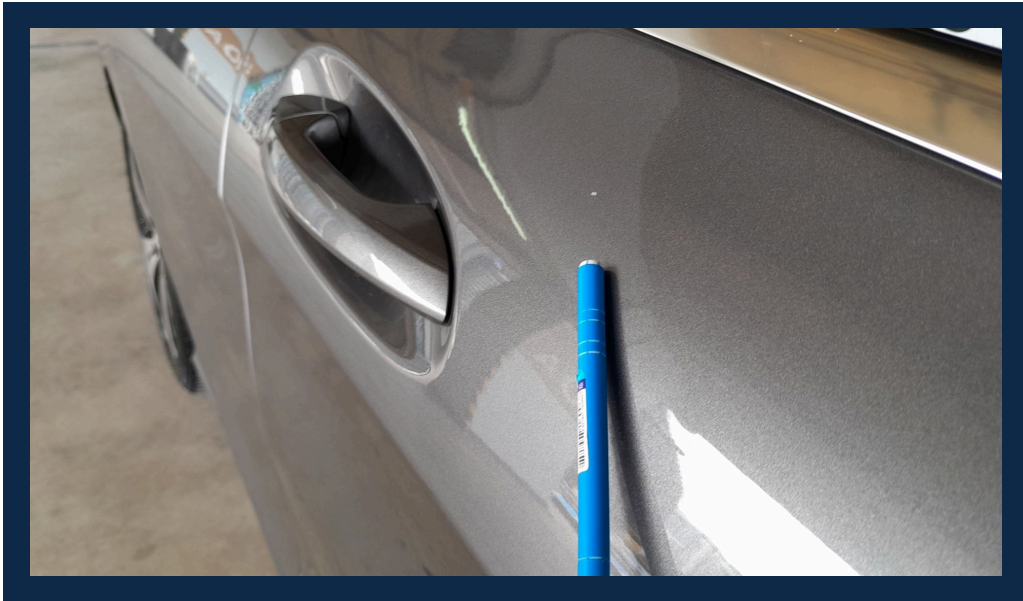
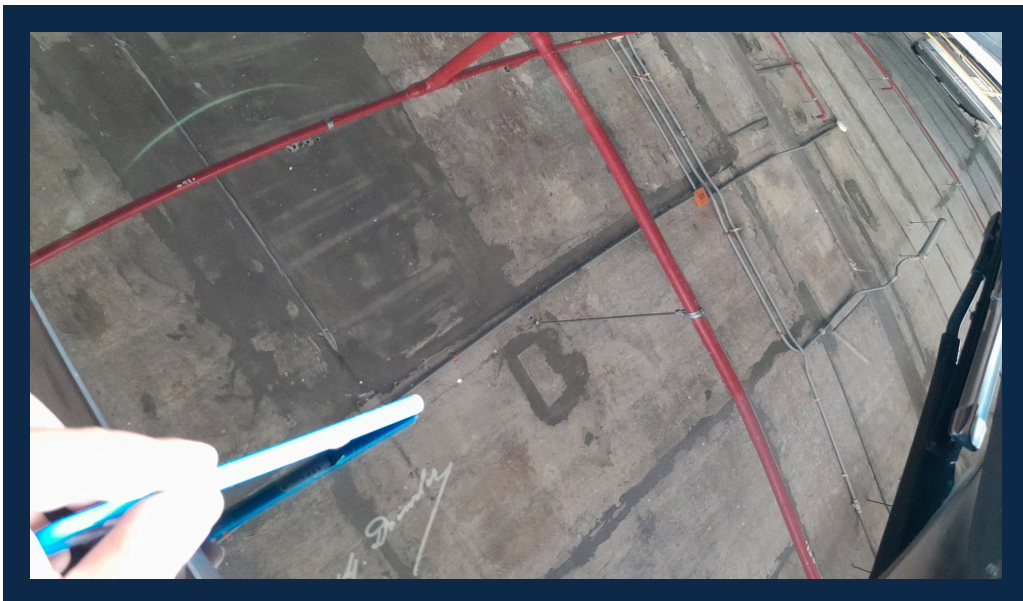
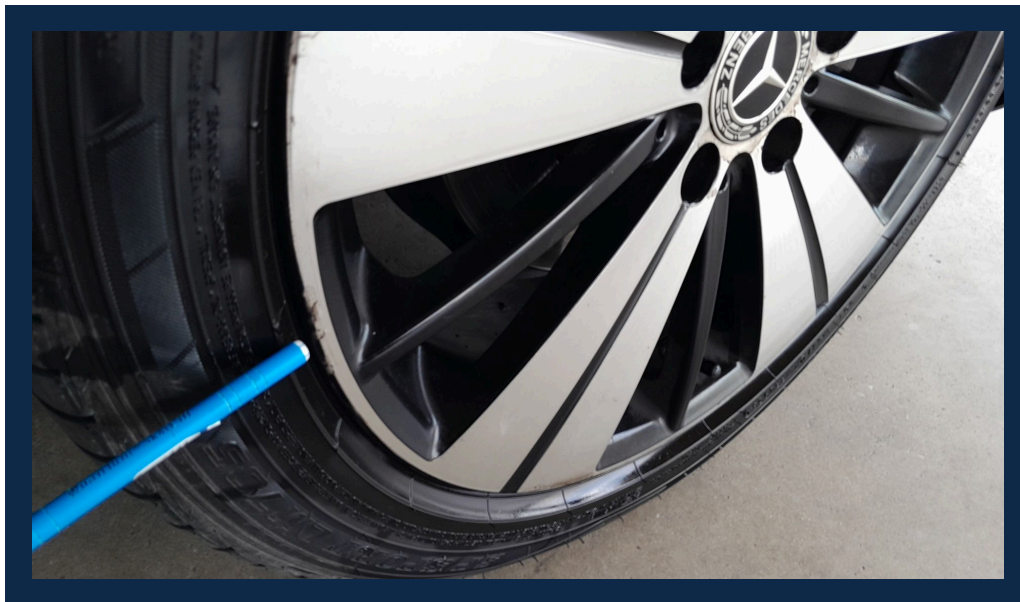
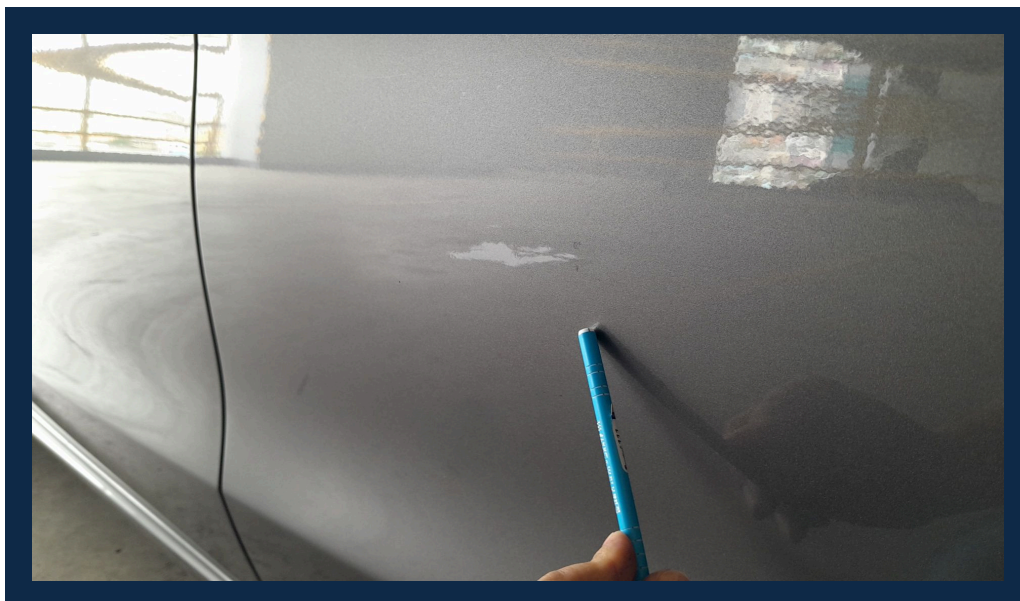
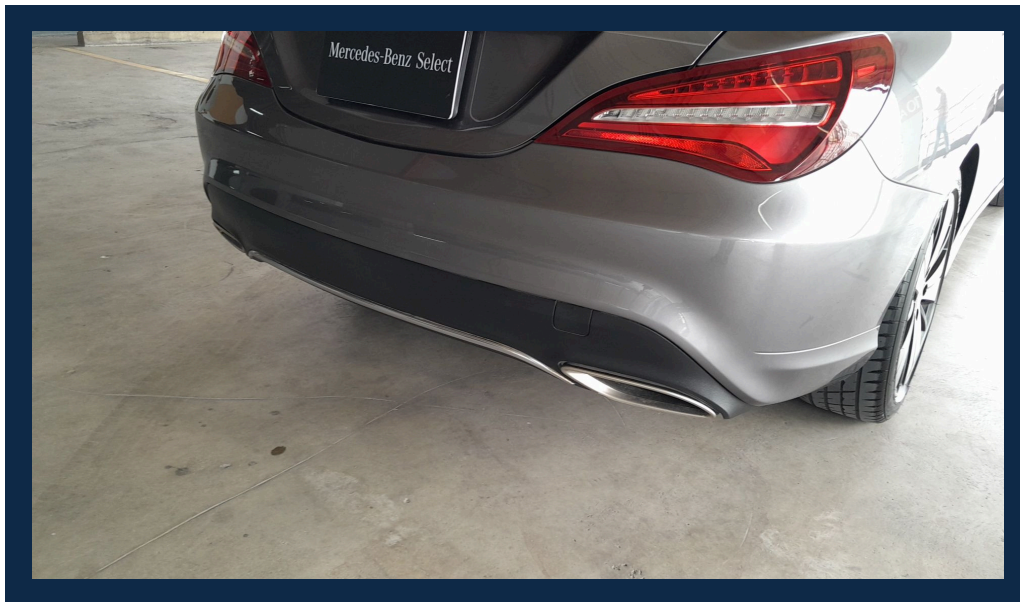
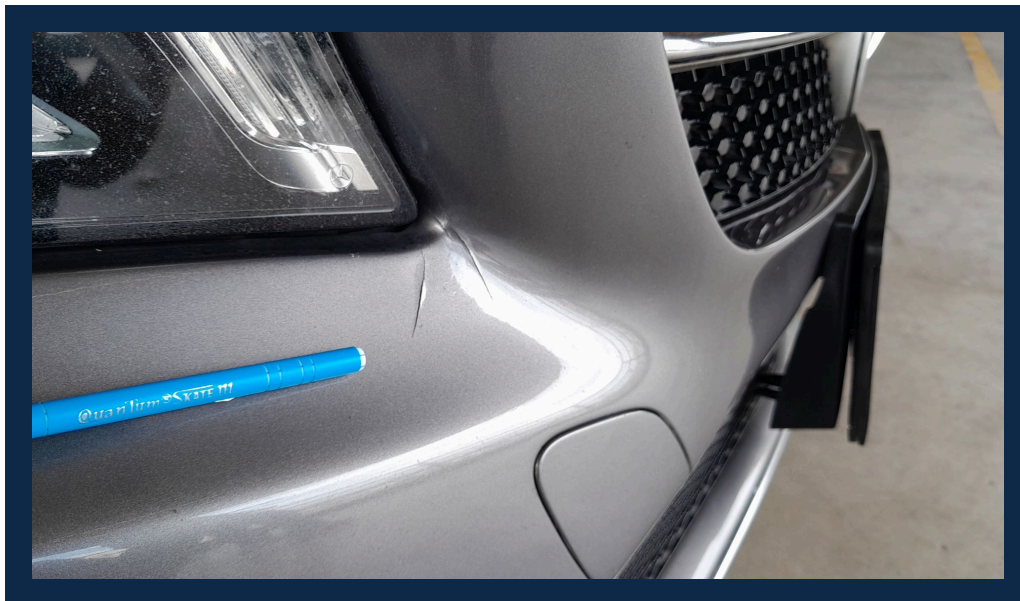
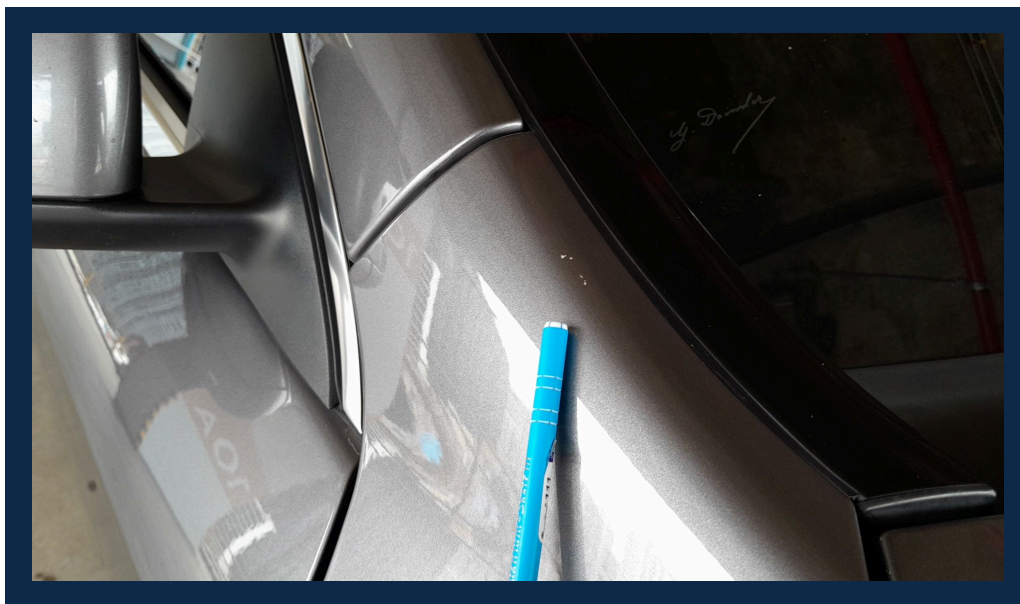
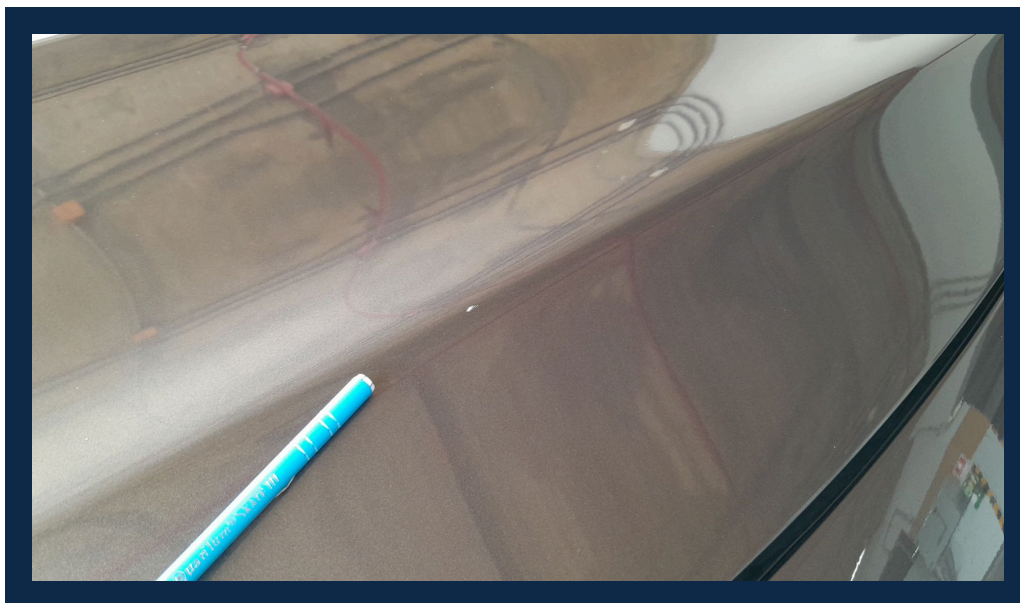
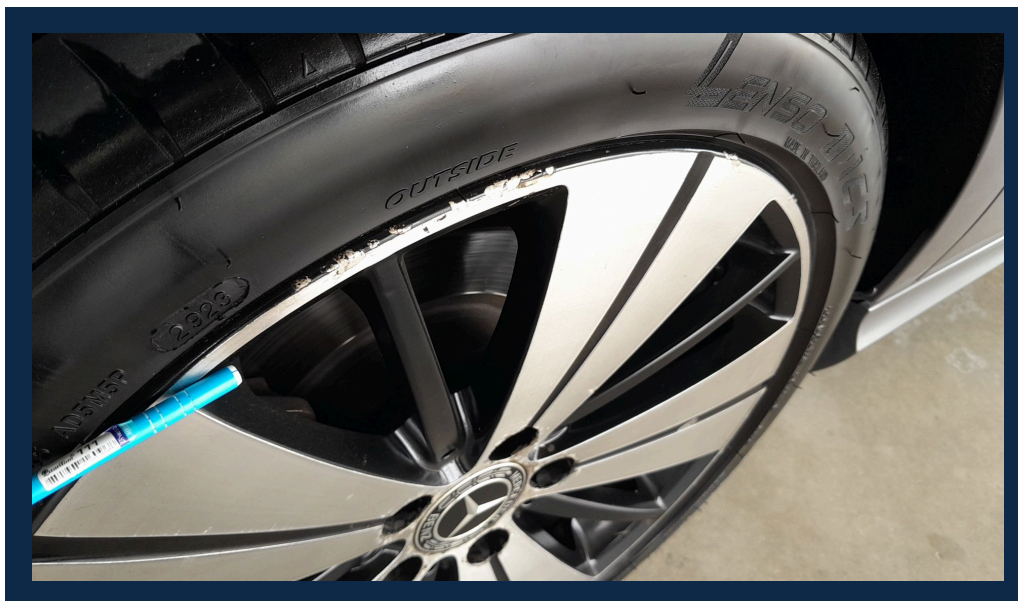
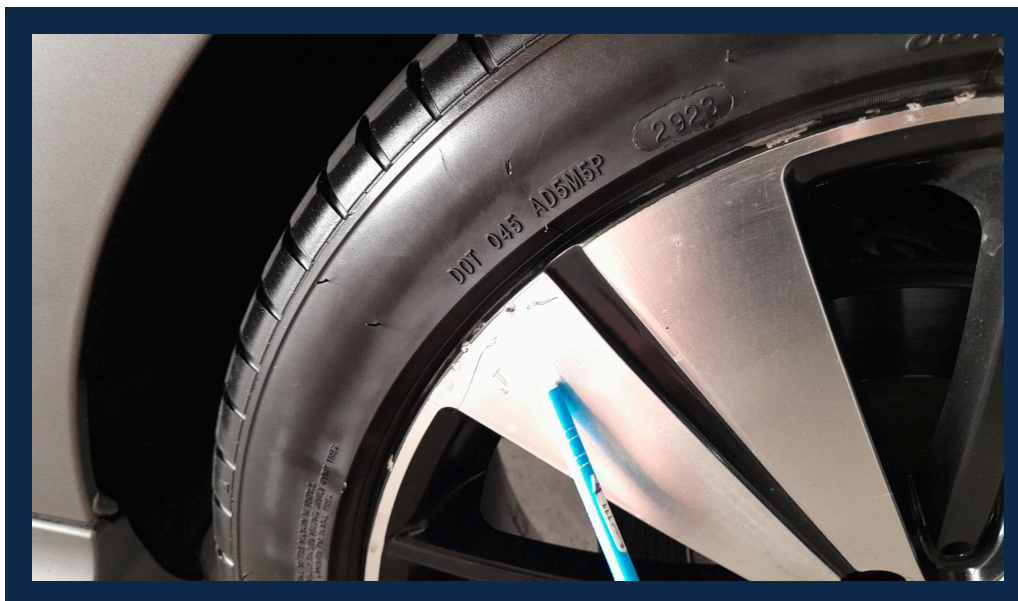
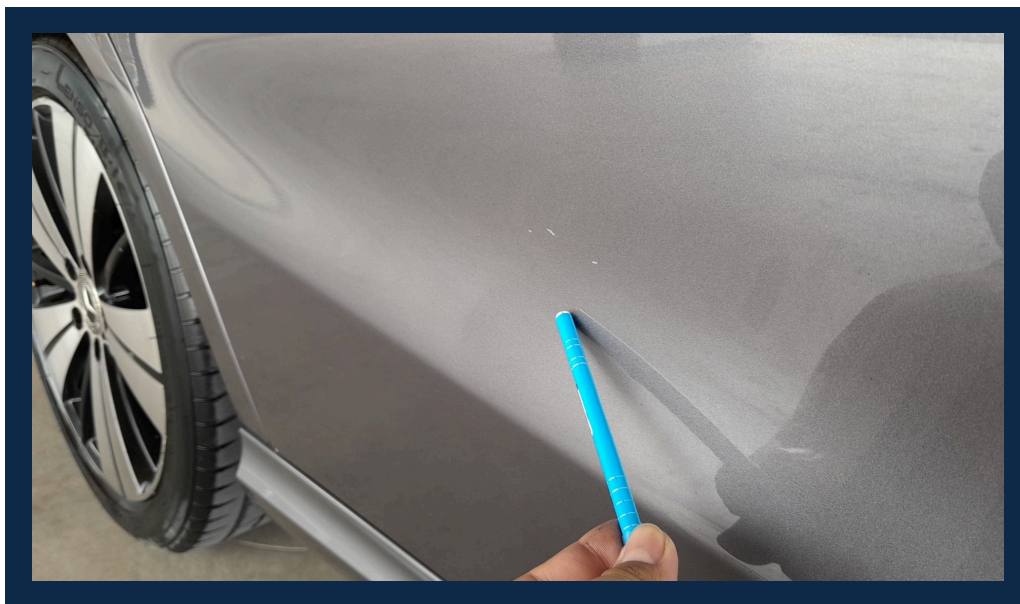
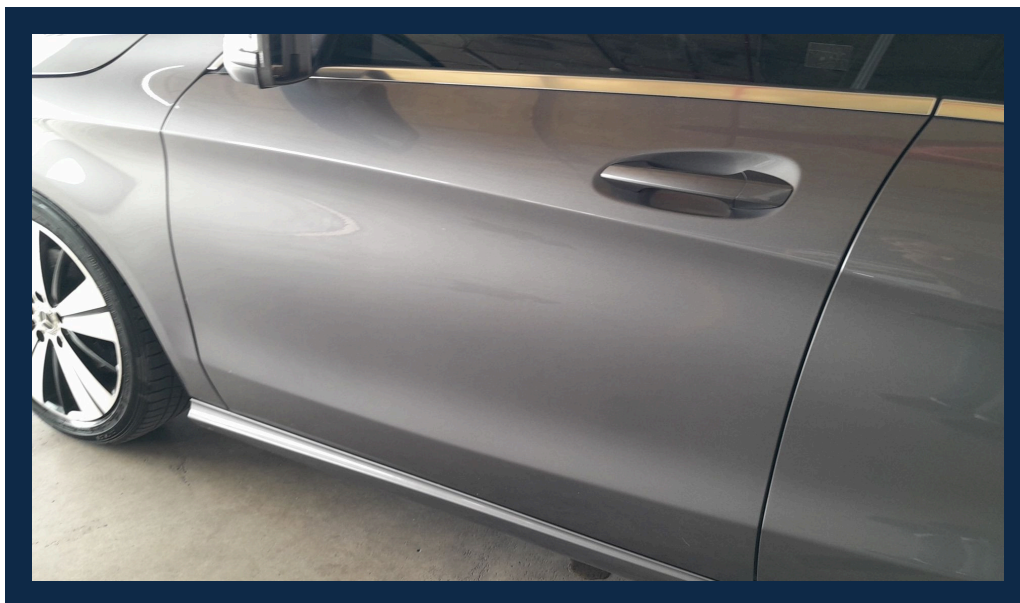
1. Front Skirt	O	14. Left Skirt	O
2. Front Bumper	BP (S1,Y)	15. Left Wing Mirror	O
3. Front Right Fender	O (S1)	16. Front windshield	N (G1)
4. Front Right Wheel	O (S1)	17. Roof	O
5. Front Left Fender	O	18. Rear Right Fender	O
6. Front Left Wheel	O	19. Rear Bonnet	O
7. Front bonnet	BP (S1)	20. Back right wheel	O (S1)
8. Right Wing Mirror	O	21. Rear Bumper	BP
9. Front right door	O (S1)	22. Rear Skirt	O
10. Rear right door	O (S1)	23. Rear Left Fender	O
11. Right Skirt	O	24. Back left wheel	O (S1)
12. Rear Left door	BP (S1)	25. Back Windshield	O
13. Front left door	BP

Inspector : ภายนอก(Exterior) : การตรวจสภาพภายนอก โดยรวมพบหลักฐานการซ่อมแซมทำสีมาบ้างชิ้น ไร้รอยถลอกรอบคัน / สภาพยางปกติทั้ง4เส้น ปี 23 ล้อแม็กเป็นรอยถลอก ภายใน(Interior) : ภายในเบาะหน้าขวาเป็นรอยขาด ตัวเปิดเบาะหน้าซ้ายชำรุด สะอาดเรียบร้อย , อุปกรณ์ไฟฟ้า แอร์ วิทยุFM ใช้งานได้ตามมาตรฐานครบปกติ
