Preowned Vehicle Inspection Report

Premium Inspection Analysis

Lemon Inspection ID : LEMON24080194

Brand	MERCEDES BENZ	Model year	2019
Model	GLA200	Engine Code - No.	27091031911618
Sub-model	Urban	Registration year	2020-02-07
License Plate		Chassis No.	WDC1569436L013667
Current Mileage(km.)	44618	Engine Capacity(cc.)	1600

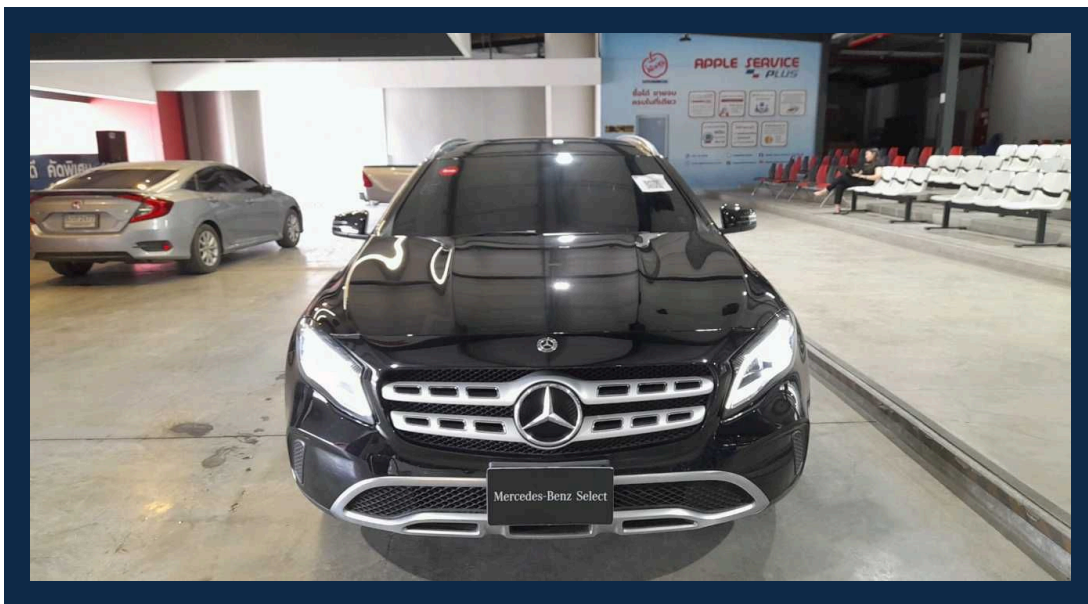
Vehicle Front Image

Inspector : หมายเหตุ* ภายนอก(Exterior) : การตรวจสภาพภายนอกโดยรวมไม่พบหลักฐานการซ่อมแซมทำสี กระโปรงหน้ารอยหินกระแทะ ประตูหน้าขวาเป็นรอย กันชนหน้าครูด/ สภาพยางเสื่อม4เส้น ปี19 ภายใน(Interior) : ภายในปกติไม่มีความเสียหาย สะอาดเรียบร้อย ,อุปกรณ์ไฟฟ้า แอร์ วิทยุFM ใช้งานได้สมบูรณ์ครบปกติ

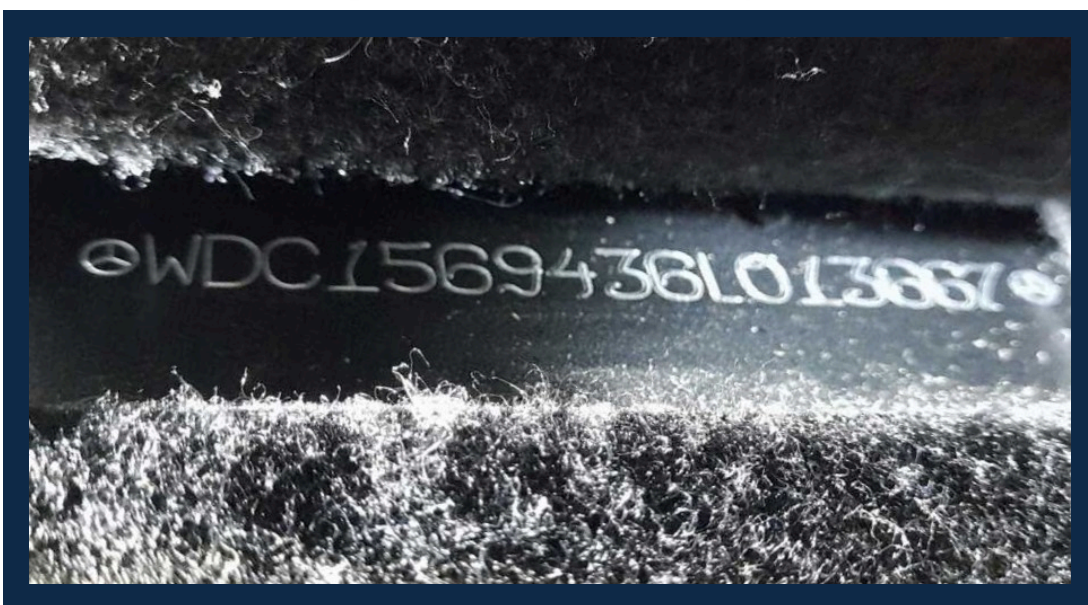
Vehicle Chassis Image

No dent in the under carriage (th)	PASS
No deform chassis or chassis frame (th)	PASS
No visible corrosion on the chassis or chassis frame (th)	PASS
No missing part on the chassis frame (th)	PASS
Half cut Analysis (th)	PASS
Chassis Damage Level	No Damage

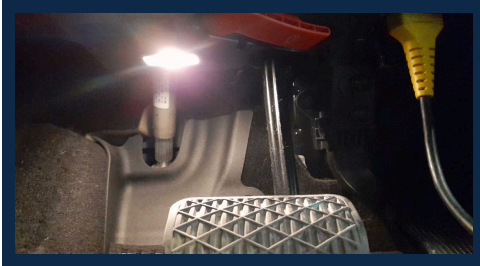
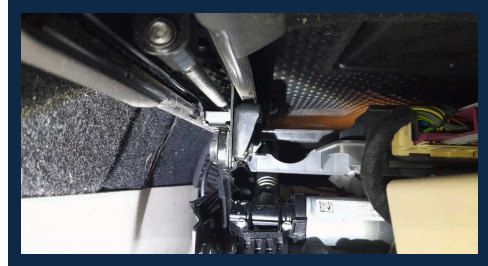
Flood Report

Evidence of Flood

No

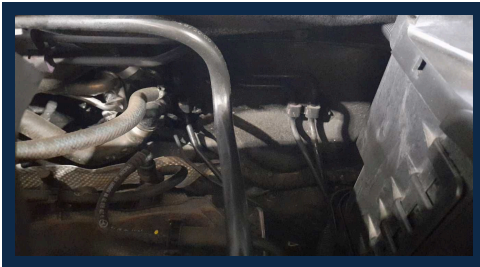
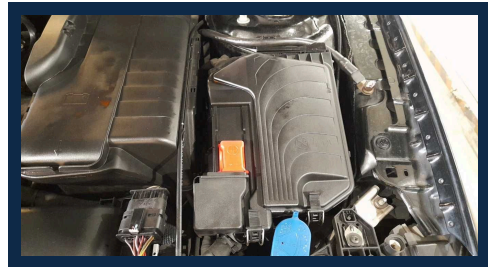
Fire Report

Evidence of Fire

No
