# Preowned Vehicle Inspection Report

Premium Inspection Analysis

| Tel. | : | Lemon Inspection ID | : LEMON24080317 |

| Brand | MERCEDES BENZ | Model year | 2020 |

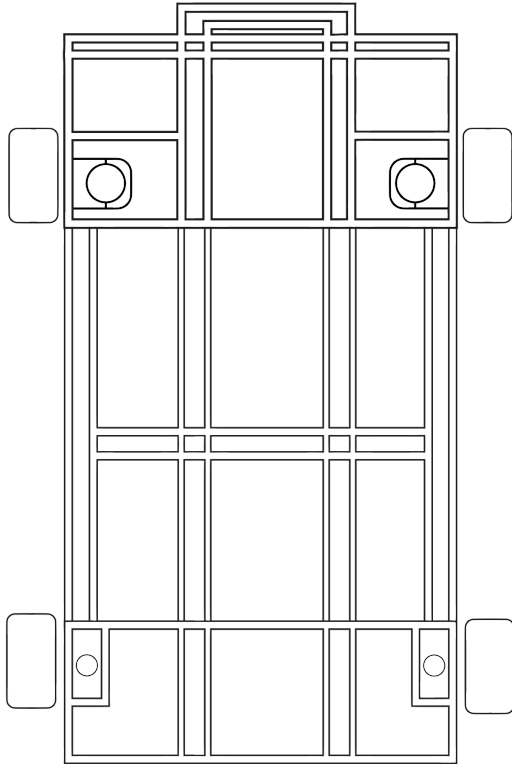
**Chassis Report**

| No dent in the under carriage | PASS |
| No deform chassis or chassis frame | PASS |
| No visible corrosion on the chassis or chassis frame | PASS |
| No missing part on the chassis frame | PASS |
| Half cut Analysis | PASS |

| Chassis Damage Level | No Damage |
