Preowned Vehicle Inspection Report

Premium Inspection Analysis

Brand	MERCEDES BENZ	Model year	2021
Model	C300	Engine Code - No.	27492031969629
Sub-model	e AMG Sport	Registration year	2022-07-04
License Plate		Chassis No.	W1K2050536L063390
Current Mileage(km.)	55097	Engine Capacity(cc.)	2000

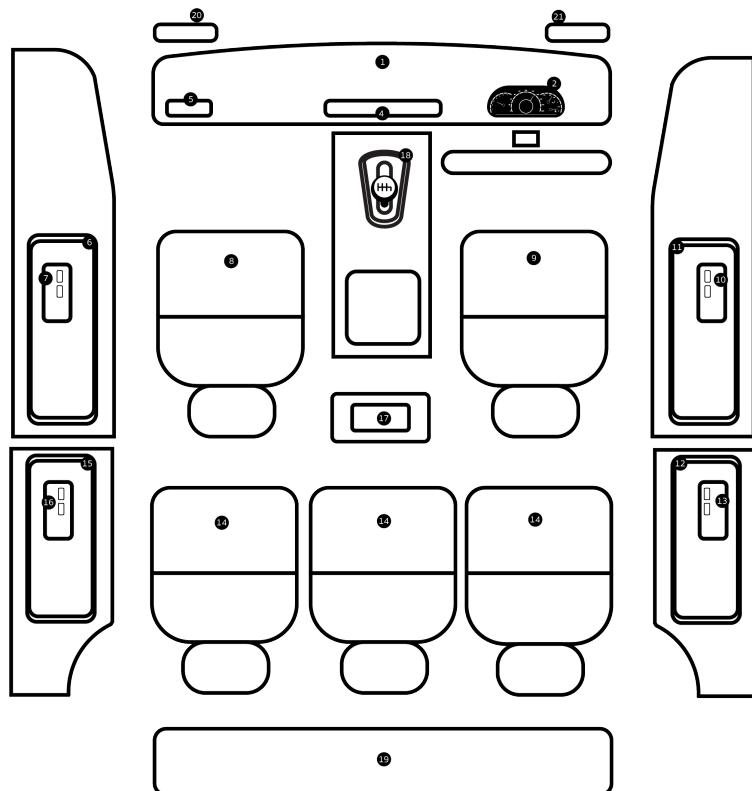
Interior Inspection Points

Scratched/Faded items	S
Sunken/Sagging car seats	D
Tear/Cracks	Y
Failed Electrical Equipment	E
