# Preowned Vehicle Inspection Report

Premium Inspection Analysis

Customer Name	: MERCEDES-BENZ MOBILITY (THAILAND) CO., LTD.	Inspection Date	: 2024-09-17
Tel.	: <a href="tel:08123456789">08123456789</a>	Lemon Inspection ID	: LEMON24090155
Inspector	: ເອກົງລົງ ປັສີລາວ	Approved By	: Chaimongkol C

Brand	MERCEDES BENZ	Model year	2022
Model	C43	Engine Code - No.	27682331150726
Sub-model	AMG 4MATIC (Coupe)	Registration year	2023-03-15
License Plate		Chassis No.	W1K2053646L066435
Current Mileage(km.)	21155	Engine Capacity(cc.)	3000

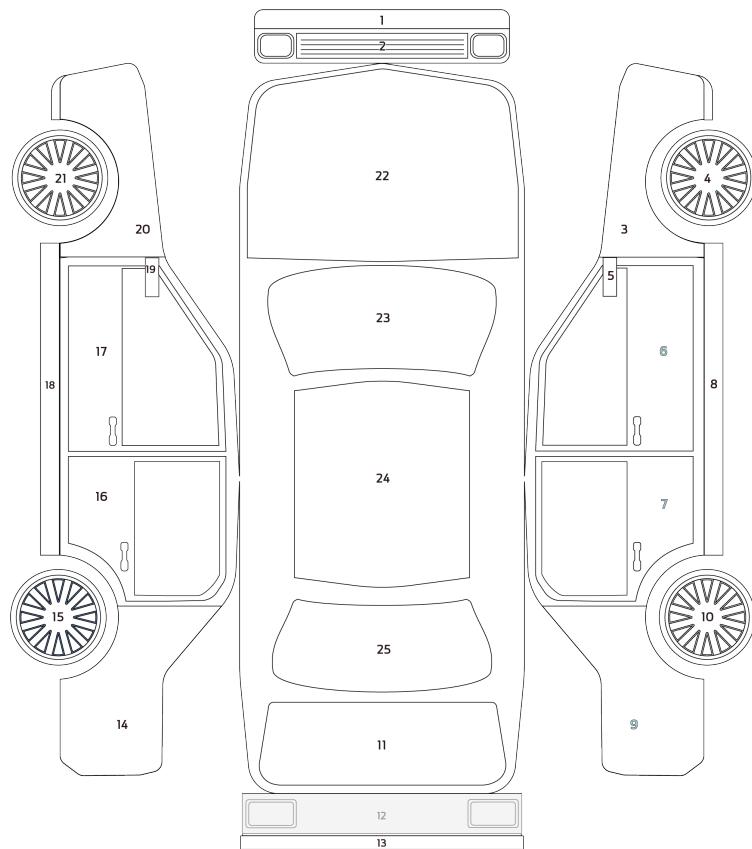
## Exterior Inspection Points

1. Front Skirt	O	14. Left Skirt	O
2. Front Bumper	O	15. Left Wing Mirror	O
3. Front Right Fender	O	16. Front Windshield	O
4. Front Right Wheel	O	17. Roof	O
5. Front Left Fender	O	18. Rear Right Fender	O
6. Front Left Wheel	O	19. Rear Bonnet	O
7. Front Bonnet	O	20. Back Right Wheel	O
8. Right Wing Mirror	O	21. Rear Bumper	O (S1)
9. Front Right Door	O	22. Rear Skirt	O
10. Rear Right Door	O	23. Rear Left Fender	O
11. Right Skirt	O	24. Back Left Wheel	O
12. Rear Left Door	O	25. Back Windshield	O
13. Front Left Door	O

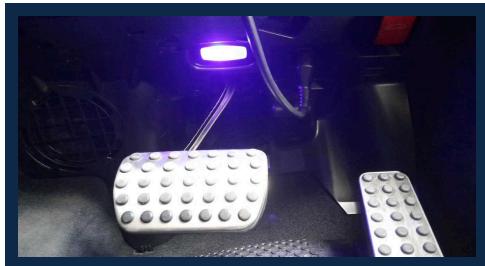
**Flood Report**

Evidence of Flood

No

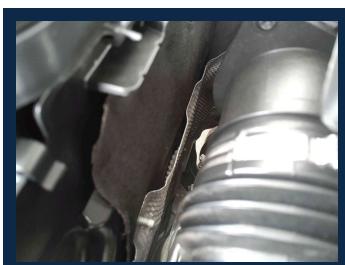
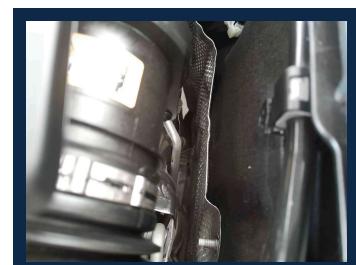
**Fire Report**

Evidence of Fire

No
