# Preowned Vehicle Inspection Report

Premium Inspection Analysis

| Tel. | : | Lemon Inspection ID | : LEMON24090163 |

| Model | C300 | Engine Code - No. | 27492031798482 |

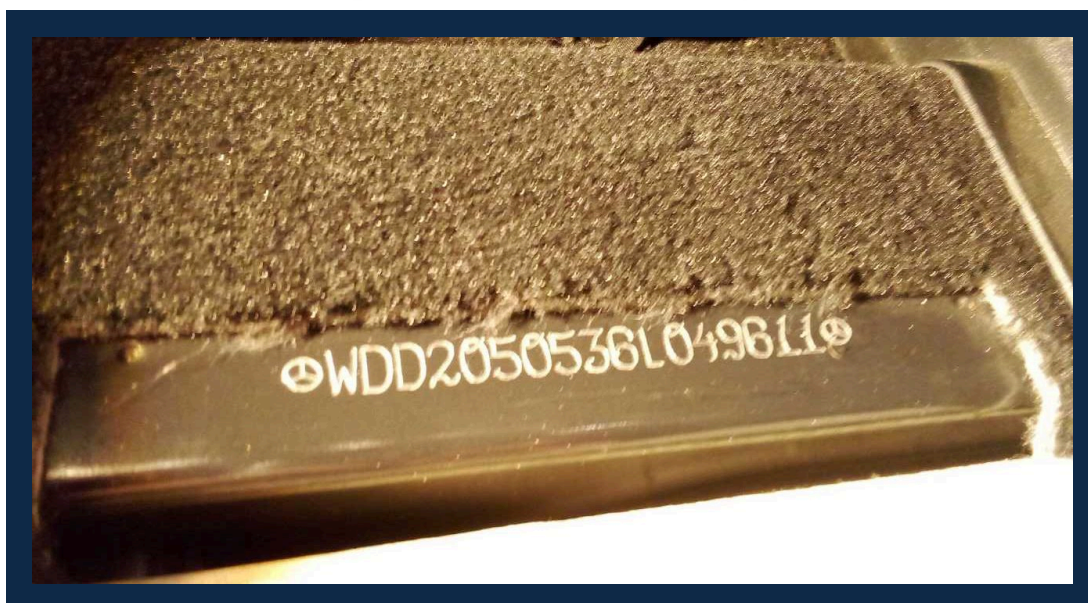
Vehicle Chassis Image

| No dent in the under carriage | PASS |
| No deform chassis or chassis frame | PASS |
| No visible corrosion on the chassis or chassis frame | PASS |
| No missing part on the chassis frame | PASS |
| Half cut Analysis | PASS |

| Chassis Damage Level | No Damage |

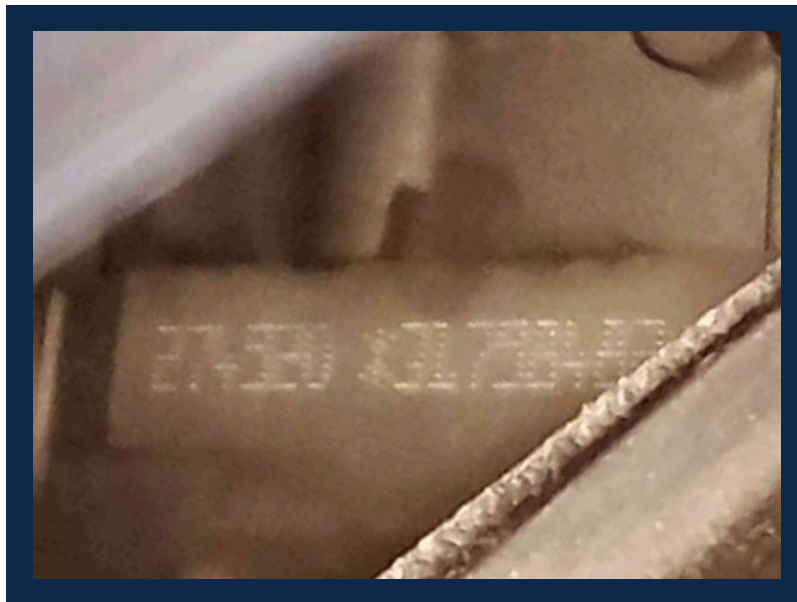
**Vehicle Engine Number Image**

| 1. Vehicle Engine Number Analysis | PASS | 14. Air Conditioning and Heating System | PASS |

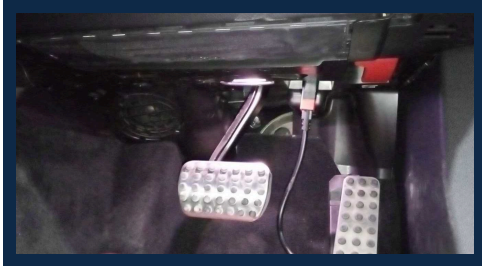
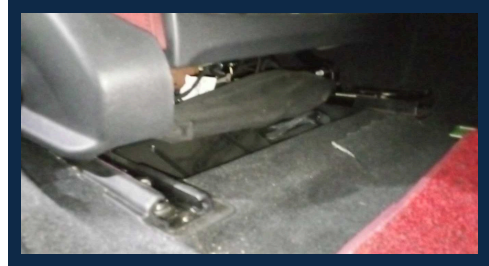
Evidence of Flood

No

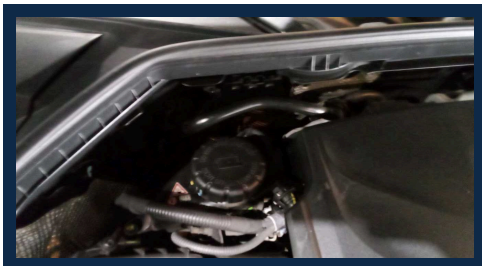
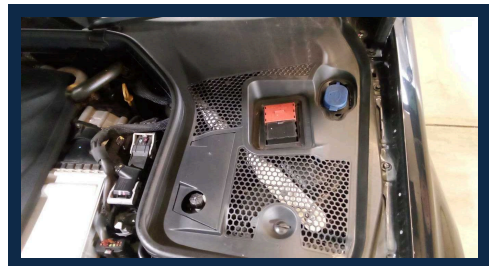
**Fire Report**

Evidence of Fire

No
